Hamar ruin

Archaeological investigations 1996-1998

Stan Reed

Reed, S. 2004. Hamar Cathedral ruin. Archaeological investigations 1996-1998. - NIKU Rapport 6: 1-244.

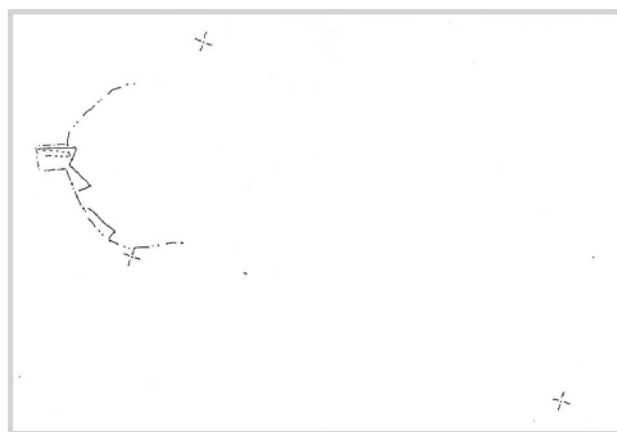
Fig. 28. Group 1:3, area R96.

Group 1:3 consists of the remains of a stone structure, probably a wall (R240) in the crossing. Two flat stones, laid side by side with mortar on their upper surface, were exposed in the eastern end of grave cut R131. The top of one of the stones was partially uncovered, the mortar on its surface clearly indicated that another stone had been mortared onto its surface. No other parts of the structure were exposed. The stones lay c. 0.50m under R169, the mortar surface interpreted as the earliest floor level in the crossing and c. 0.65m under R70 the later tile floor. R240 had no connection to the structure of the cathedral. It was overlain by a number of deposits, dumped as make-up, (group 2:16 and group 2:17) to build up the ground surface to the level required for the use of the cathedral. It was clearly part of a structure, as it was

only partially uncovered in the edge of grave cut R131 it is difficult to interpret however. It might be a temporary structure connected to the construction of the cathedral, but as it was mortared this seems unlikely. The make-up deposits that overlay it included a thick deposit of mortar and stone (R238, group 2:17) which indicates the demolition of a stone structure. Mortar and stone demolition deposits were also used as make-up outside the west front of the cathedral (group 2:24), also indicating the demolition of a stone structure. It is possible in both cases that part of the cathedral was demolished and re-built. Both of these demolition layers appeared to be primary make-up deposits however, i.e. dumped at a very early stage of the construction process. These demolition layers support the tentative interpretation of R240 as the remains of an older stone structure that was demolished and replaced by the cathedral. Not enough of the structure was uncovered however to be sure of this interpretation or to suggest its size. The structure may not even have been completed before it was demolished to make way for the cathedral.

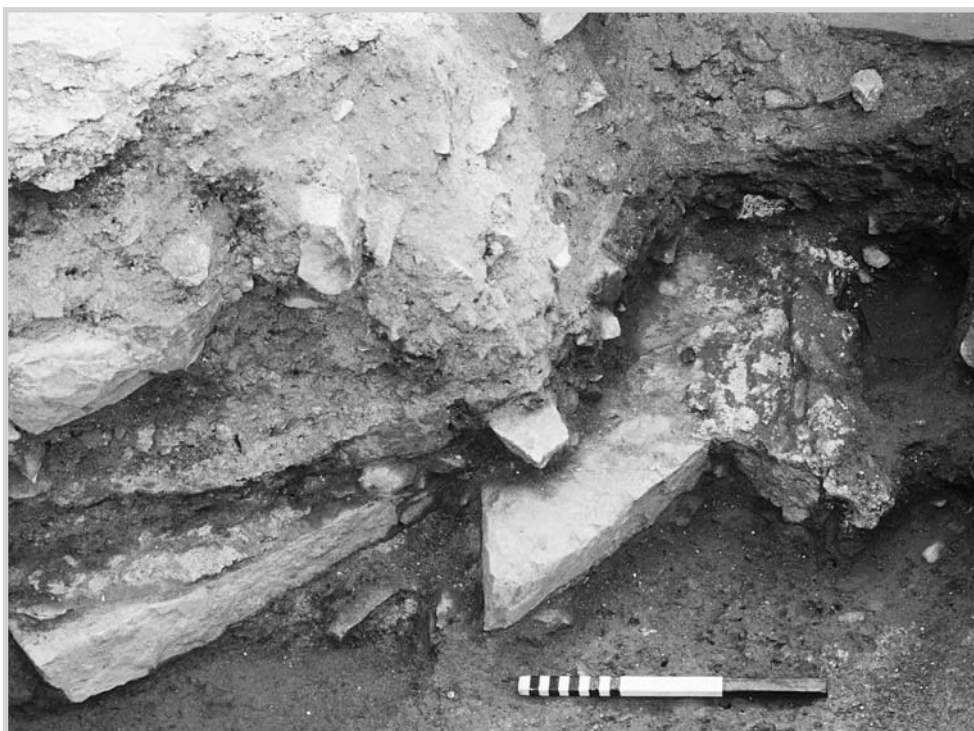
R240. Two flat stones exposed in the base of grave cut R131 (group 2:14), a small test area was excavated over the northernmost stone in order to document the structure. The stones were laid side by side, traces of mortar were present on the surface of both stones. The area of the northernmost stone that was exposed showed an imprint in the mortar that clearly indicated that another stone had been mortared onto the top of it. The stone appeared to be aligned roughly E/W, approximately the same alignment as the cathedral. There didn't appear to be any more stones beneath these two, but as the structure was not excavated this possibility cannot be excluded. R240 is interpreted as the remains of a wall that was demolished or dismantled. No other structural remains were visible in the opposite edge of the grave cut, neither was there any

Fig. 29. Wall remains R240, group 1:3, exposed in the base of grave cut R131 (group 2:14). Facing W. Photo Bruce Sampson, NIKU.

evidence of a return wall in the northern or southern edges. The grave cut bottomed out onto R239, the layer that appeared to cover these remains, but at a slightly lower level than the stones. It is therefore possible that more of the structure was extant at a lower level, below R239. It may also have been completely demolished or removed by the grave cut. Under R239.

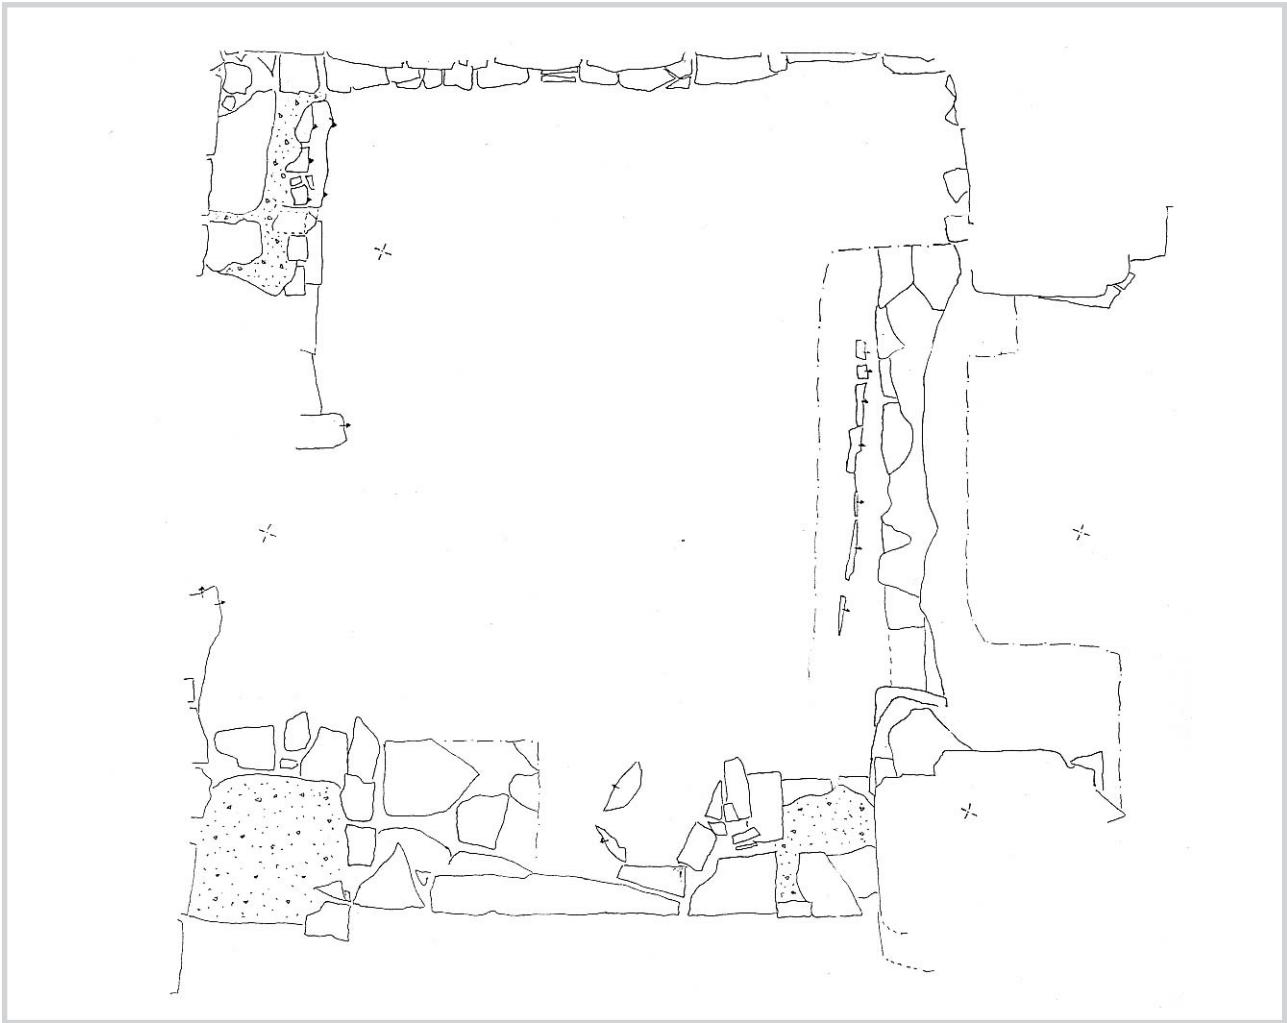
Fig. 31. Group 2:1, area R96, south aisle.

Group 2:1 consists of structural elements of the cathedral documented in the SW corner of the south aisle, in the room under the SW tower. Some of these remains consisted of upstanding masonry, whereas others were only partially exposed in the edges of cut features or through limited keyhole excavation. It appeared as though there had been some reworking of the standing structures in

this room, especially at its southern and eastern edges. As most of the features were only partially exposed it was impossible to record the complete sequence of stratigraphic relationships. The structural elements have been gathered into two groups (2:1 and 4:2). This group is interpreted as representing the original structural elements of the cathedral. Some of the features placed in this group should perhaps be placed in group 4:2 that documents the reworking activity however.

Group 2:1 included the cathedral walls and their foundations, a column base and a stone structure that ran between column base R372 and R377, the respond in the western wall. This was only partially uncovered but appeared to have been built up of several discreet contexts (R373, R374, R408 and R409). This foundation (R408) had a linear, E/W aligned southern edge, a mortar wall core (R409) and two mortar deposits (R373 and R374) laid across its upper surface. It may have been part of an older structure but was probably a foundation raft laid between the columns. Remains of a possible raft were also uncovered in the north arcade (see group 2:7).

standing stone implies that the area against column R372 may have been walled up. If there was an open arch here it would have been very narrow. It is possible that the area at the southern end of R330 was not a respond foundation but that both ends of R330 were walled, and the threshold sealed by a door, the upstanding stone forming one side of a door frame.

The southern wall of the cathedral had a foundation in the SW corner that was 0.80m thicker than the actual wall. The foundation was stepped and was given two context numbers (R379 and R380). Only 1.50m of the southern wall (R384) survived. Along the rest of the southern wall of the south aisle a one course high, cement bonded wall (R364, group 7:1) had been reconstructed in its place. The function of the wide foundation is unclear, it appeared to be confined to this room. The foundation of the western wall (R382) extended up to 0.20m out from under the upstanding wall (R383). The surface of the western wall appeared to have been partially reconstructed.

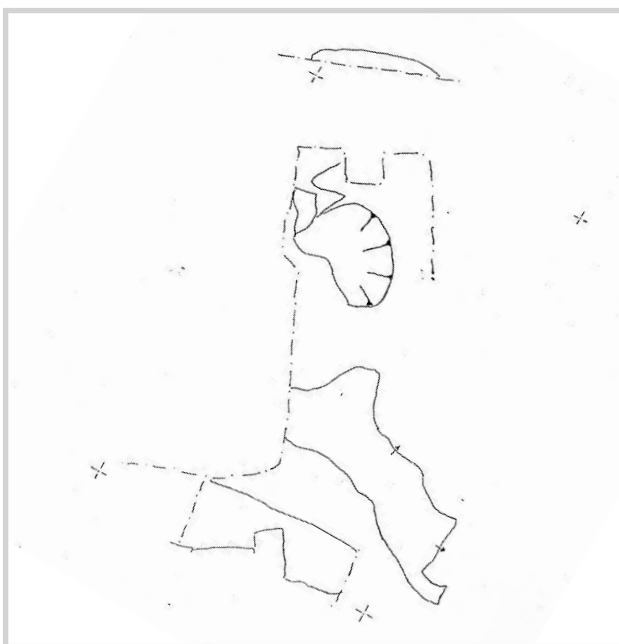
Fig. 32. Group 2:2, area R96, south aisle.

The stone working debris layers represent dumping of debris from the building of the cathedral. They were probably deposited as a result of stone working in this area. They were relatively thin and are not interpreted as waste deposits brought in from elsewhere as make-up.

R381. Mortar bonded stones seen in the base of cut R386. R381 was only partially exposed in a test slot cut through R385, the fill of cut R386. The test slot was immediately back-filled. R381 was not drawn. The slot was exposed against the northern edge of wall R380. The stones that were exposed were not facing stones, but appeared to be part of a wall core. It is uncertain whether R381 was part of a foundation for R380, a foundation that was wider than the wall itself, or part of an earlier structure that was demolished and re-built as R380. Under R385.

A possible foundation R381 (group 2:2) was uncovered in a small test trench dug through stone working debris R385. This context filled a cut feature (R386), but also extended beyond the cut. The remains of a mortar bonded wall core (R381) were uncovered in a small area. This may be an older structure, but was most likely part of a wide foundation for the southern wall. Cut R386 didn't run parallel with the southern wall, but it may have been a later feature that bottomed out upon the top of R381, rather than being a construction cut for R381. The alignment of cut R386 therefore doesn't necessarily reflect the alignment of structure R381. The rest of group 2:2 consisted of construction debris spread around the SW tower room. These layers were only partially exposed, they appeared to overlay the original turf horizon and the natural moraine clay (groups 1:1 and 1:2). This construction debris is interpreted as make-up dumping. It could be grouped together with a series of slaked lime deposits in period 4 (group 4:1), rather than being placed in period 2. No traces of the original floor in the SW tower room were uncovered.

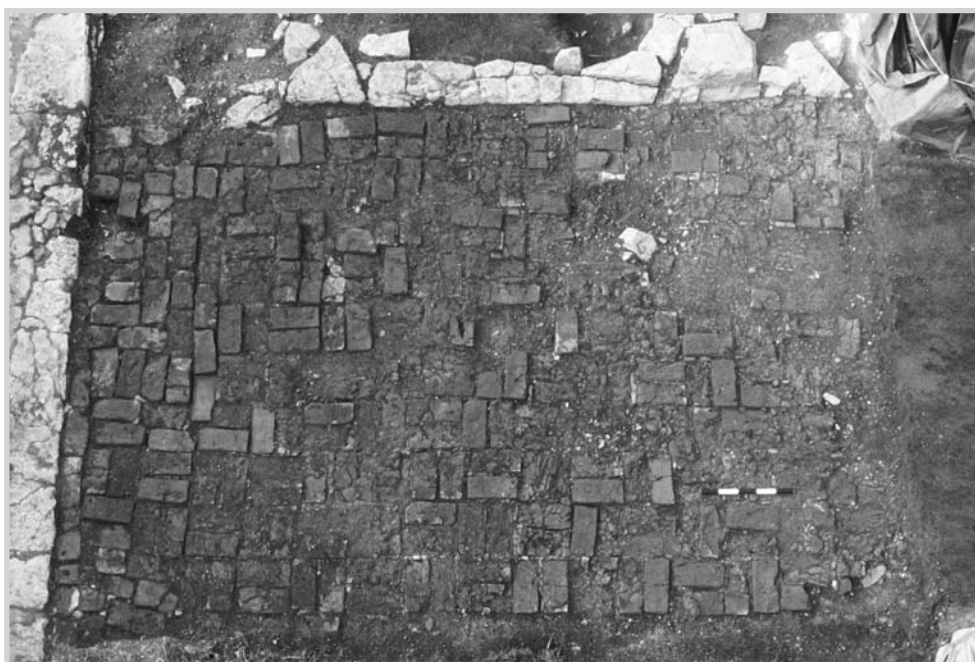
R179. Layer of mortar, serving as a bedding for brick floor R178. The mortar was also present between the bricks as bonding. The brick floor was well preserved in the exposed area such that R179 was mainly visible only between the bricks, but it is assumed to have lain under the bricks over the whole area. Under R178. Same as R98, R158 and R191.

Fig. 34. Brick floor R178, group 2:3 and threshold R330, group 2:1, area R96 (south aisle) looking W. Photo Bruce Sampson, NIKU.

The earliest floor surface recorded in the north and south aisles was of pairs of bricks set in a bed of mortar. This floor surface was uncovered in the SW and SE corners of the south aisle (groups 2:3 and 2:4 respectively) and in the north aisle (group 2:6). It was only uncovered where the overlying tile floor had not survived. In some places it appeared as though the bricks may have been removed prior to the laying of the tile floor, possibly to maintain the same level. The only documented remains older than this floor were interpreted as part of a foundation raft under the columns of the north arcade (group 2:7). No traces of this brick floor were uncovered in the crossing or the transepts. The mortar floor has been dated by a coin find as being in use by 1260, possibly earlier. Brick is known to have been in use in Norway around 1250 (Ekroll 1997:69). A grave excavated outside the west front in 1992 contained a coin and brick fragments. This find indicates that brick was in use at Hamar by 1263 (see Pedersen, E. A. 2000:196). It is possible that the crossing/transepts were completed prior to the use of brick in Hamar, but that the first floor in the nave and aisles was laid later, after brick was in use. No traces of an older surface were uncovered in the nave and aisles but the possibility that traces of an earlier mortar or stone floor lay beneath the brick floor cannot be discounted.

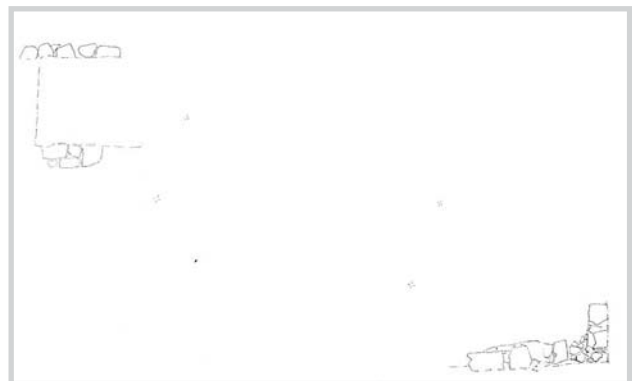
Fig. 36. Group 2:5, area R96, south aisle.

Group 2:5 consists of structural remains of the cathedral at the SE end of the south aisle. Two short sections of walling (R217 and R218) were partially uncovered, both were butted by R158, the bedding for brick floor R192, and were therefore earlier than the brick floor. The two sections of walling didn't appear to have been constructed simultaneously however as there no interleaving of the masonry. The function of these masonry remains is unclear. R218 may have been a thickening of the wall as an extra foundation in the corner where south aisle and the south transept met. The southern wall of the cathedral R216 (group 7:2) consisted of cement bonded stones, one course high, and appeared to be a reconstruction. An E/W aligned cut, R213, probably associated with the restoration of the wall ran along the inside of R216. The northern edge of this cut is the same as the northern edge of R217. It is possible that R217 was the remains of the southern wall of the cathedral, R217 was irregular however and was more likely part of the wall's foundation.

A stone and mortar bonded altar foundation (R188) protruded out from under reconstructed altar foundation R187. The altar foundation lay on the western side of the easternmost free-standing column in the south arcade. A gap of 0.20m on the northern side and 0.50m on the southern side was visible between R188 and the column base. Brick floor R192 and mortar bedding R157 (group 2:4) appeared to have been laid between R188 and the column base. A similar situation, where cement bonded stone altar foundations were constructed over the remains of the originals was also documented in the north arcade (group 2:7).

The documented structural elements in the SE corner of the south aisle, group 2:5, consisted of two walls (R217 and R218) and a stone altar foundation (R188). R217 was aligned E/W, R218 N/S. The two sections of walling were only uncovered in the actual SE corner of the south aisle. They appeared on the surface to butt one another, i.e. they were not interleaved and are therefore assumed to not be contemporary. R217 had been replaced to the east by the reconstructed southern wall of the cathedral (R364 group

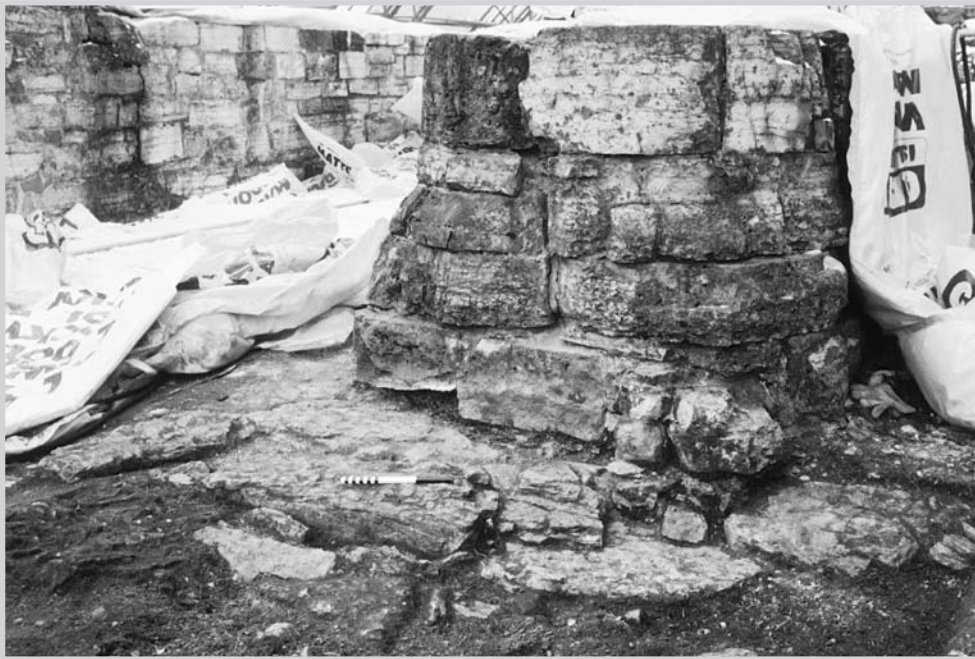
Fig. 39. Foundation R108, group 2:7 beneath and west of column base R111. Photo Bruce Sampson, NIKU.

R113. Remains of column foundation, barely visible beneath the eastern edge of column R111. Under R111.

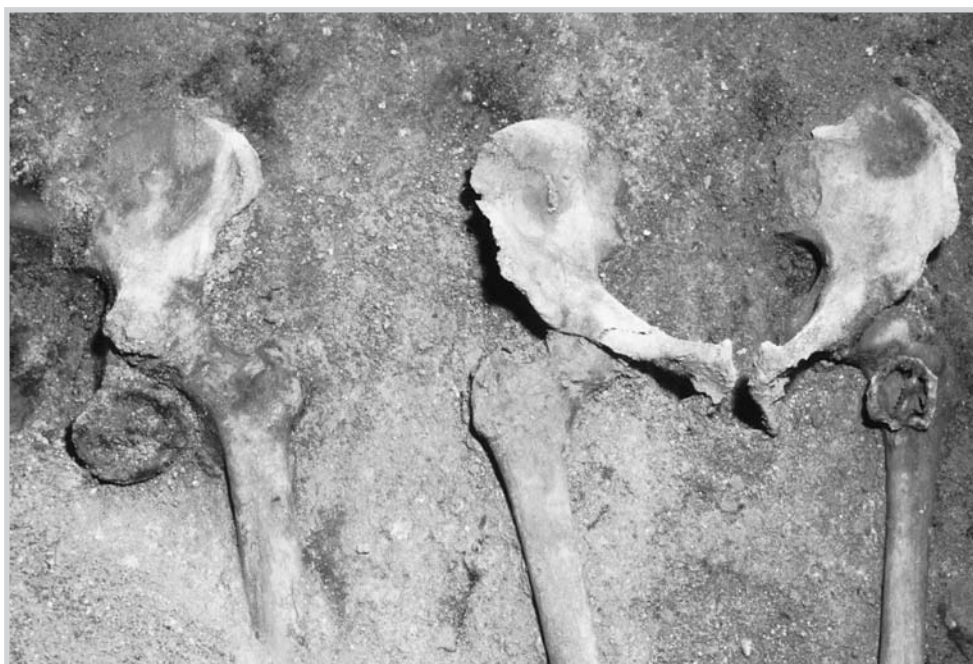
Fig. 47. Burial RG125, group 2:14, belt buckles lay upon the femurs. Note that the bones were stained reddish brown. Photo Bruce Sampson, NIKU.

The grave had been disturbed, either by limited antiquarian excavation or robbing, this activity was recorded as R71 (group 7:5). Cut 71 partially truncated the northernmost and central burials, RG126 and RG125 respectively, but didn't disturb the southernmost burial RG124. R71 extended up to the threshold with the nave R273, (group 3:3) i.e. 0.50m outside the western limit of this grave. R131 appeared to have been partially sealed by mortar surface R169, which lay c. 0.20m below the level of the latest floor, the level that R71 was cut from. This grave could not have been visible on the surface therefore when the robbing/excavation took place. That the robbing activity was not confined to within the grave supports this interpretation. Whether R71 robbed out a later grave that lay against the threshold that was visible in the latest floor and continued below the base of that grave into R131, or whether this area was chosen for exploratory digging as it was the likely location of a high status grave is uncertain. A seal stamp (HKH11821) was recovered from R72 the fill of R71. It was not certain whether this was originally buried with RG125 or RG126 or a third individual from the postulated later grave. The seal is associated with canon Thorodd Thorsteinsson who wrote two still existing letters in AD 1346 (DN II, number 274 and DN III, number 233). Mortar surface R169/R170 overlay the grave, it contained a coin dated to AD 1206 - 1260, indicating that the grave was sealed before the seal stamp was in use. This supports the interpretation of a third grave that Thorodd Thorsteinsson was interred in.

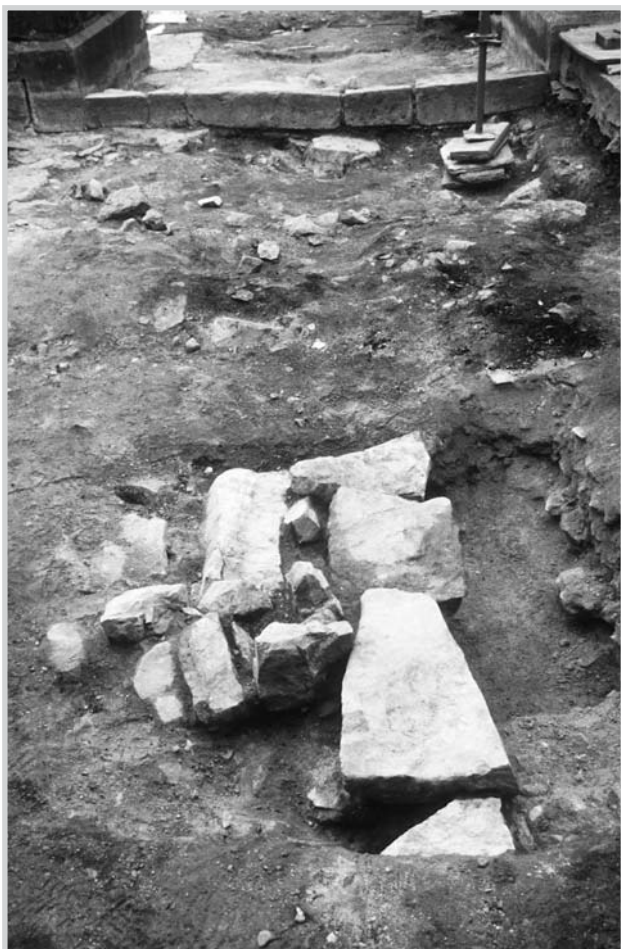
Fig. 51. Group 2:15, area R96 stone slabs R285 looking N.
Photo Stan Reed, NIKU.

R285. Stone structure, consisted of a single, N/S aligned, row of flat limestone slabs, 0.30-0.50m wide. R285 was only partially exposed: over 1.40m in the crossing and over 0.80m under the threshold between the crossing and north transept. The stones lay directly upon the remains of a wooden beam, R298. A depression in the overlying layers could be followed between the two exposed sections of R285, caused by the rotting of beam R298 or settling of the structure, this depression was also visible c. 1m to the south of R285. A posthole R299, was constructed immediately west of R285. R285's function is unclear, it appears to be connected to beam R298, post hole R299 and slab R300. Under R295, over R298.

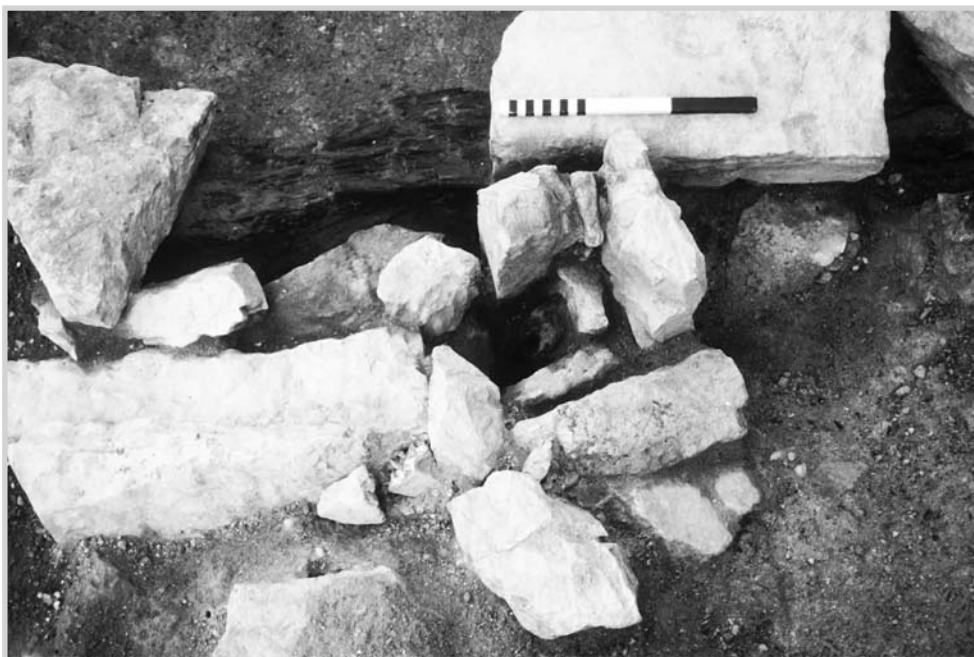
Fig. 52. Group 2:15, area R96 wooden beam R298, stone post packing R299 under stone slabs R285, looking E. Photo Stan Reed, NIKU.

R298. A wooden beam only partially exposed. The wood had decayed slightly but was relatively solid. R298 lay beneath stone slabs R285, the stones lay directly upon R298, sandy silt R295 was dumped around both the beam and the slabs. R298 was c. 0.15m x 0.15m, it was exposed over a length of 1.40m in the crossing, and seen but not exposed under the stones of R285 where they were uncovered under the threshold between the crossing and the north transept. A depression in the overlying layers indicates that R298 and R285 continued into the gap between the towers on both the north and south sides of the crossing. The beam lay upon a compact crushed mortar layer, it was recorded as lying upon mortar layer R238, this layer was only exposed in the profile of grave cut R131 however, i.e. not exposed in plan. This relationship is therefore not 100% certain. A wood sample from the beam was radiocarbon dated to CAL AD 1170 - 1250 at

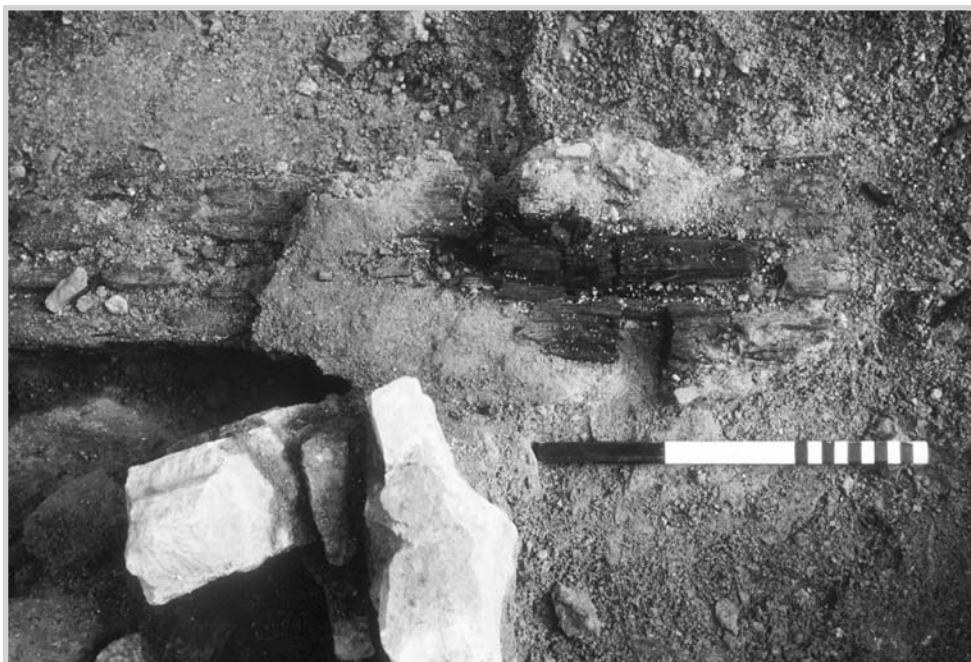
Fig. 53. Group 2:15, area R96 wooden beam R298 exposed, part of stone post packing R299. Photo Stan Reed, NIKU.

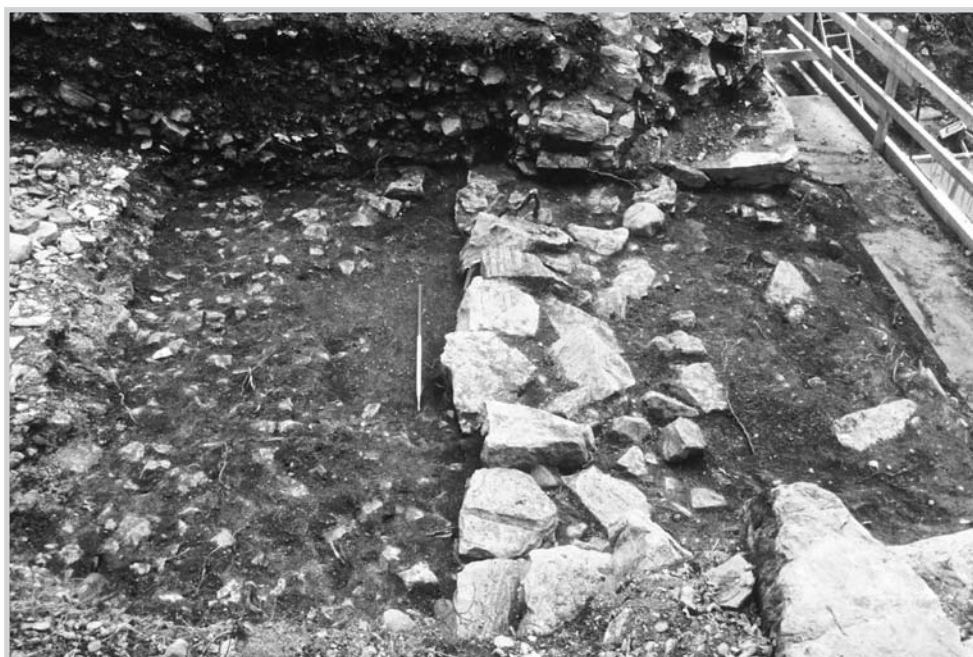
Fig. 56. Remains of the first churchyard wall P51/52, group 2:25 in trench P96. Facing W. Photo Stan Reed, NIKU.

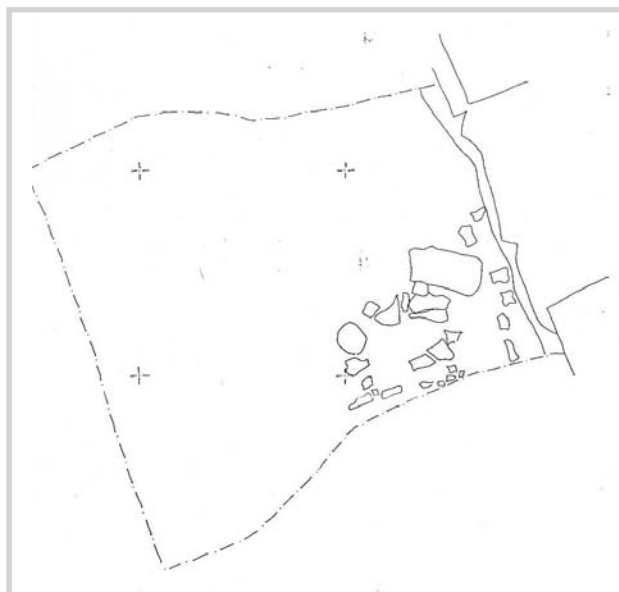
Fig. 59. Group 2:29, trench D96.

D110. Foundation of the west wall of the cathedral. Consisted of six courses of mortar bonded flat stones, varying in length from 0.40-1.10m and in thickness from 0.15m - 0.30m. The foundation had a total height of 1.60m, the

lowest two courses extended 0.05m further west than the overlying courses. The ashlar masonry of the cathedral wall was set back 0.20m, such that 0.20m of the foundation was visible beneath the wall. D110 was built directly upon bedrock and layer D109 (group 1:12), this layer was partly removed, but only to the south, presumably to create a level surface to build upon. A white mortar bonded the stones, gaps were plugged with smaller stones. Under D106, over D109.

The foundation of the western wall of the nave (D110, group, 2:29) was exposed at its external face in trench D96. The wall was constructed of six courses of mortar bonded flat stones to a height of 1.60m. It was constructed directly upon bedrock and make-up deposits were dumped against it to build up the ground level, forming the churchyard and supporting the foundation. An unbonded stone structure (D107) lay against the foundation. It is possible this was the remains of the foundation for a temporary structure connected to the construction process, but it was more likely a dump of stones with no structural function.

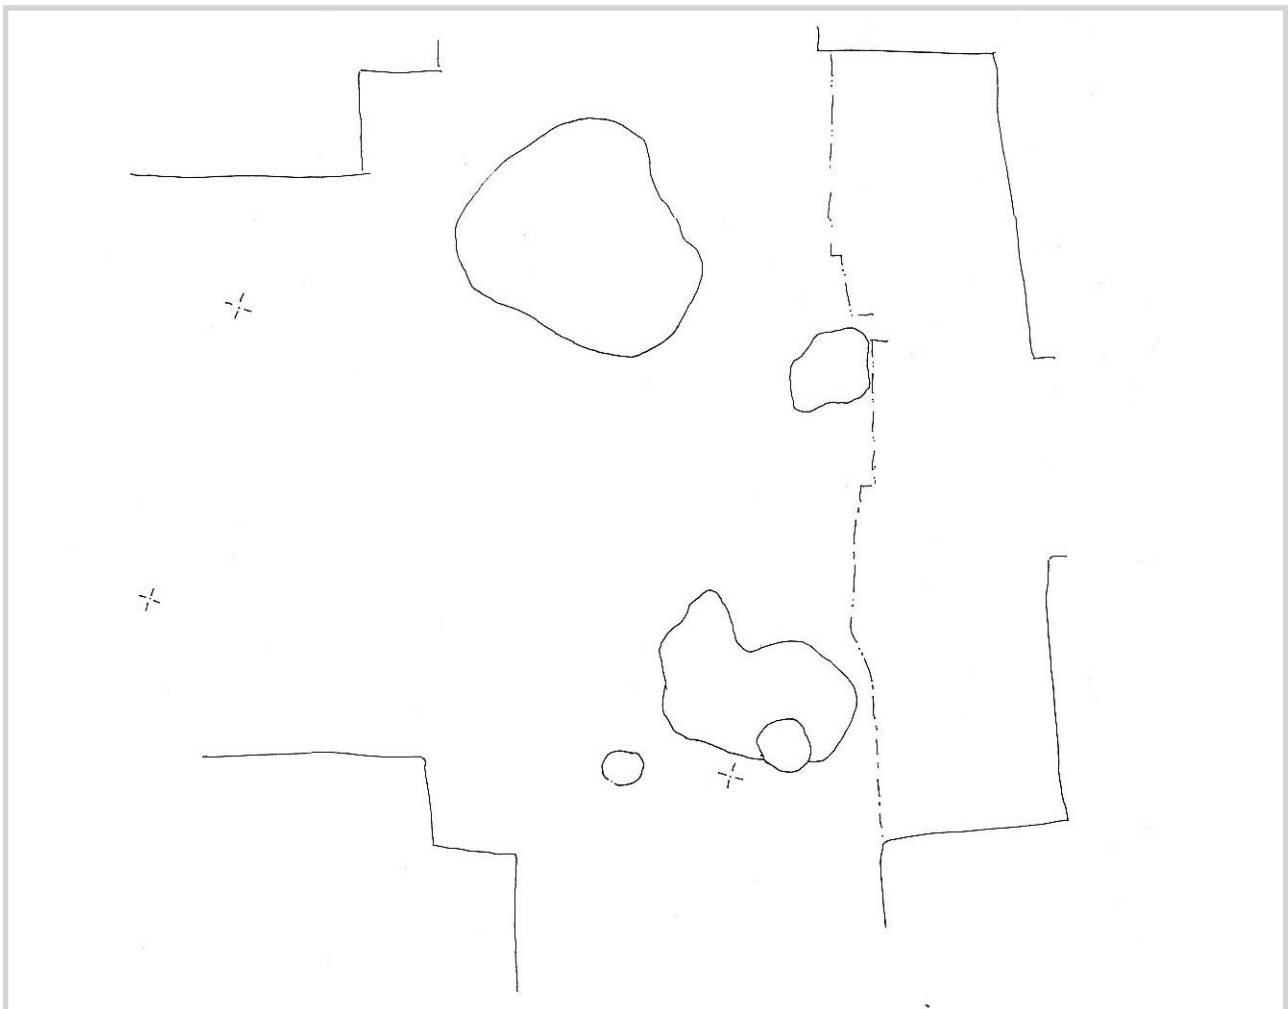
Fig. 66. Group 3:5, area R96, the crossing.

Group 3:5 consists of a spread of crushed mortar or sand (R269) spread over burnt layer R248 (group 3:6) in the crossing. Irregularly shaped cut feature (R245 and R246), two possible post-holes (R309, R310, R311 and R312) located between the two southernmost tower bases and R293, the fill of the top of earlier post packing R299 that covered the remains of earlier post R294 (group 2:15). R293 was not excavated until the posthole was identified but it is interpreted as representing the disuse of the post, it appeared to partially overlie mortar surface R169,

(group 2:12) and is placed in this group. The cut features represent a period of activity where there was no floor surface and probably relate to repair/rebuilding work in the area. Possible postholes, R309 and R311 may have been related to construction work, possibly scaffolding.

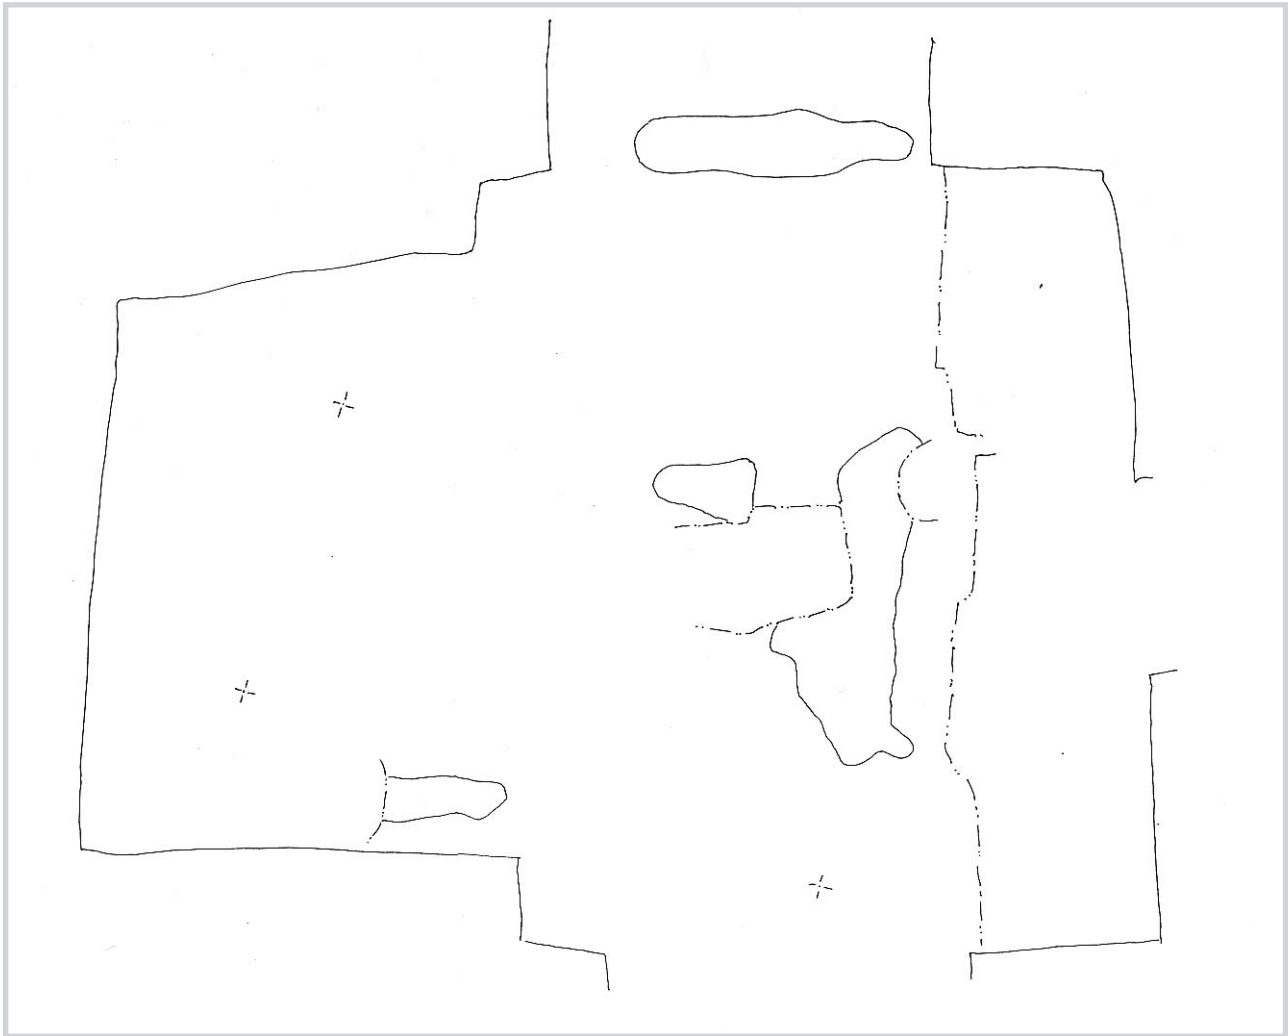
Fig. 67. Group 3:6, area R96, the crossing.

R248. Layer of charcoal and small fragments of limestone. There was very little silt in this layer, it appeared to be primarily charcoal dust and small fragments with a few larger fragments where the structure of the wood was

still visible. The limestone fragments were cracked from burning and were present in irregular concentrations. The layer was present in patches in the eastern half of the crossing and under threshold R60, it was not fully excavated. A charcoal sample from R248 was radiocarbon dated to CAL AD 1020 - 1250 at the 95% level of confidence (Beta-135934, sample HKH11866). Under R241, R269, R340 and R344, over R270, and R345, same as R341.

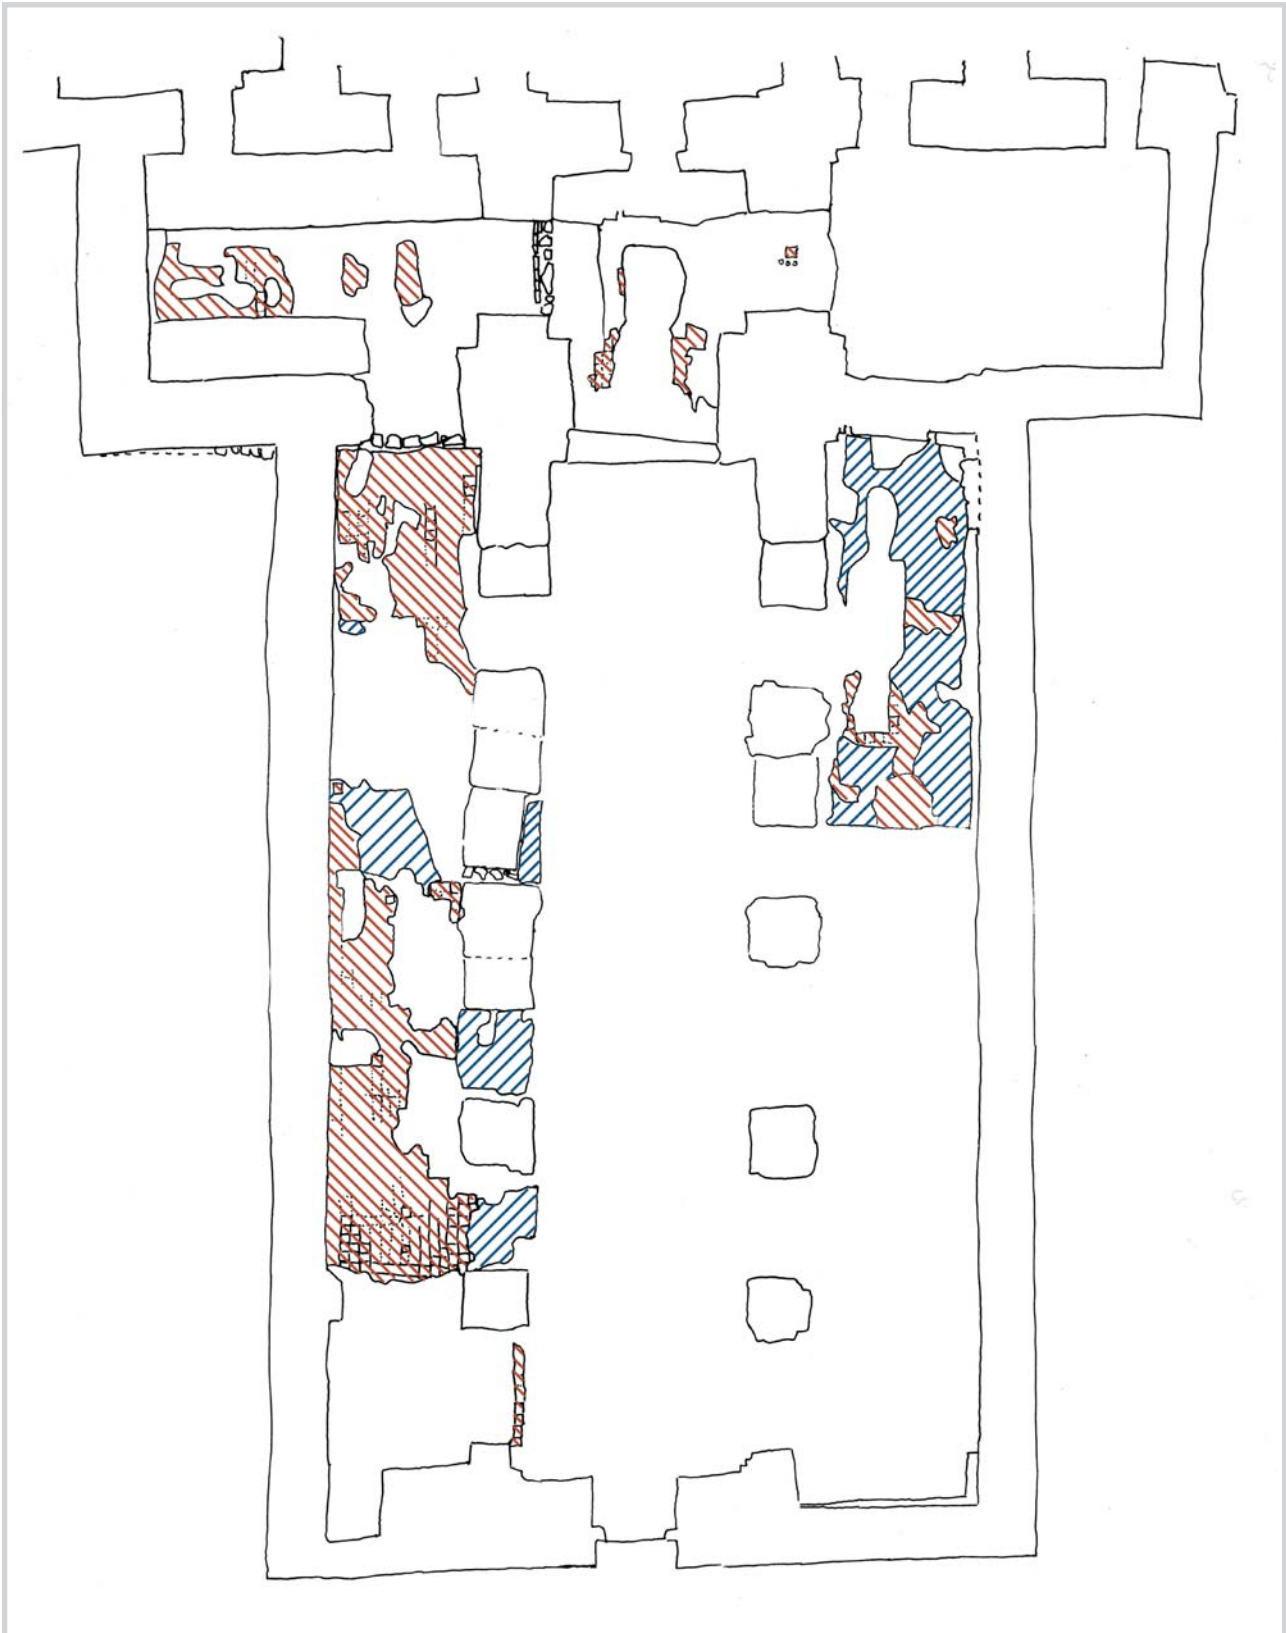
Plate 2. Upper brick floor, period 4. The tile floor covered most, if not all of the cathedral. South aisle group 4:3, north aisle group 4:5, north transept group 4:7 and crossing/south transept group 4:8. Areas with bricks are marked with red hatching, areas with only beach gravel acting as bedding for the tiles are hatched blue.

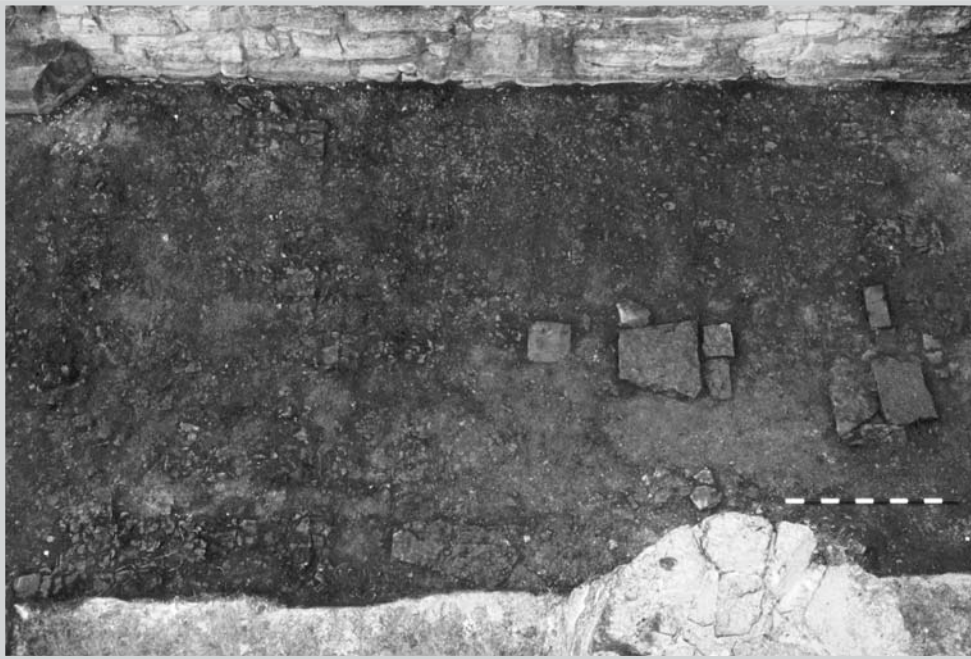
Fig. 80. Remains of the tile floor R24, group 4:5 in the north aisle. Photo Bruce Sampson, NIKU.

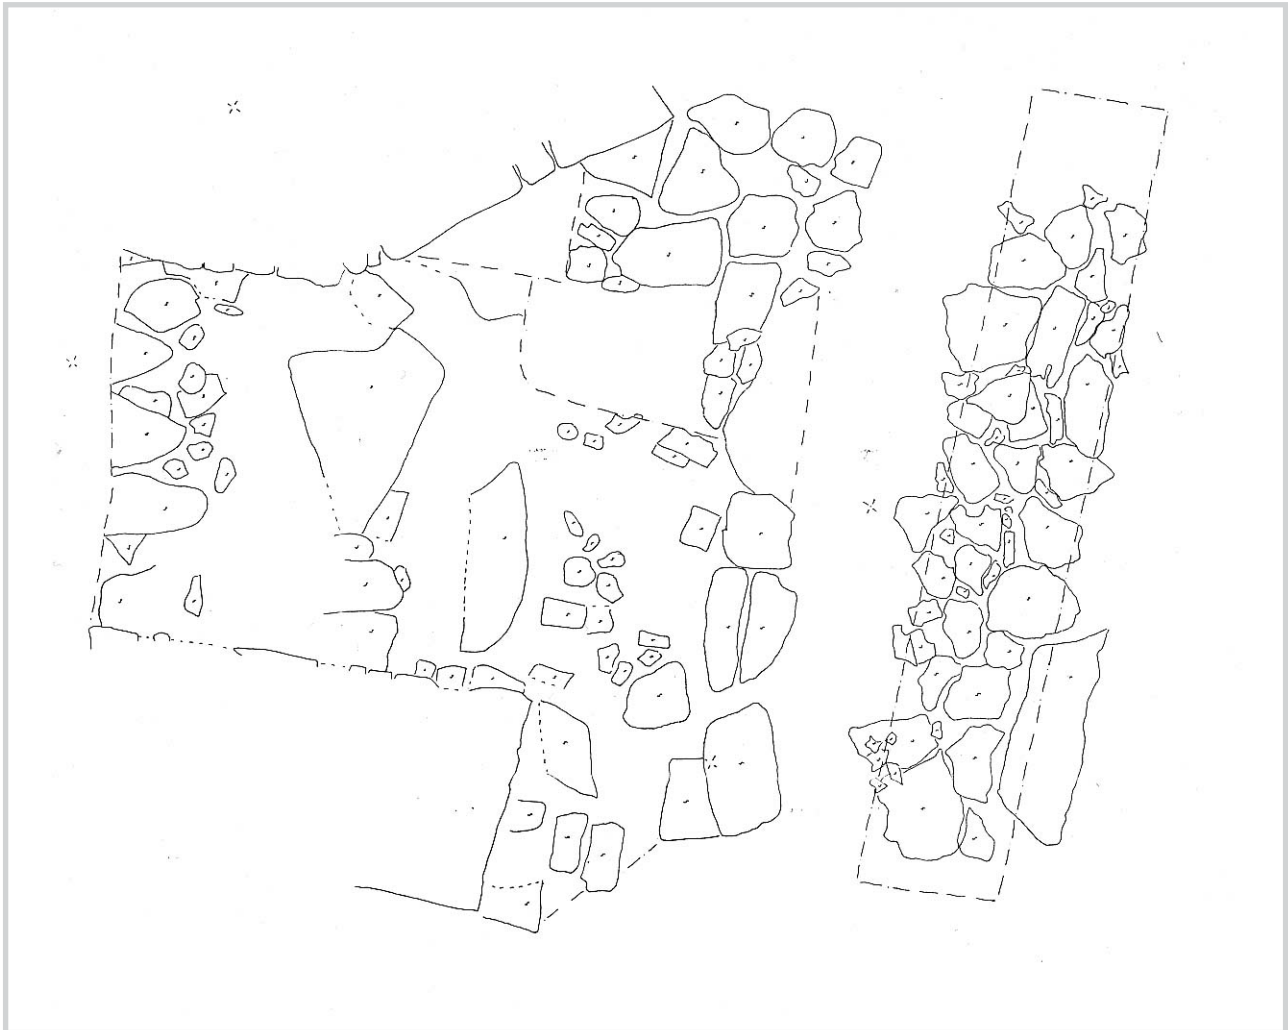
Fig. 85. Group 4:13, trench M96-15.

were preserved on the south side (MG160 and M161), but later cuts (group 4:12) had truncated the construction cut on both the north and south sides, it is therefore not clear when the structure was built. The foundation is interleaved with stone foundation/wall M193 to the NW. M193 was aligned WSW/ENE, it was only exposed on the surface but appeared to be constructed in a similar manner to BF30, mortar layer M189 lay partially over the surface of M193. The wall probably meets NNW/SSE aligned wall M191 under buttress M198. M191 was constructed of large stones with a layer of compact yellow mortar (M190) over them. M190 was not excavated but M191 appeared to be constructed as a solid stone foundation, as M193 and BF30 were, with a capping of mortar (M190) laid over it. M191 had approximately, though not exactly, the same alignment as the east wall of the chancel. It was slightly wider and was clearly not constructed in the same manner. M191 must be secondary to the construction of the chancel. It is debatable whether M191 functioned as a regular external wall, it appears to

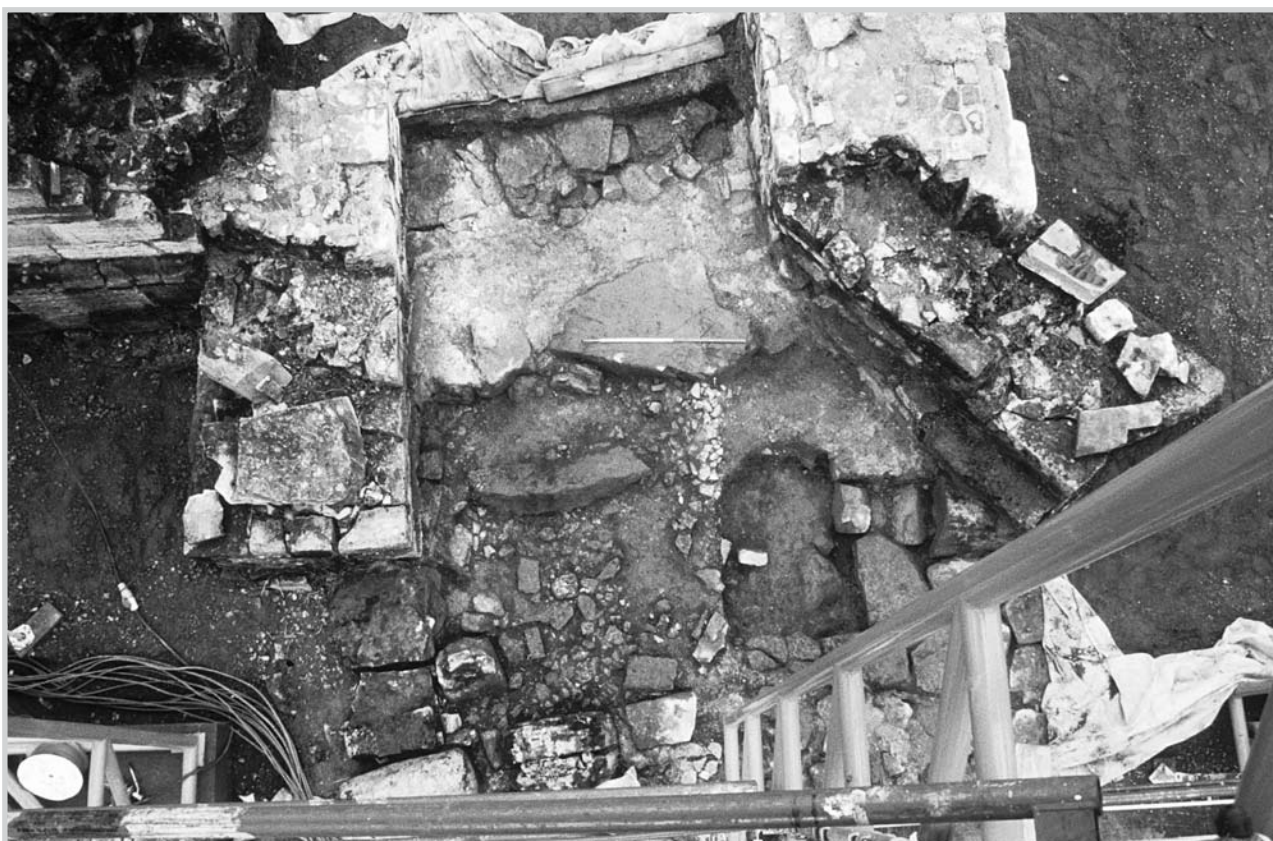
Fig. 86. The western edge of the 'Bishops Foundation' and walls M191 and M193, group 4:13, trench M96-15. Facing W.
Photo Stan Reed, NIKU.

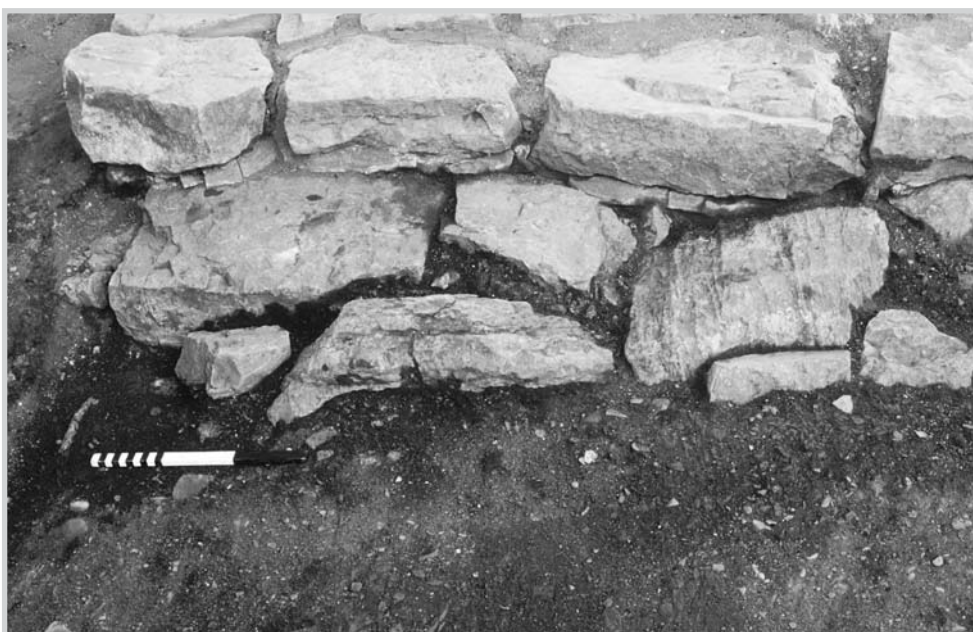
stones in R216 may have been part of the original wall that still were in-situ, but the structure as a whole is largely reconstructed. The cut R213 along its inner face cut through the medieval floor deposits clearly indicating the inner edge of the wall had been rebuilt in the modern period. R215 was only one course high but hung over beach gravel/silt layer R209, with a void between the stones and the layer. Both R216 and R215 were built upon stone/mortar constructions, presumably the original walls, R217 and R218 respectively (group 2:5).

Fig. 114. Group 7:2, area R96 R187. Photo Bruce Sampson, NIKU.
