Hamar ruin

Archaeological investigations 1996-1998

Stan Reed

Reed, S. 2004. Hamar Cathedral ruin. Archaeological investigations 1996-1998. - NIKU Rapport 6: 1-244.

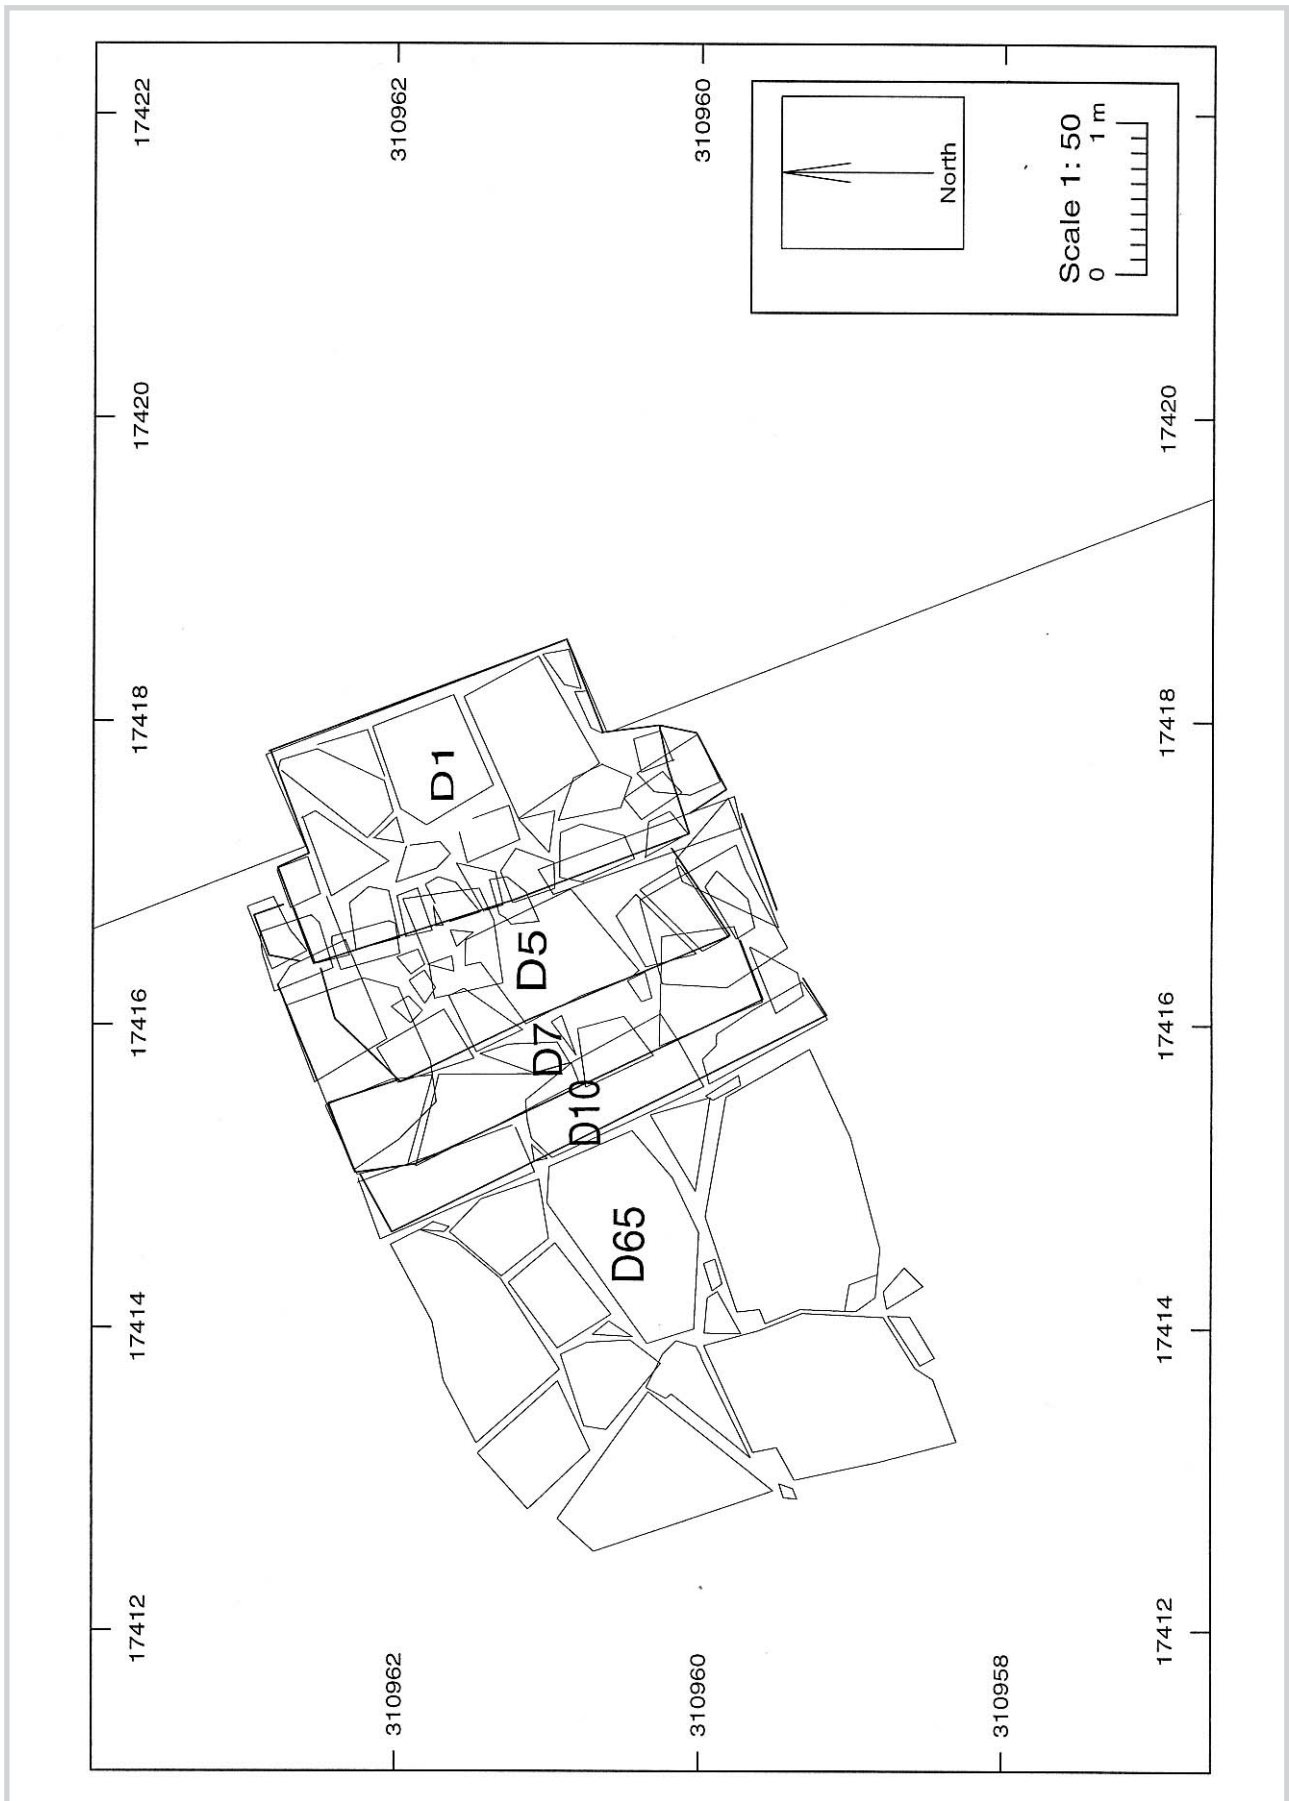
Fig. 120. Group 7:16, trench D96.

wall. The outermost 0.75m - 0.90m of step 5 was visible, the rest lay under step D1. Under D6, over D8.
