Article

# Coastal Erosion Affecting Cultural Heritage in Svalbard. A Case Study in Hiorthhamn (Adventfjorden)—An Abandoned Mining Settlement

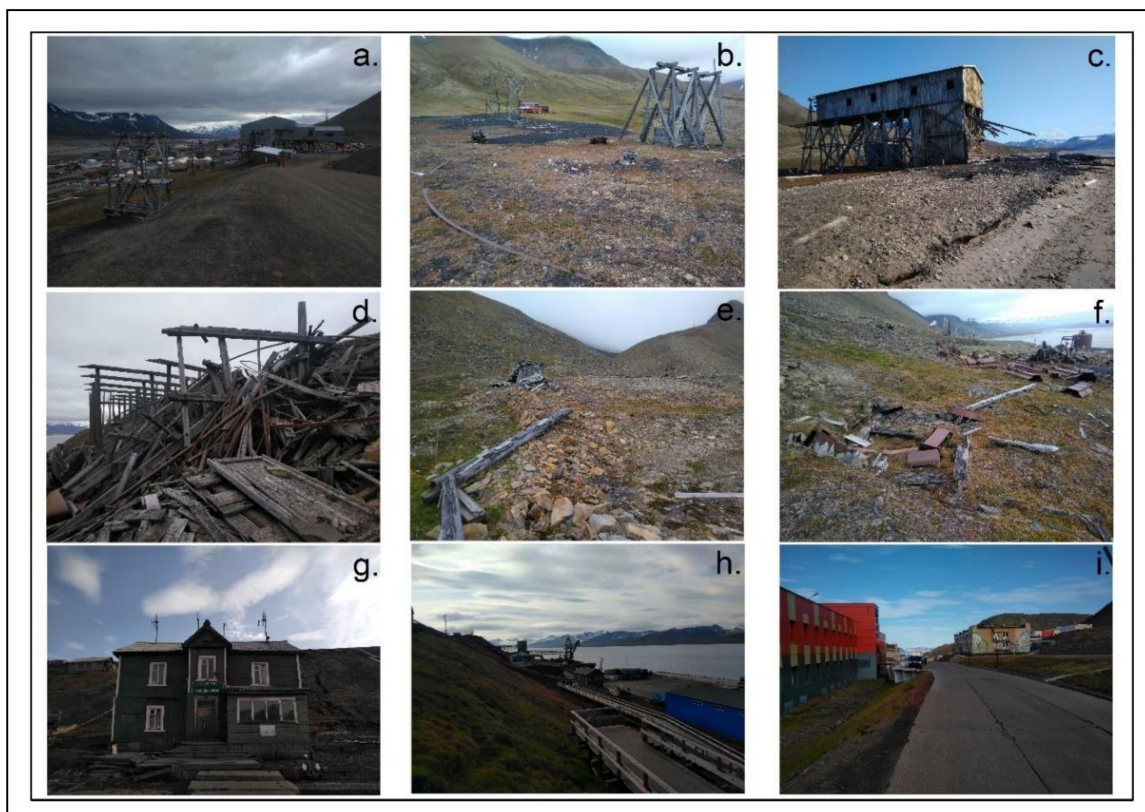
**Figure 3.** (a) Former coal-mining infrastructure in Longyearbyen; (b,c) Former coal-mining infrastructure in Hiorthhamn; (d–f) Remains of the coal-mining exploitation in Svea; (g–i) Current images from the Russian coal-mining city of Barentsburg.

The central cable car station in Hiorthhamn was built in 1939 (Figure 3c) and is listed in the National heritage database Askeladden under the ID 93040-6. It consists of a large wooden loading construction. The inside machinery is in good shape, with wheels and gears on cast foundations. A wooden staircase leads to the top of the construction. Remains of two railway tracks come out from the southern side of the building directly into the sea. From the side towards the mountains, rests of cable car wires are hanging [70].

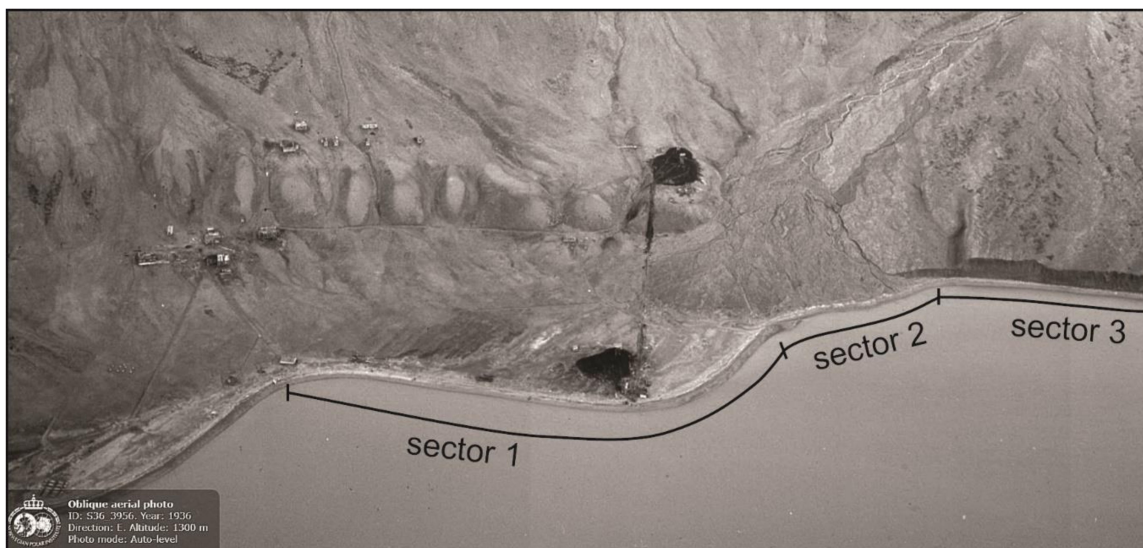
**Figure 4.** Detail of Hiorthhamn mining settlement from 1936, with emphasis on the three sectors analysed in this study (image courtesy: Norwegian Polar Institute) [84].

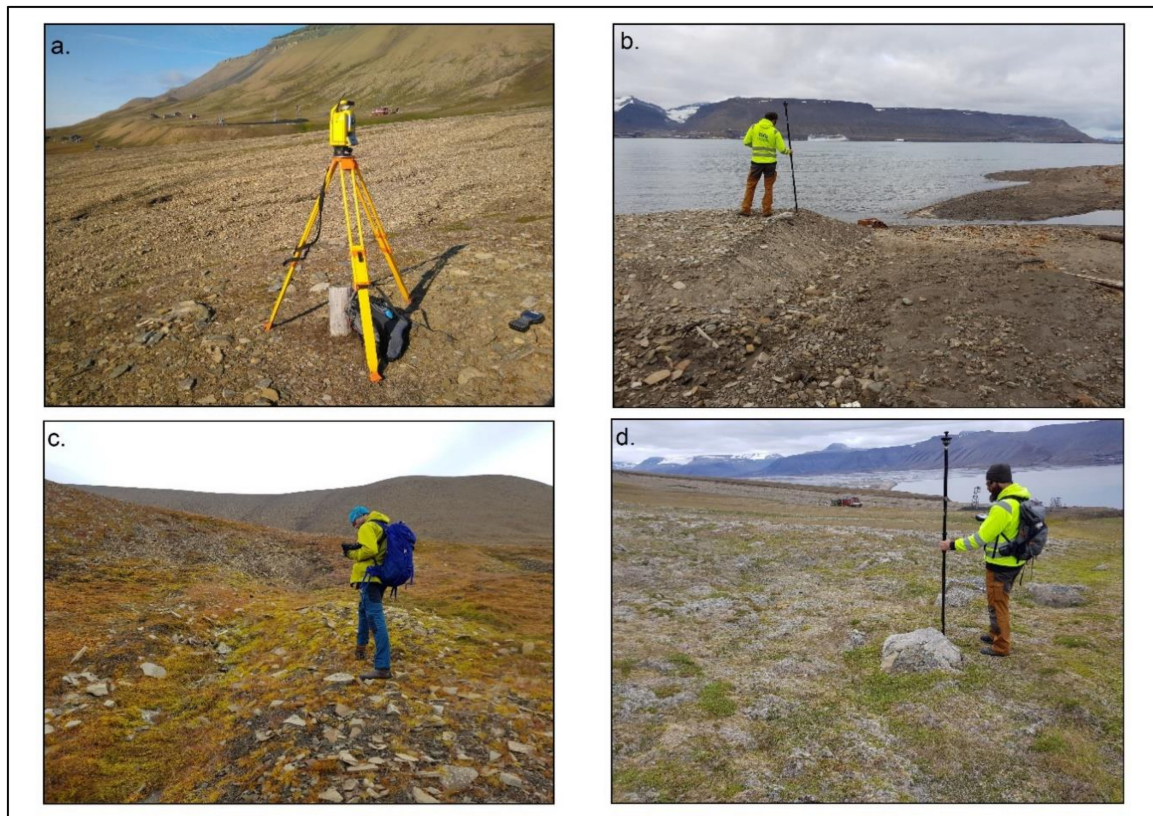
**Figure 5.** (a) Total station and controller on one of the fixed points; (b) Coastline survey; (c) Geological mapping of the upper area of Hiorthhamn; (d) Survey of surface soil movements.

Field surveys were made in August 2019 using a GPS system comprised of an Altus APS-NR2 antenna and a Carlson controller. Two initial points were surveyed with the GPS system ( $\pm 0.5$  m accuracy), then the survey was conducted with a Trimble S5 Series Motorized total station, along with a Trimble TSC3 controller (Figure 5a). In total, a number of four fixed points were established and recorded for present and future monitoring of the shoreline (Figure 5b), to gather data to support the geomorphological mapping (Figure 5c) as well as for monitoring of surface soil movements over time (Figure 5d).

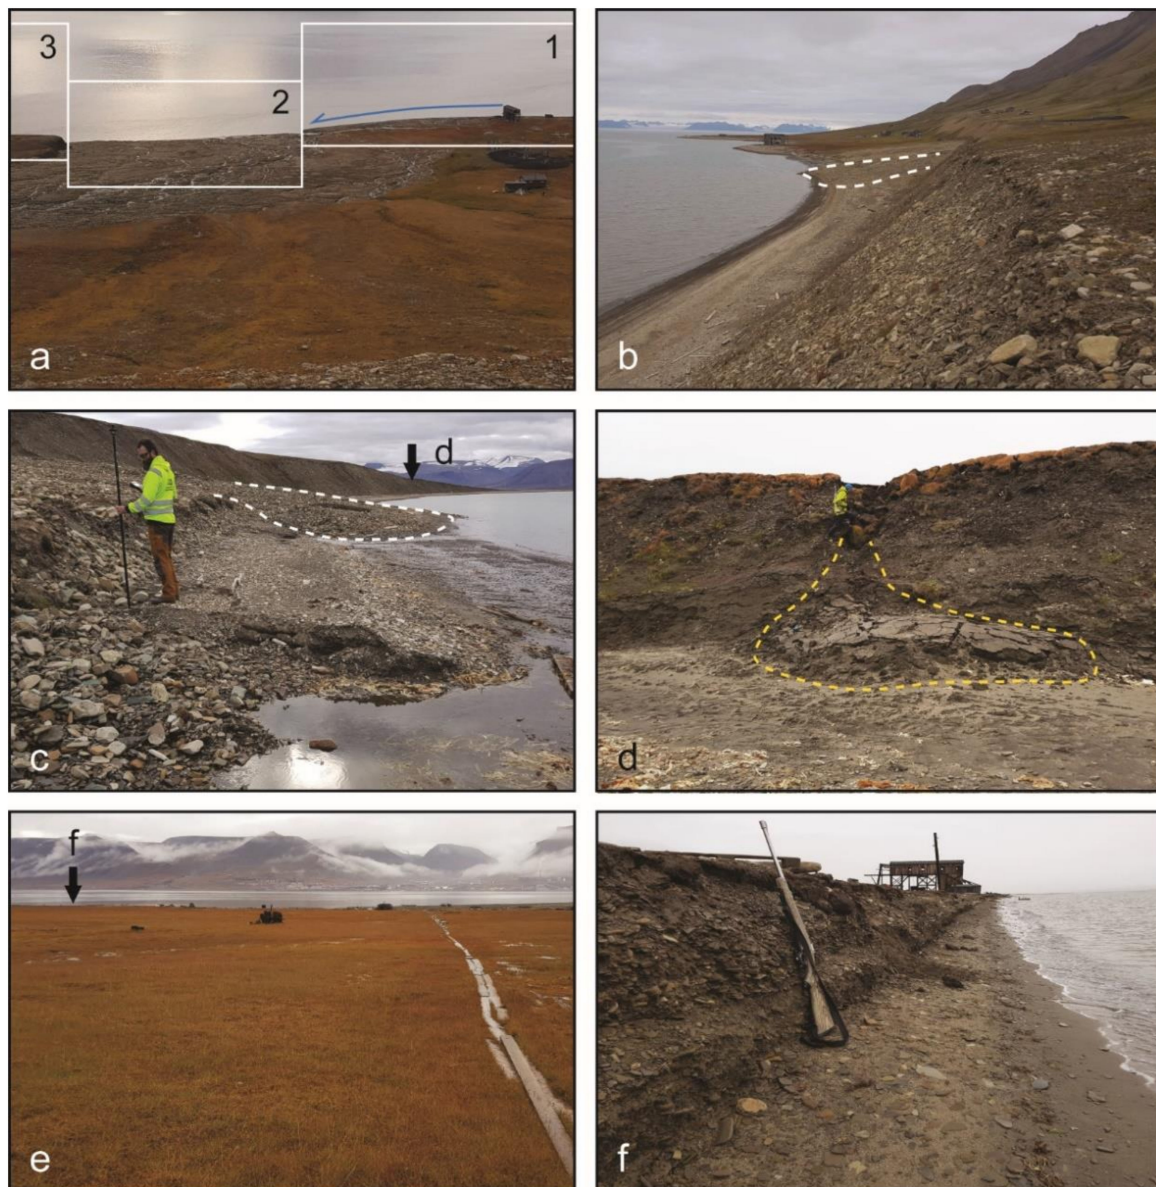
**Figure 7.** (a) Overview of primarily the active fan with boxes marking the position of interpreted coastal sectors. Note that Sectors 1 and 3 extend outside the photo. Blue arrow indicates the long-shore sediment transport direction forming a small spit-bar in the eastern end of Sector 1; (b) Photo towards north west, from the coastal escarpment of the relict alluvial fan in Sector 3, towards sectors 1 and 2. Dotted line delineates the post 2009 debris flow advance of the coastline in Sector 2; (c) Photo from the middle of Sector 2 towards east showing shoreline erosional edge (left of person) and the recent debris flow deposit (dotted line); (d) Sector 3. Fresh small slump from the shoreline escarpment in the relict alluvial fan; (e) The peat covered relict beach ridge plain in Sector 1; (f) The active erosion edge of the shoreline in Sector 1 at high tide (rifle for scale). Note the coarse sorted beach sediment in the section and the thin strip of beach separating the shoreline scarp from the water line.

The gently sloping plain down to the shoreline in the northern part of the study area (Sector 1) is mainly covered by peat and grass vegetation, and the low wave-cut section (Figure 7a,e) clearly shows how today's organic material overlies gravelly beach sediments. A series of low subdued gravelly ridges oriented obliquely from the present-day beach and inward is only visible in the aerial photos and is interpreted as relict beach ridges formed during earlier beach migration towards south east. This development requires a net sediment supply to Sector 1 and long-shore sediment drift from northwest towards southeast, which is confirmed by the ongoing build-up of a small spit bar shifting the small tidal channel outlet towards southeast between 2009 and 2019 (south-eastern end of Sector 1 and Figure 7a).

The wave-erosion shoreline scarp (Figure 7f) which cuts the old subdued beach ridges at an angle, together with observed in-land displacement of over-wash deposits parallel to the beach, indicate a change in shoreline environment towards increased erosion. This change may be the result of a shift in dominating wind-, and hence, wave direction during especially erosive storm events. The detailed land survey data of the present shoreline (Figure 6) supports this interpretation.

Sector 2 of the study area includes the distal part of an active alluvial fan system which is subjected to both erosional and depositional processes. A braided fluvial system is transporting coarse and poorly sorted sediments towards the shoreline and episodic debris flows or debris torrents transport larger masses, which are later remodelled by the more continuous fluvial processes. According to [86] detailed descriptions of sedimentary processes and environment, fluvial channels migrate laterally over the fan throughout the summer due to melting of a snowpack that deflects the water flow. Dynamic

shifts in location of the fluvial transport and debris flows down to the swash zone today (Figure 7b,c) result in an irregular shoreline with significant yearly and seasonal changes (Figure 5b).

The south-eastern Sector 3 of the study area forms a long erosional escarpment through a raised abandoned alluvial fan–delta [86]. Wave action forms the steep escarpment by undercutting the raised delta sediments. Slumping of primarily sandy sediments in the over-steepened escarpment moves sediments down to the beach (Figure 7d) where they are moved into the sea and further eastwards by wave action and long-shore transport. The shoreline displacement between 2009 and 2019 (Figure 6) clearly highlights the shoreline retreat resulting from the undercutting and erosion.
