ANCIENT SOFIA

CULTURAL HERITAGE RESTORED,
RENOVATED AND PROTECTED

Ancient Sofia
Cultural Heritage Restored, Renovated and Protected

by Kristine Ødeby and Vibeke Vandrup Martens,
Norwegian Institute for Cultural Heritage Research

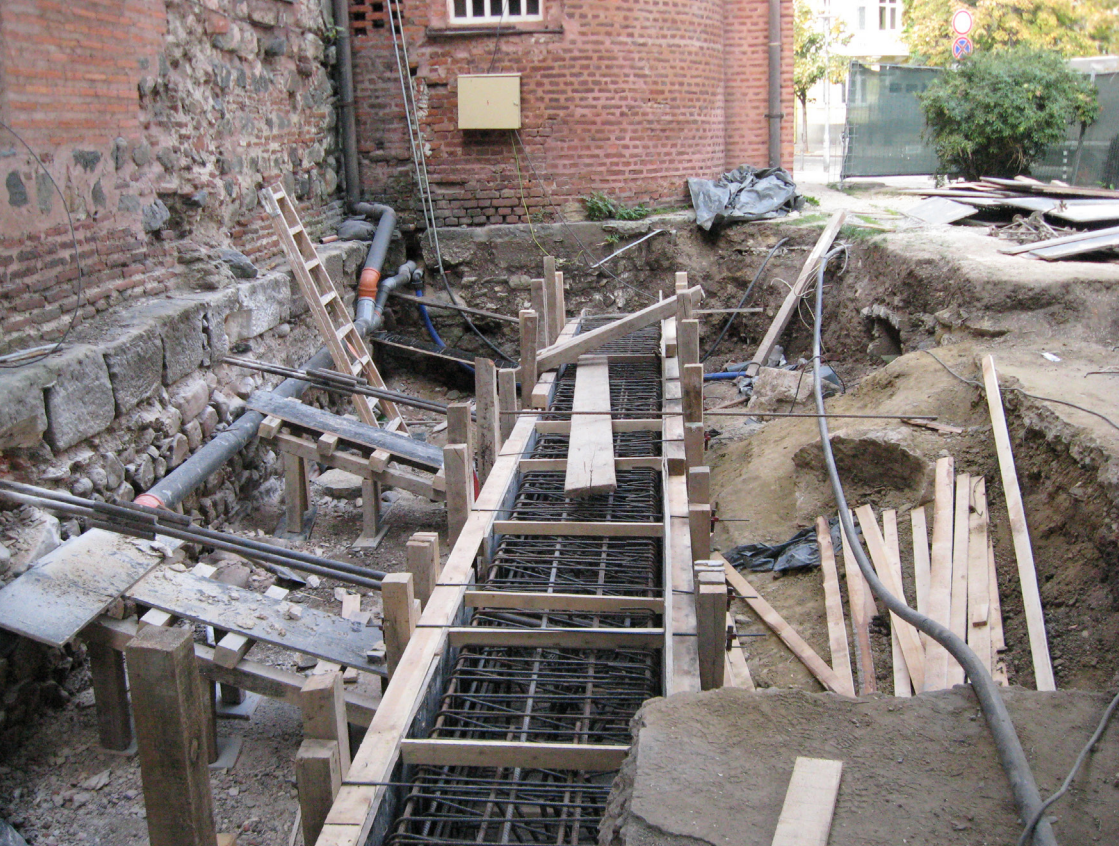
ДЪКЕРНА К-ЦИЯ СЕВЕР

Previous page top: The construction of the structural retrofits on the north side of the basilica.

During its long life, the basilica has suffered greatly from an unknown number of earthquakes. The effects from the quakes are a serious problem, not only in the many cracks in the walls, arches and domes, but at times having crushed whole parts of the construction. A recent 2012 quake reminds us that the church is still in danger. To prevent future earthquakes from destroying the basilica further, it became necessary to secure it. This project involves the implementation of two structural retrofits that will significantly strengthen and improve the seismic resistance of the building, as well as waterproofing the basement stone walls.

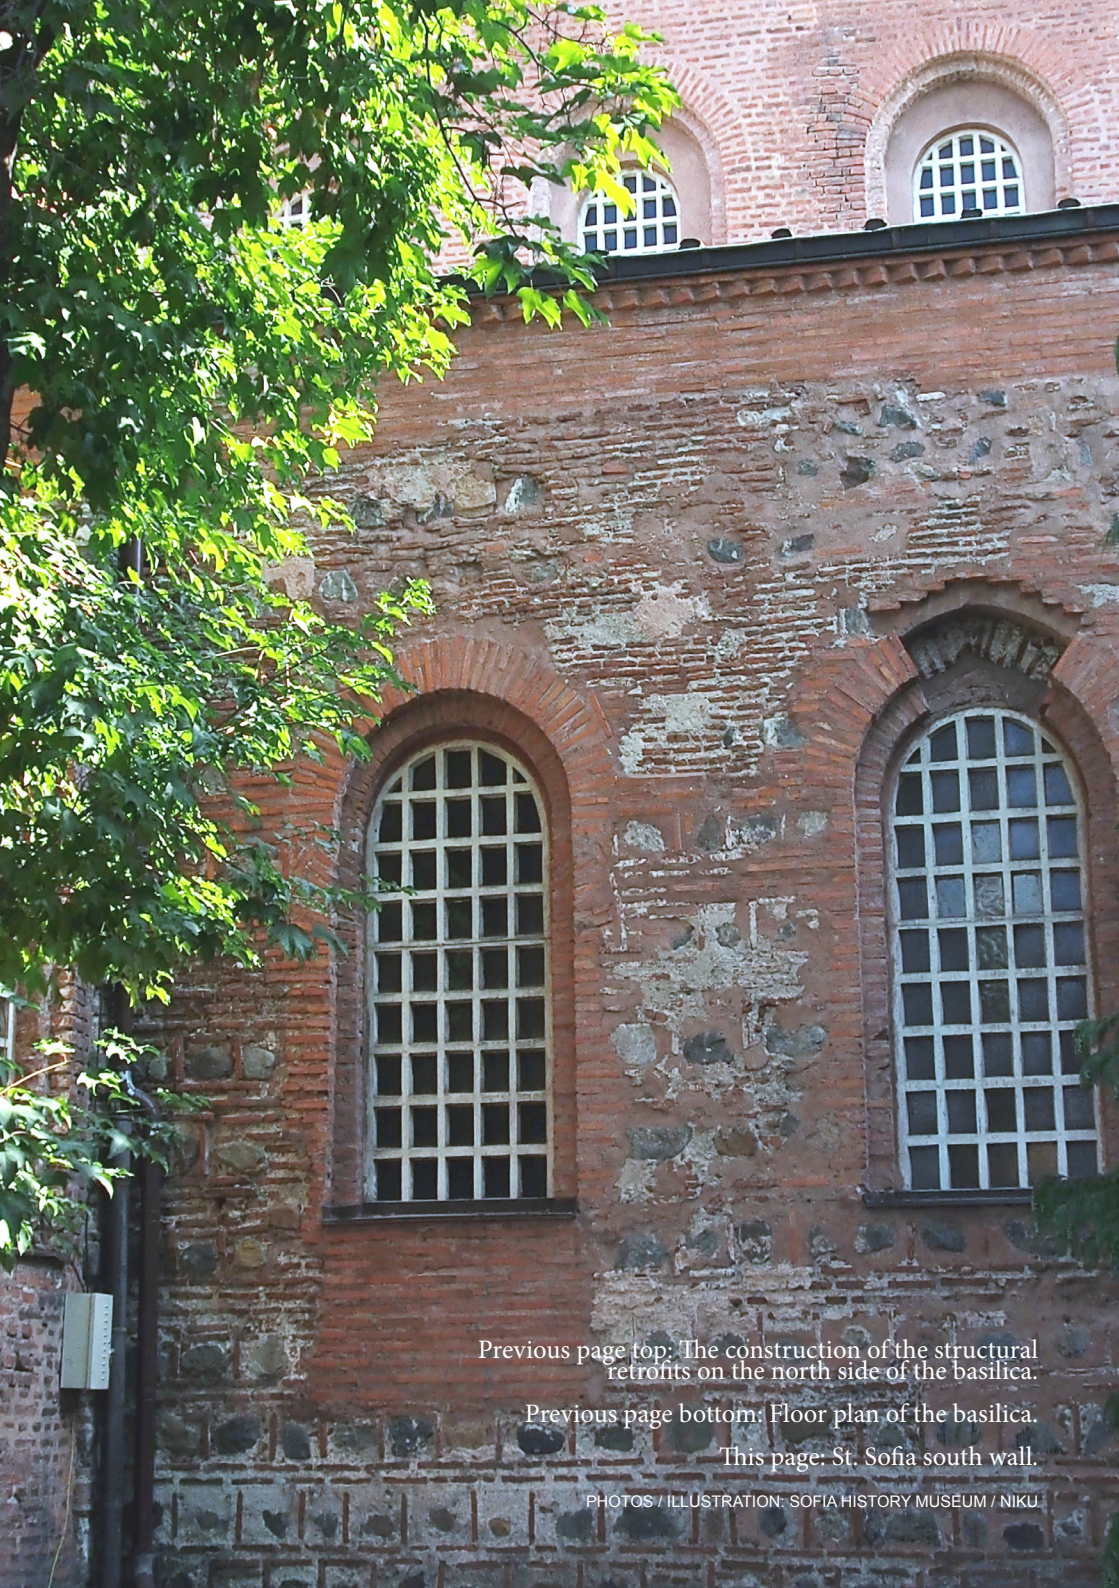
This page: St. Sofia south wall.

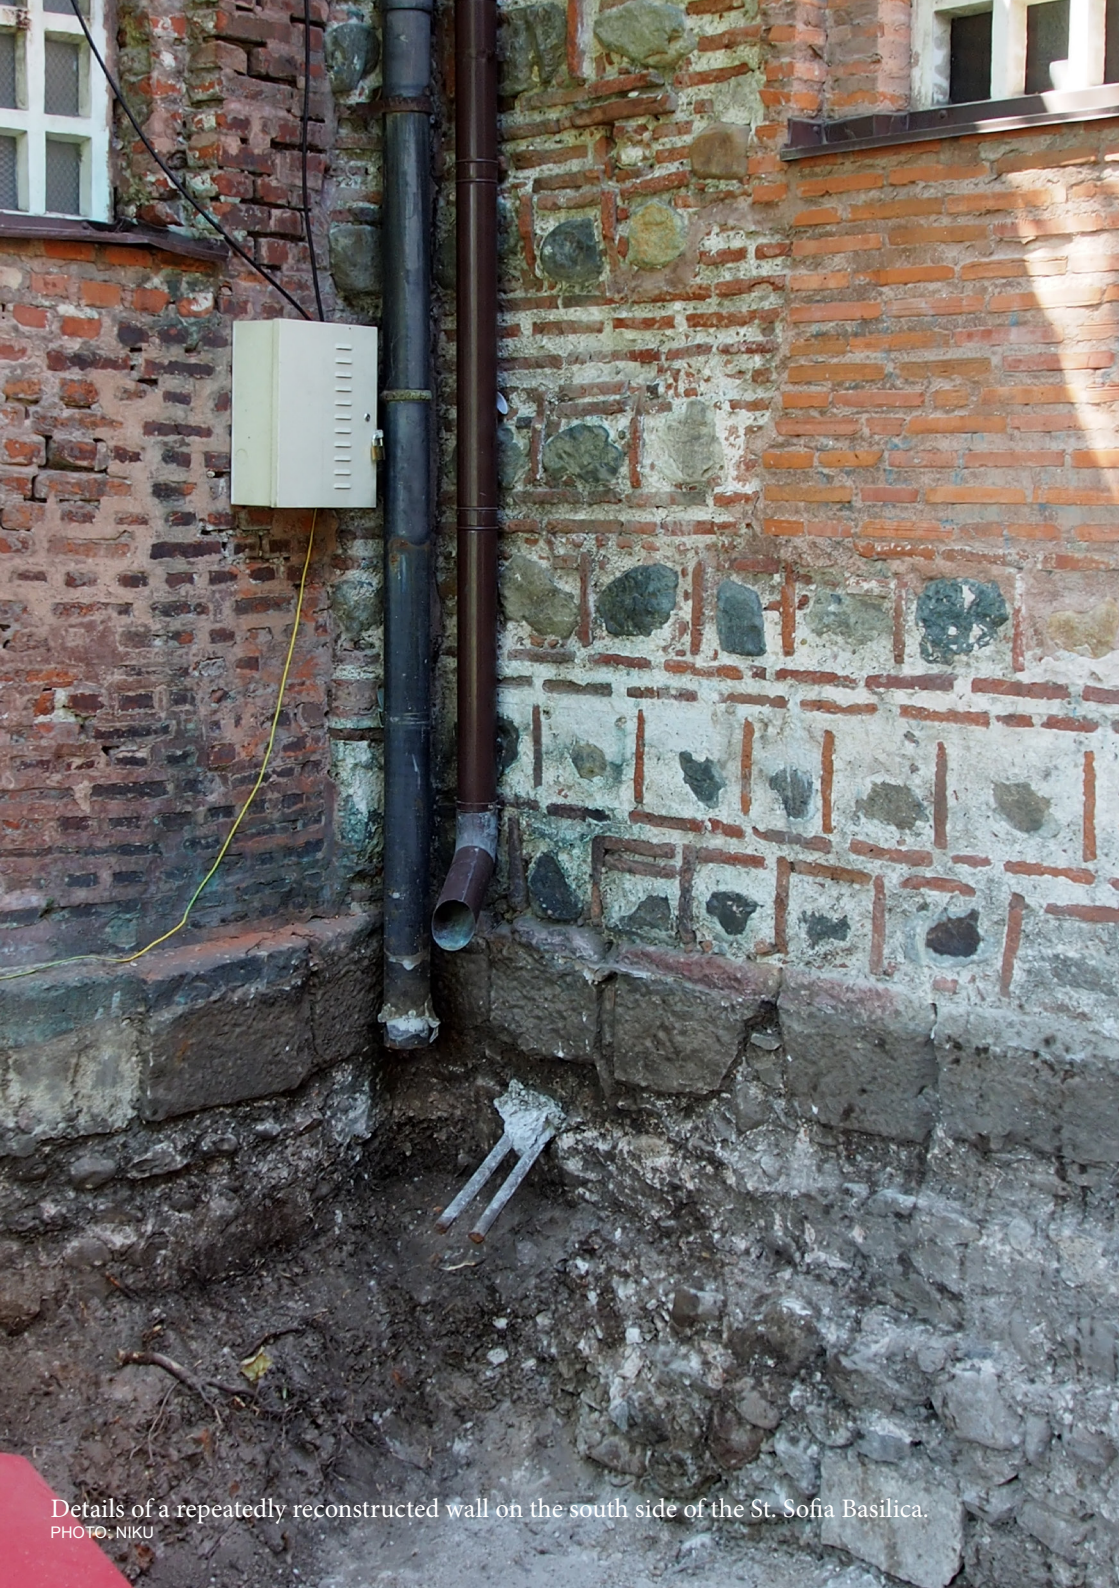
Details of a repeatedly reconstructed wall on the south side of the St. Sofia Basilica.
PHOTO: NIKU

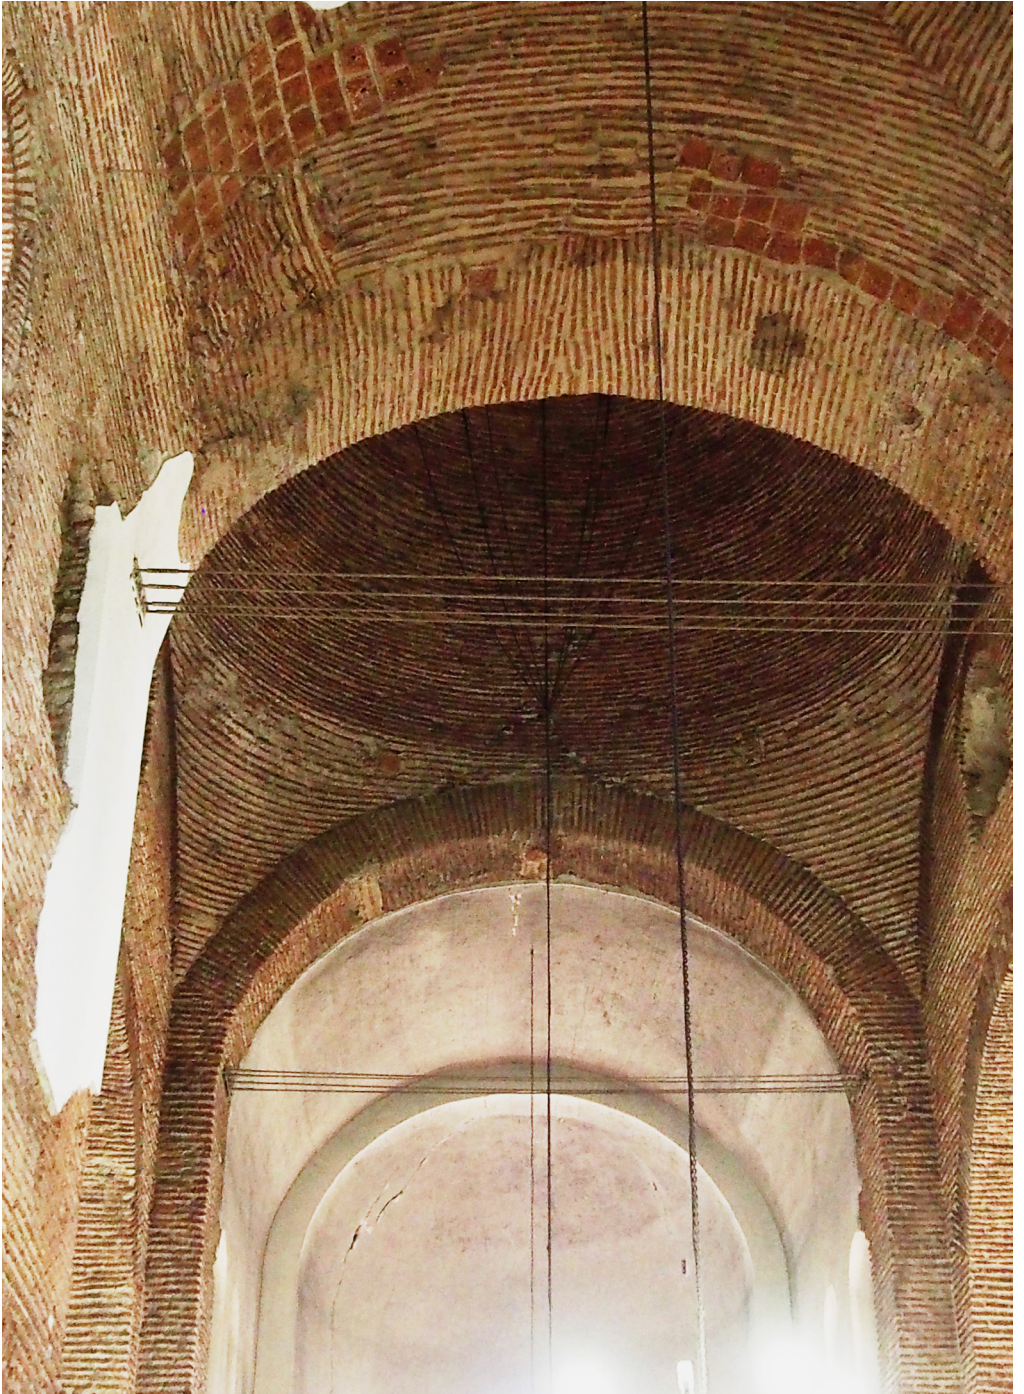
Indoor wall strengthening implementations in the St. Sofia Basilica.
PHOTO: NIKU

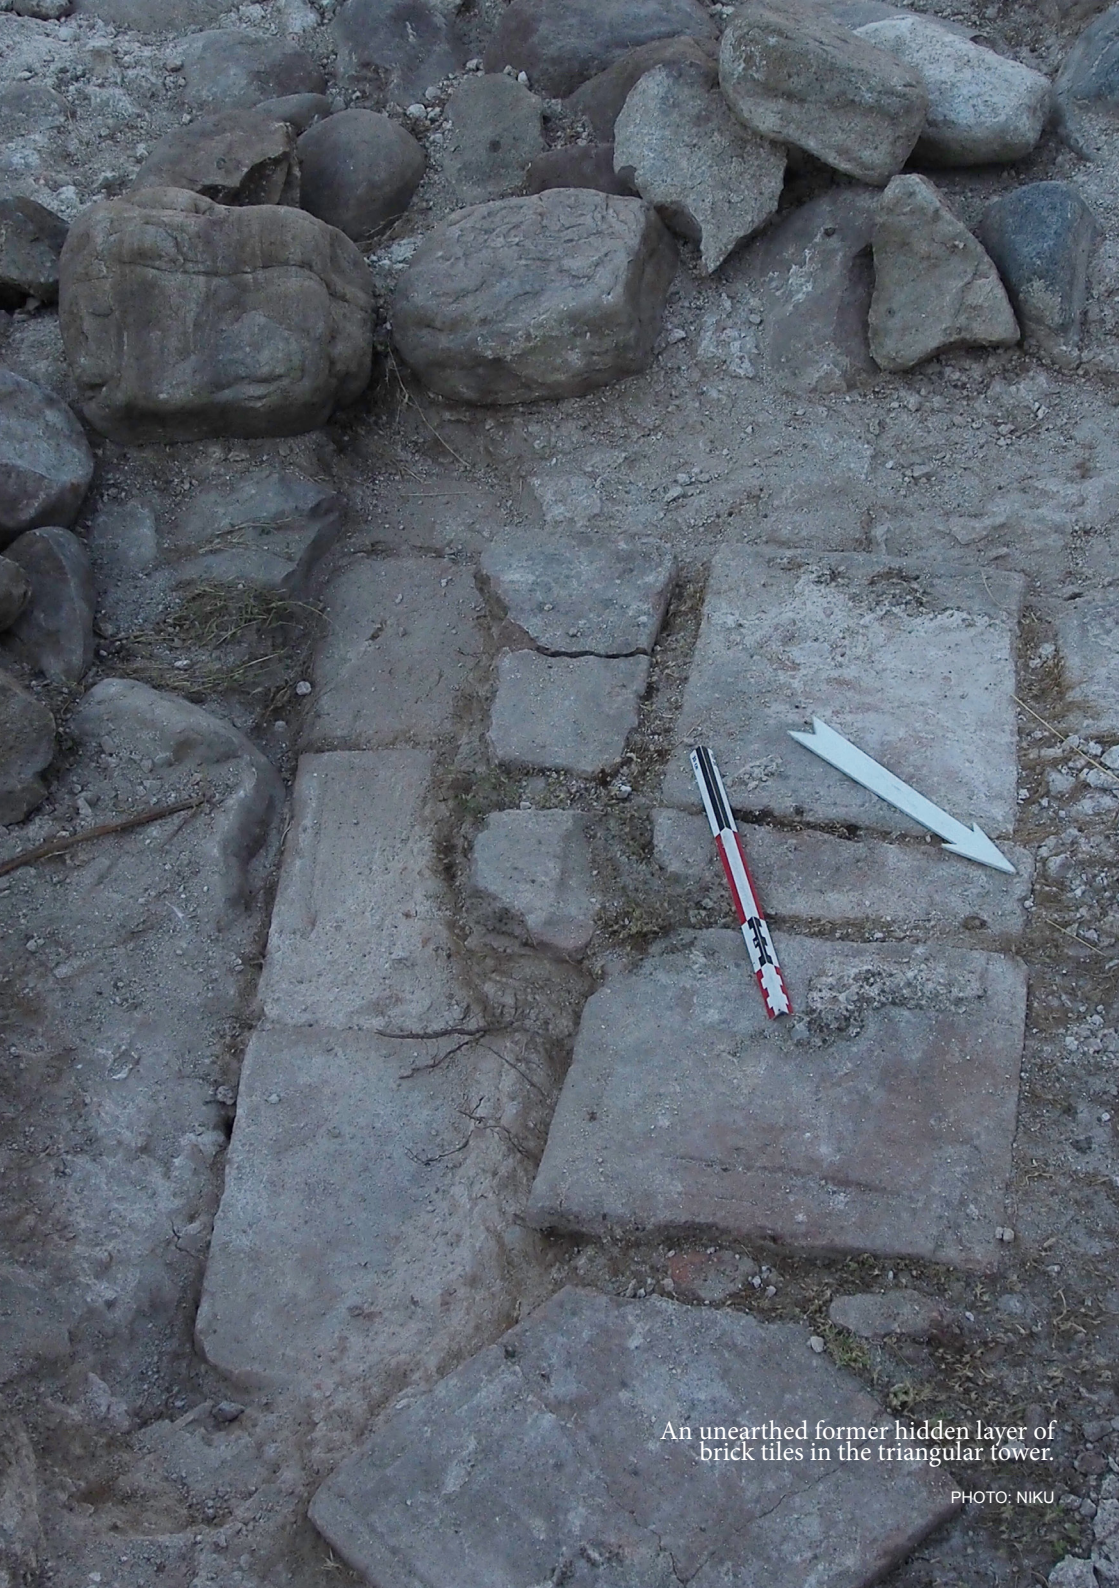
An unearthed former hidden layer of brick tiles in the triangular tower.

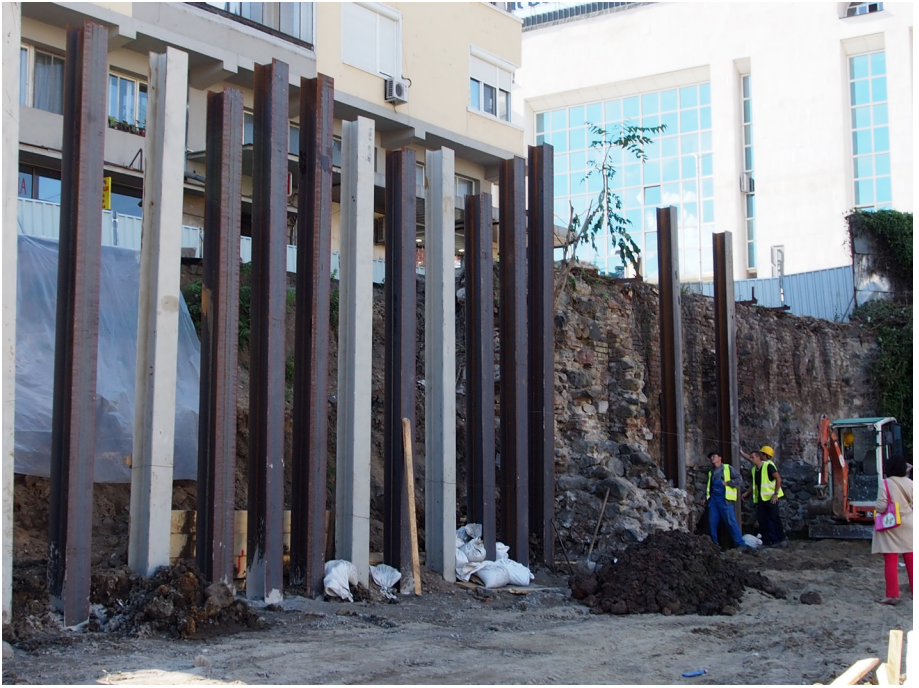
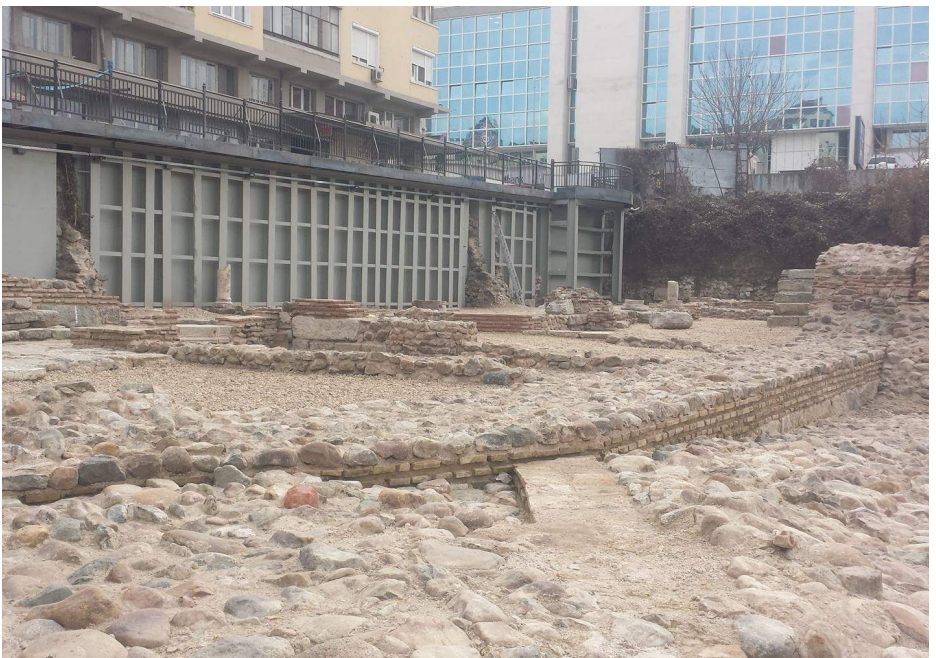
Next page: The wall section under George Washington street during (top) and after (bottom) safeguarding.

The archaeological investigations were mostly over by July 2016, though an extra emergency rescue investigation had been necessitated because parts of the George Washington street at the south-eastern corner of the plot had fallen down. This demonstrated how dangerous and unprotected the exposed section was, so measurements to secure the section and thus protect both the site and the street were carried out.

The best method was piling along the wall to stabilize the street. To enable the piling, it was necessary first to excavate a minor area just beneath the exposed section. Then piles were

driven down parallel to the wall, and plates were put between these to ensure a safe transition from the road to the site.

Behind these plates, excavation soil was used as back fill, to ensure that the adjoining archaeological deposits were not unnecessarily exposed to oxygen. Oxygen is a degradation factor on archaeological remains. For that reason, and in order to protect and preserve some of the archaeology for future generations, some of the earlier excavated mosaic floors in the living quarters were covered with protective sand, before even these areas had been backfilled with excavation soil.

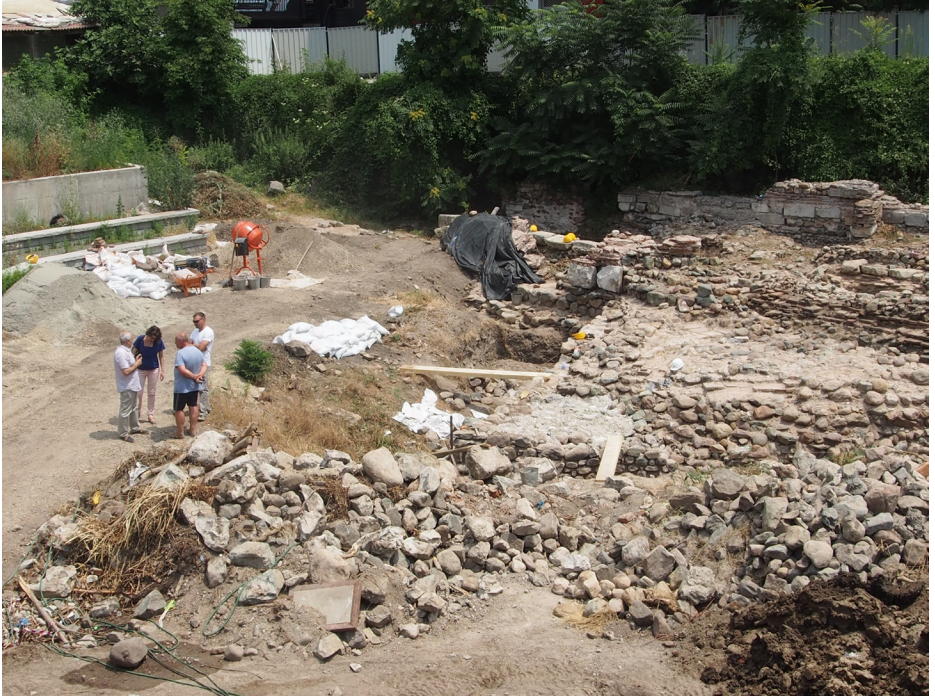
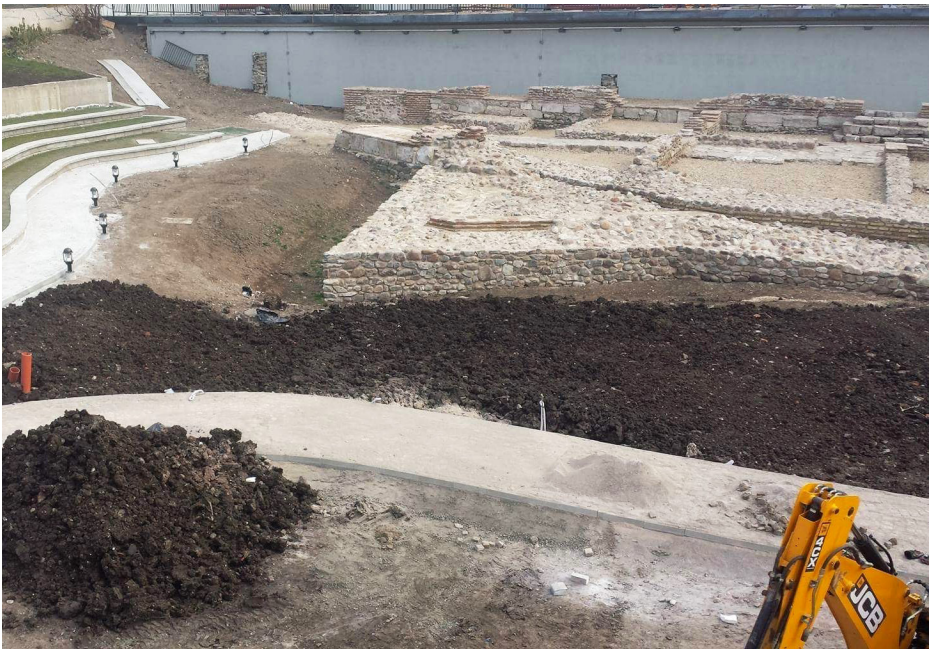
Next page: The Western Gate's triangular tower during (top) and after (bottom) reconstruction.

The Western Gate has a high cultural and historic value, and a large communication potential, therefore it was partially reconstructed to be enjoyed by the public. The walls are reconstructed to a level where they can be immediately understood by a general audience. An additional benefit is that this re-

construction also protects the original walls from direct influence of the weather, which in Sofia may range from temperatures of 20 below zero to the 40's above. The reconstructions also mean that the ruins may be touched by people without risking degradation or destruction.

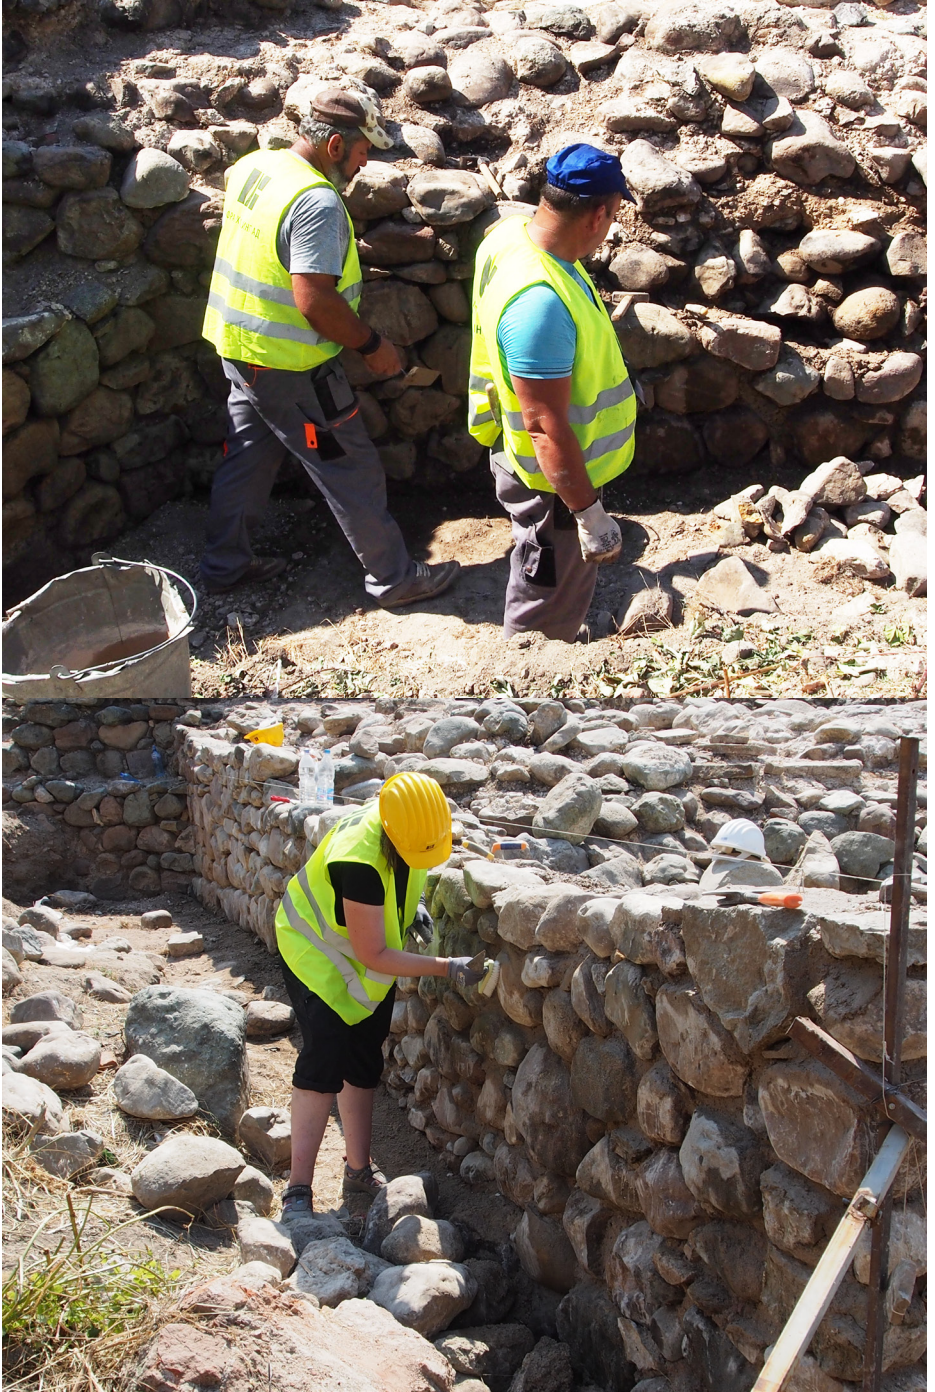
Previous page: The Western Gate's
triangular tower during
reconstruction.

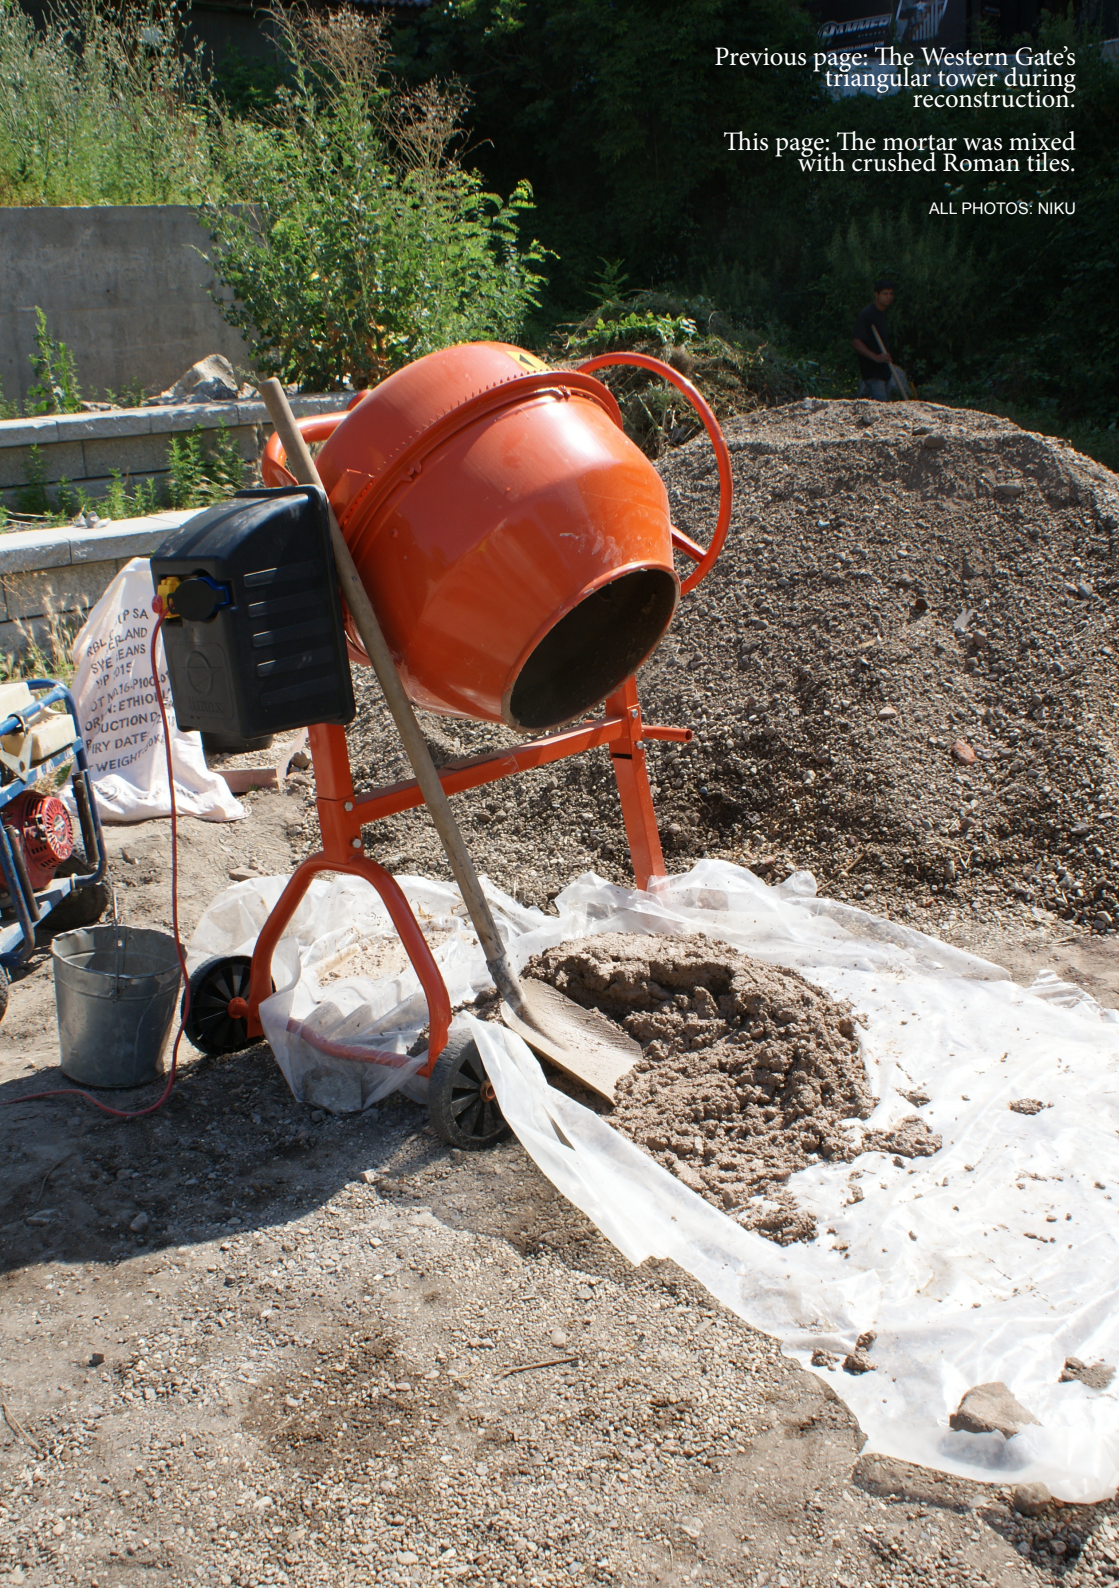
This page: The mortar was mixed
with crushed Roman tiles.

To make the reconstructed walls look as much like the original ones as possible, and to preserve the original parts in the best possible way, even the original Roman Period mortar was reconstructed. The reconstruction mortar consisted of crushed Roman

tiles, mixed with hydraulic lime, sand, gravel and water. When the work was finished, a line was painted on the wall, indicating the original level and what was new. The same method has been used at the metro *in situ* museum.

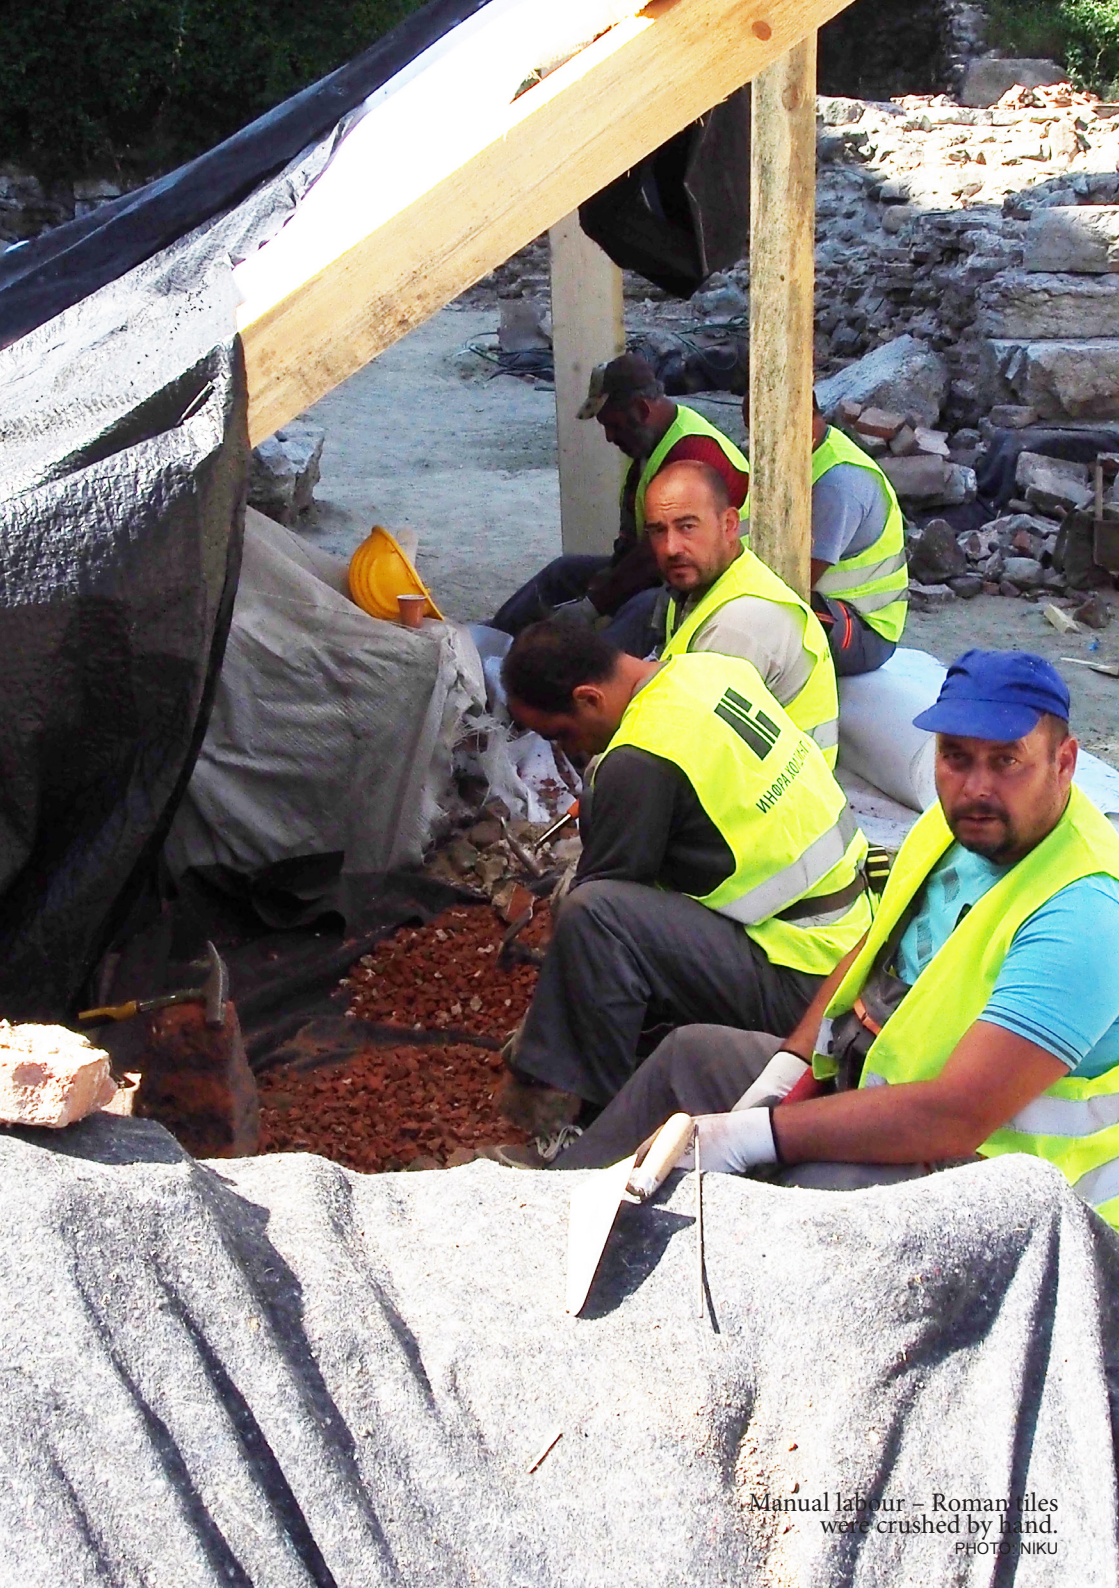
Manual labour - Roman tiles were crushed by hand.
PHOTO: NIKU

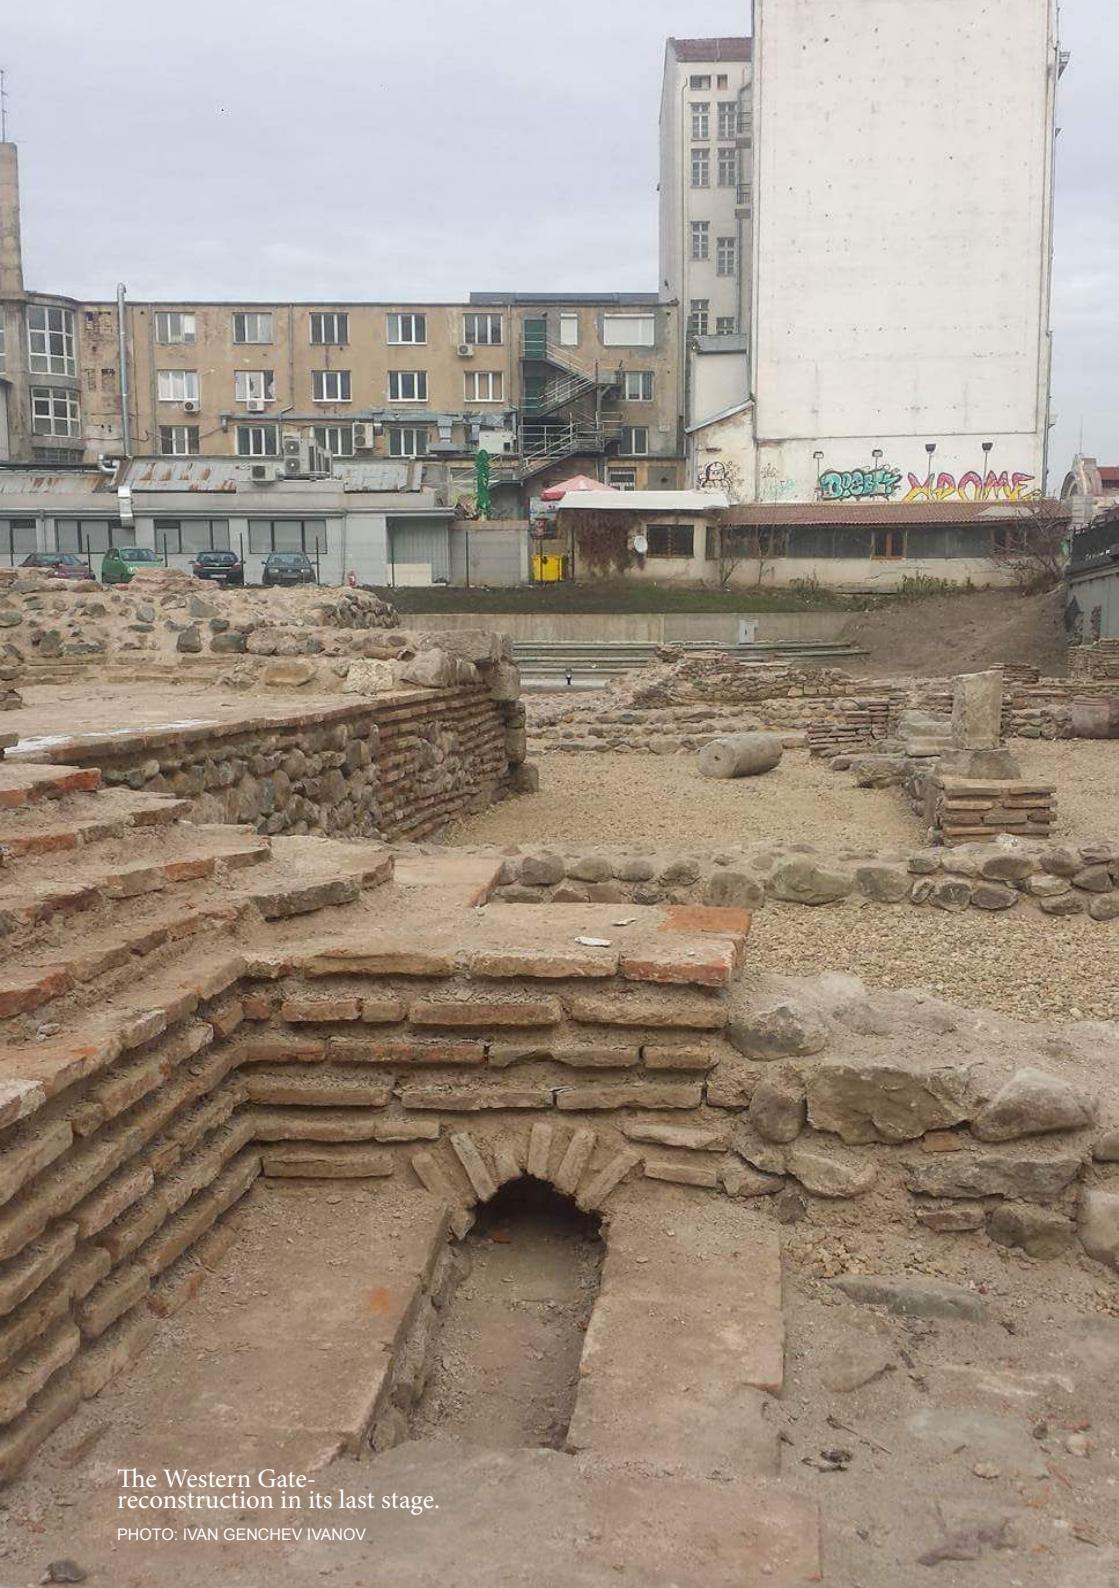
The Western Gate-
reconstruction in its last stage.

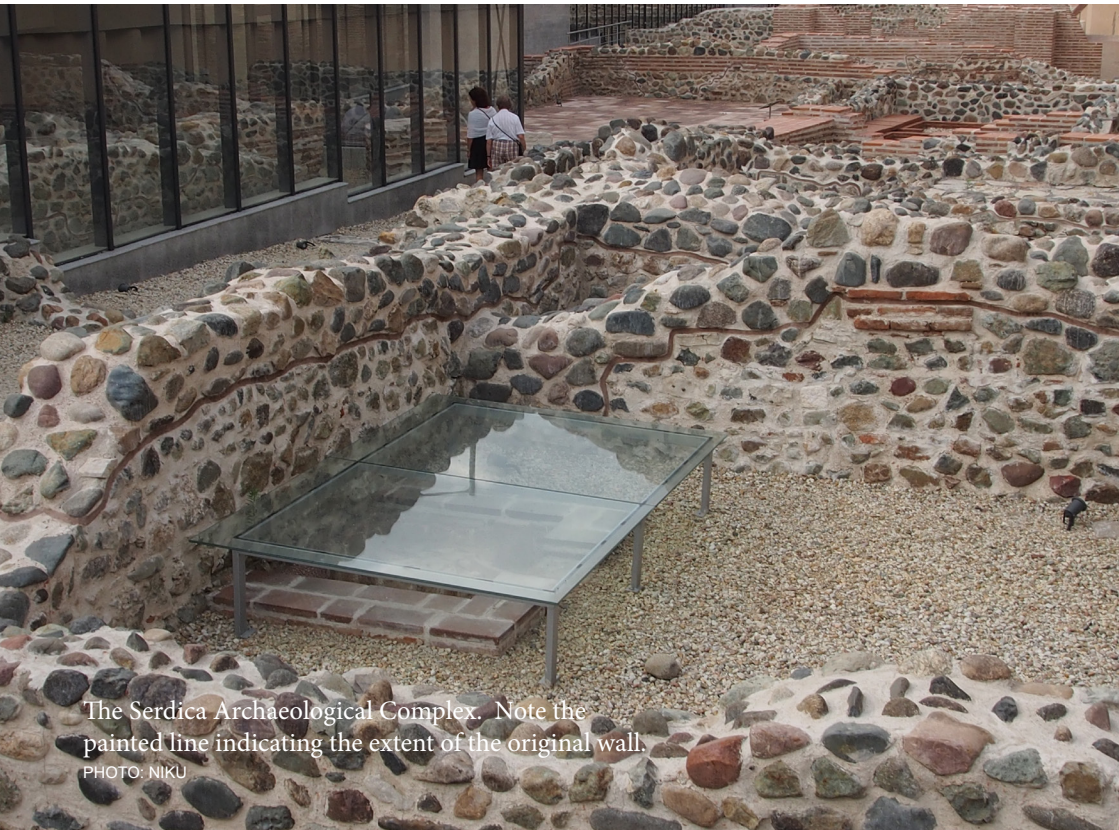
The Serdika Archaeological Complex. Note the painted line indicating the extent of the original wall.

The model exhibition for the Western Gate reconstruction is the Metro station “Serdika II” and the Serdica Archaeological Complex. The excavated ruins

are rebuilt to a certain height, and a line is painted in the mortar to point out where the original ends and the reconstruction begins.

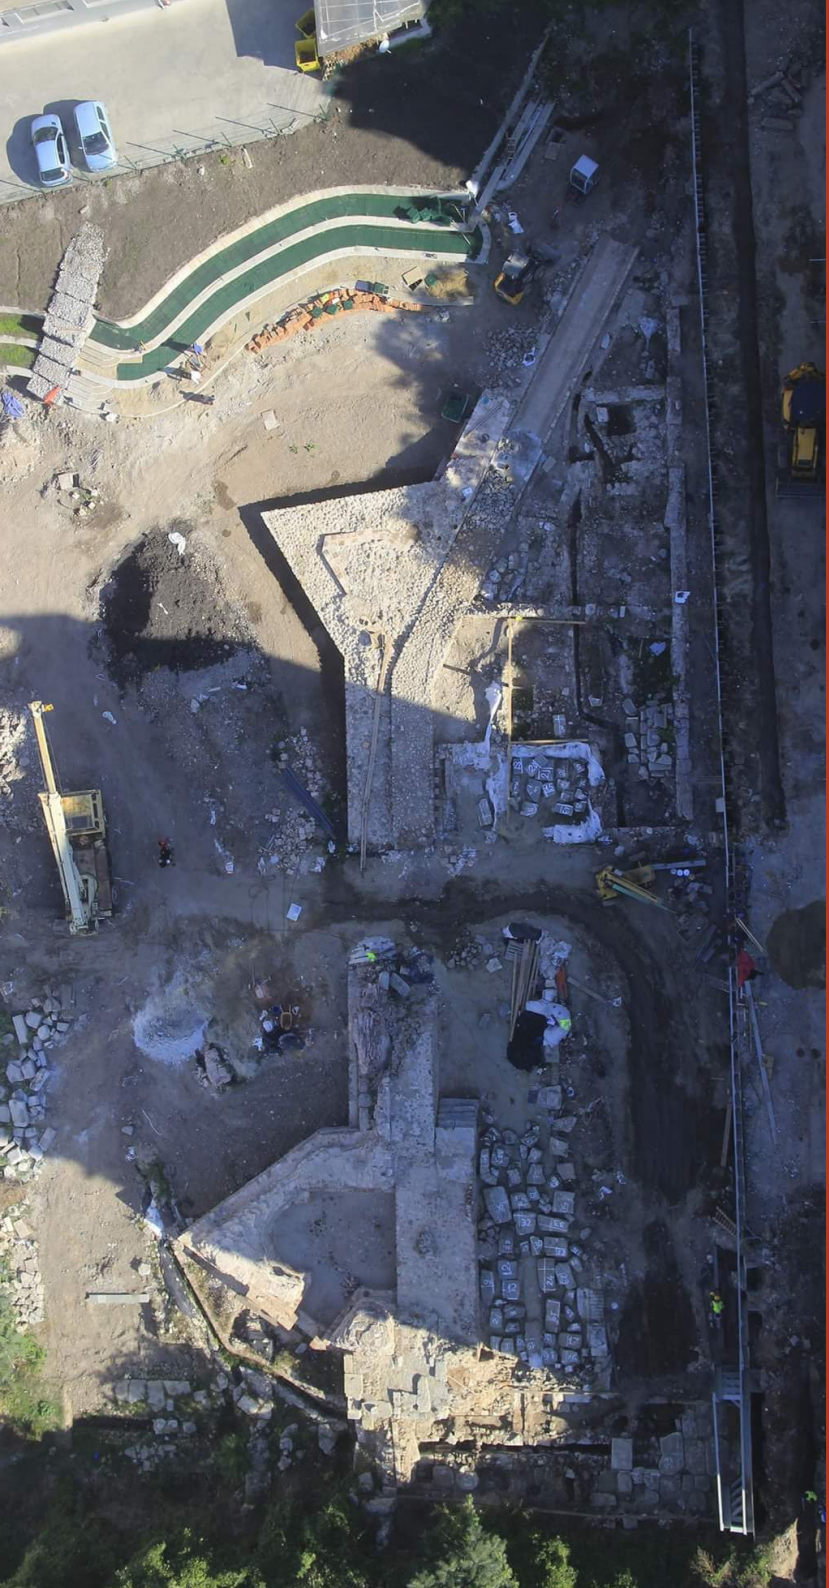
The Western Gate of Serdica during its final stages of reconstruction. PHOTO: IVAN GENCHEV / IANOV
