THINK GLOBALLY; ACT LOCALLY

SUPPLEMENTARY CHECKLIST FOR SAFEGUARDING HISTORIC OBJECTS AND INTERIORS FROM EXTREME HAZARDS

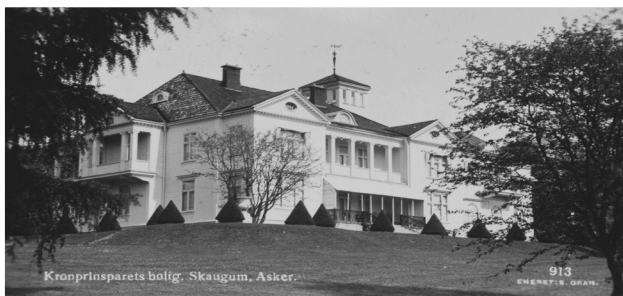
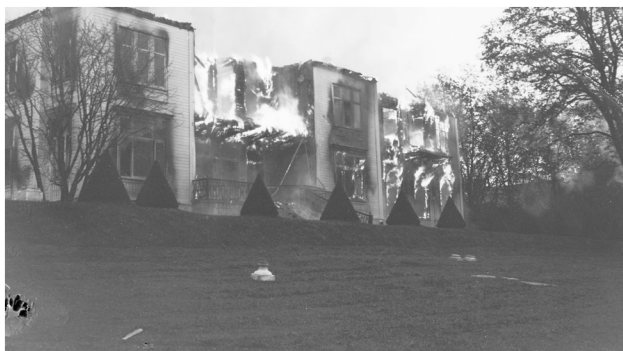
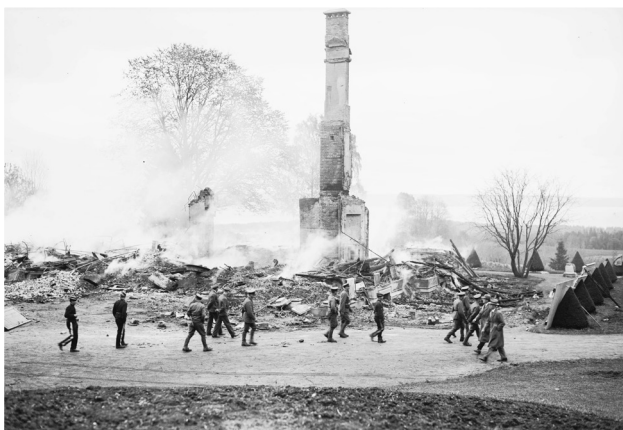
Figures 1, 2 and 3 (to the right). Fires and floods top the list of disasters affecting cultural institutions. Skaugum in Asker Municipality is a manor house and the residence of the Crown Prince of Norway, which caught fire in 1930. Photographs before, during and after the fire. Figure 1: S. Gran 1925. Figures 2 and 3: Steen and Henriksen 1930. (All photographs: Nasjonalbiblioteket www.nb.no, CC0 1.0 licence).

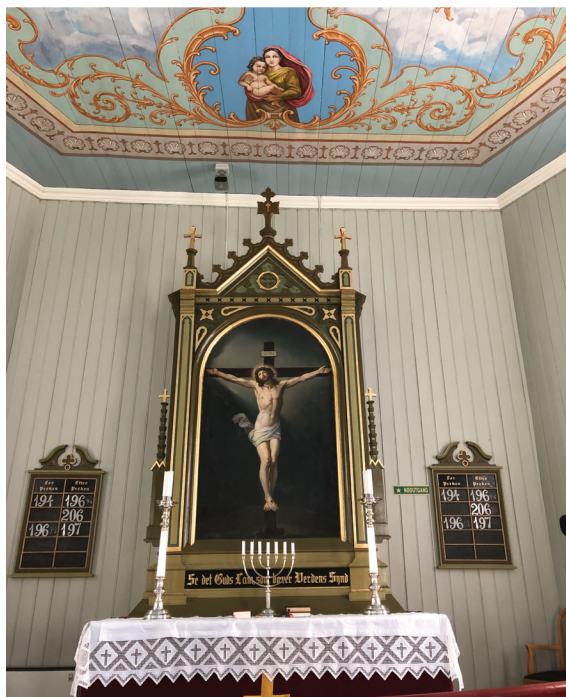
Figure 5. Mykland Church in Froland Municipality, with decorated ceilings (1931) by Torkild Gill. This is a typical example where documentation prior to a damage is crucial (as stated in Step 4). Photo: Nina Kjølsten Jernæs (2019).

Does the interior have decorated ceilings or walls? There might be challenges, such as the fire brigade needing to use the roof to let out smoke and rig for the fire hoses, damaging a painted ceiling (Figure 5). In general, the important parts or pieces cannot be covered or salvaged. To be prepared for the worst-case scenario, painted walls and ceilings should be documented with high-quality photographs, together with thorough descriptions of the materials, techniques and motifs. This will enable reconstruction or copying the decoration or the wallpaper after any damage (see Step 9). As Kincaid lists in his overview of the needs for a robust risk management plan, the records, drawings, photographs and other information on the whole building should be stored offsite for use in rebuilding in the event of partial or total damage (2012: 27).
