## In the Heat of the Moment: Testing Fire-Protective Covers for Mitigating Damage to Large Historic Inventories

Nina Kjølseth Jernæs & Ragni Fjellgaard Mikalsen

Since the 1990s, the Norwegian management for cultural heritage has increased its focus on finding effective solutions for protecting Norway's wooden cultural heritage from fire damage. The medieval churches in general, including the wooden stave churches, with their interiors and inventories, are of special interest. However, the usefulness of protecting valuable interiors and inventories when fighting fire has been questioned. An experiment was carried out to find manageable solutions for protecting large inventories by using fire covers in case of fire. An experiment using seven commercially available products was conducted by fire fighters to investigate whether these products could protect historic interiors from water and fire. The preliminary results show that it is possible to find manageable, large format covers for the protection of large, immovable historic inventories.

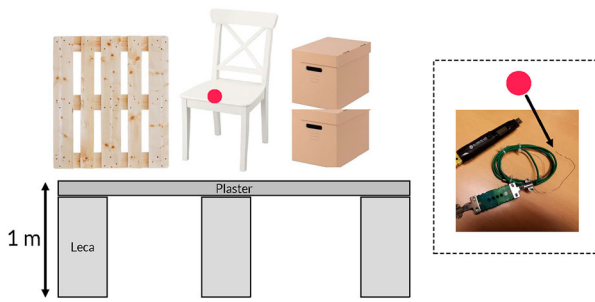
**Figure 1.** Experimental set-up for the fire service, showing wooden pallet and cardboard boxes stacked on a table, along with a painted wooden chair holding the thermocouple arrangement.

The experimental set-up is shown in Figures 1–3. In the part 3 fire experiment, temperature was measured on the unexposed side of the textile using a 0.5 mm type K thermocouple positioned mid-air on top of the chair, logged every 1 s by a portable EasyLog EL-USB-TC-LCD thermocouple data acquisition unit.

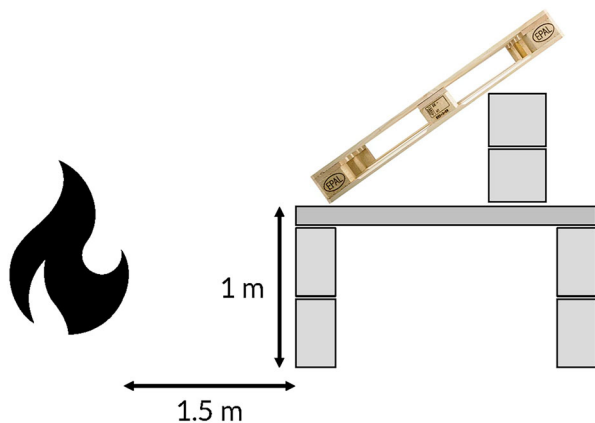
**Figure 2.** Experimental set-up for the fire service, side view.

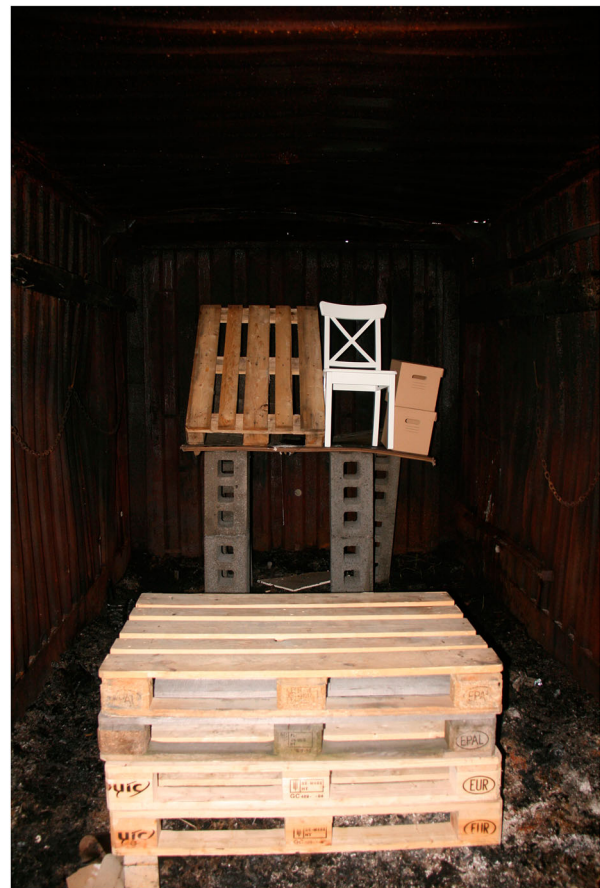
**Figure 3.** Set-up before covering the items and before igniting the fire using the wooden pallets stacked in front.

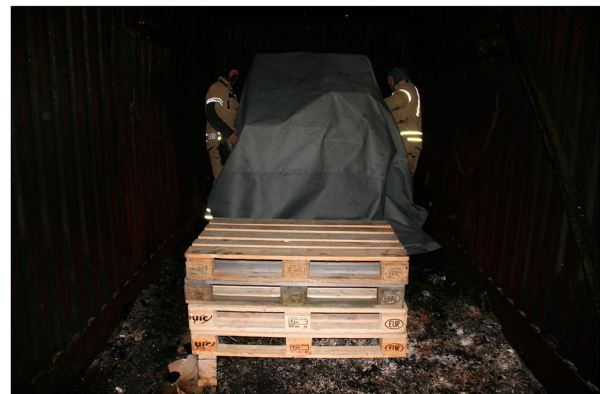
**Figure 4.** Covering the items while the clock is ticking, where the fire personnel had one minute.

Unwrap the product outside its container if it is not raining. Familiarise yourself with the product for a few minutes. Time from unwrapped condition until placed carefully over the items to be protected: 1 min. (Figure 4)

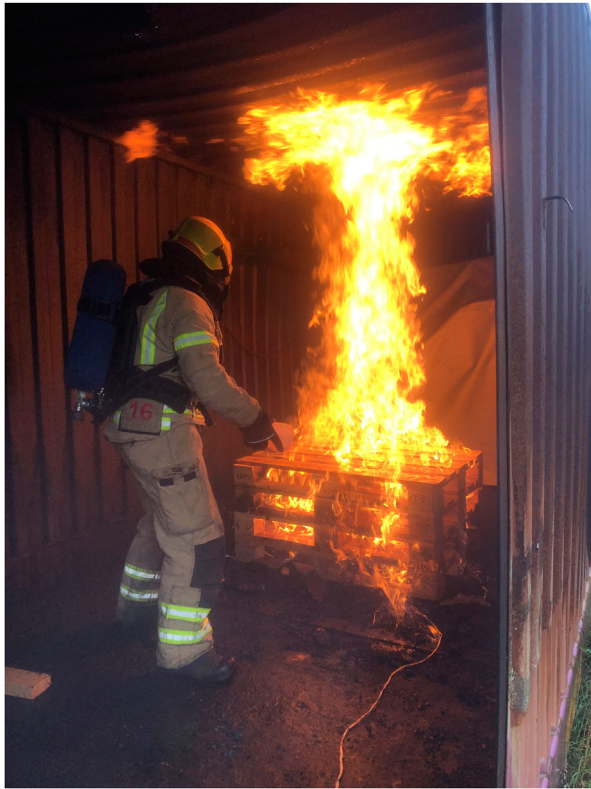
**Figure 5.** Igniting the stacked pallets for fire test.

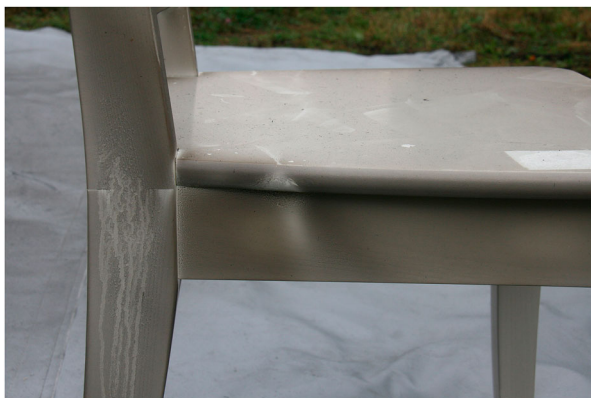
**Figure 6.** Example of damage after the fire test: soot on painted wooden chair. Minimal covering with gaps on the side allowed soot to get inside.

variations in the temperature reached during the free-burning part of the fire test. The reasons are probably variations in draft, outdoor temperatures, and humidity of the fuel. There may also be some variations in the time when the temperature was measured on the surface, based on the maximum fire temperature that was reached. The variations were between 224 and 270°C on the fabric surface, measured by IR camera. However, high temperatures on the surface did not always correlate with high measured temperature on the inside, which shows tendencies towards good or poor insulation properties when testing different textiles. An overview of the preliminary test results can be read in [Table 3](#). Photographs with example damage observed after the experiments are presented in [Figures 6–8](#).

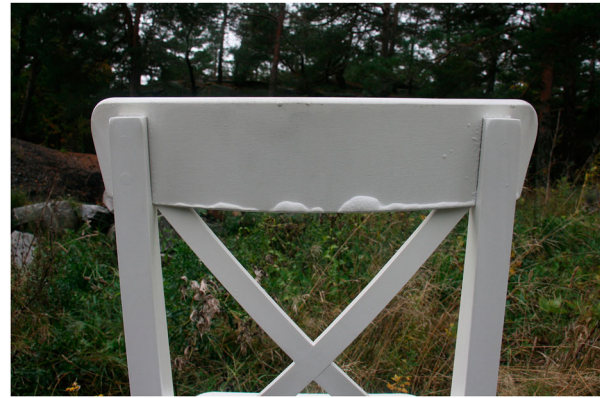
**Figure 7.** Example of damage after the water test: water damage on painted wooden chair. Minimal covering with gaps on the side allowed humidity to get inside and react, causing the material to swell.

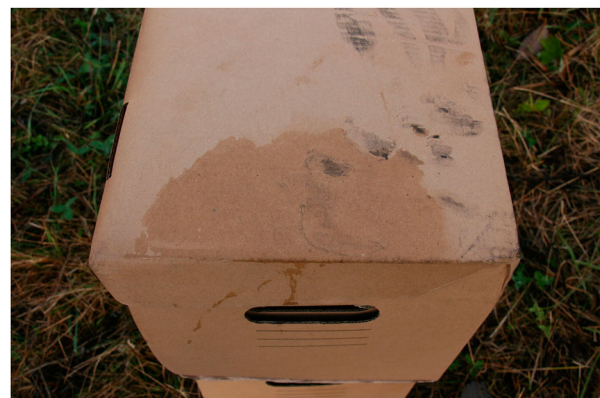
**Figure 8.** Another example of damages caused by water on the cardboard box. The seams on some of the covers resulted in wet cardboard boxes underneath the cover.

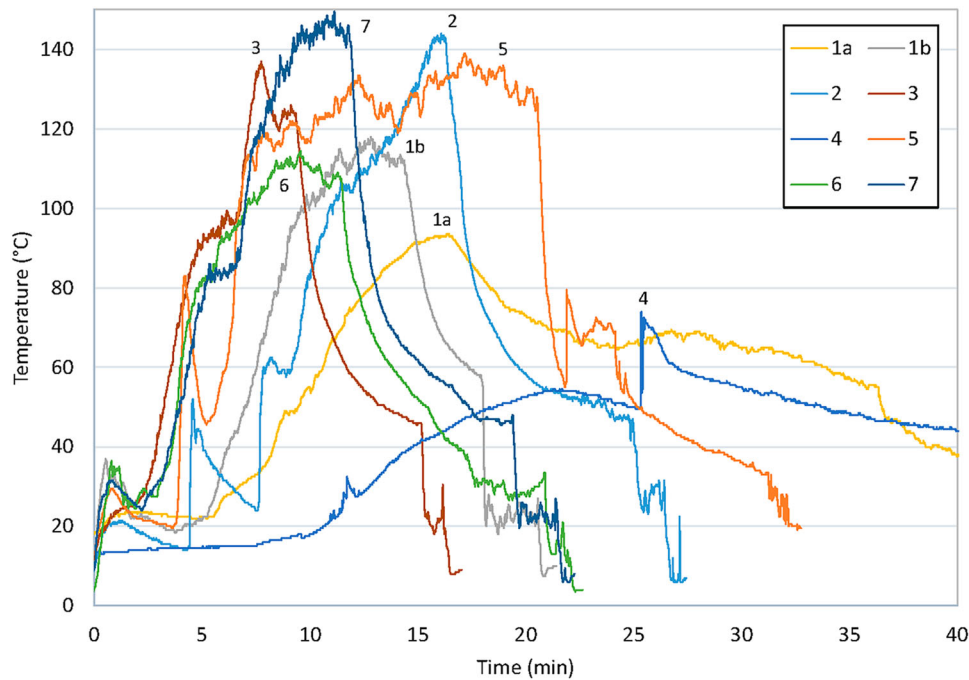
**Figure 9.** Temperature development during the experiments. For product 1a, there is an apparent discrepancy in the temperature measurement compared with its performance (destroyed). This is most likely due to differences in radiant and conductive heat transfer modes (see main text).

products is presented in [Figure 9](#). The temperature data for each product is presented in [Figure 10](#), including the time stamps for events during the test. Key events were ignition, the time when the fire service assessed that the fire had reached its maximum by visual observations of the fire, the logged temperature maximum, time when extinguishing was started, and end of extinguishment. As seen in [Figure 10](#), in four cases the initial fire development was slow, and fuel was refilled one or two times (indexed by Ignition refill 1 and 2). In one case, the fire re-ignited after termination of the extinguishment, and extinguishment was started again.

The temperature development and the maximum temperatures measured on the unexposed side give an impression of the insulation capability of each product. Based on an evaluation of the initial temperature development, the amount of fuel and number of fuel refills, the overall temperature maximum, and the time of extinguishment compared with the temperature development, as well as the inspection of damage on the items after the fire exposure, the product's insulation properties were divided into three categories. The products that showed the best insulation performance were products 1a and 4, having a slower temperature increase and a lower maximum temperature; however, product 1a was destroyed in the fire. Products 1b and 6 performed at an intermediate level, and products 2, 3, 5, and 7 had the poorest insulation properties. There was only one case of charring (burn damage) to the objects (1a). For all the others, there was no visible burn damage on the objects. There were soot marks, in particular underneath the smallest (3 × 4 metres) textiles.

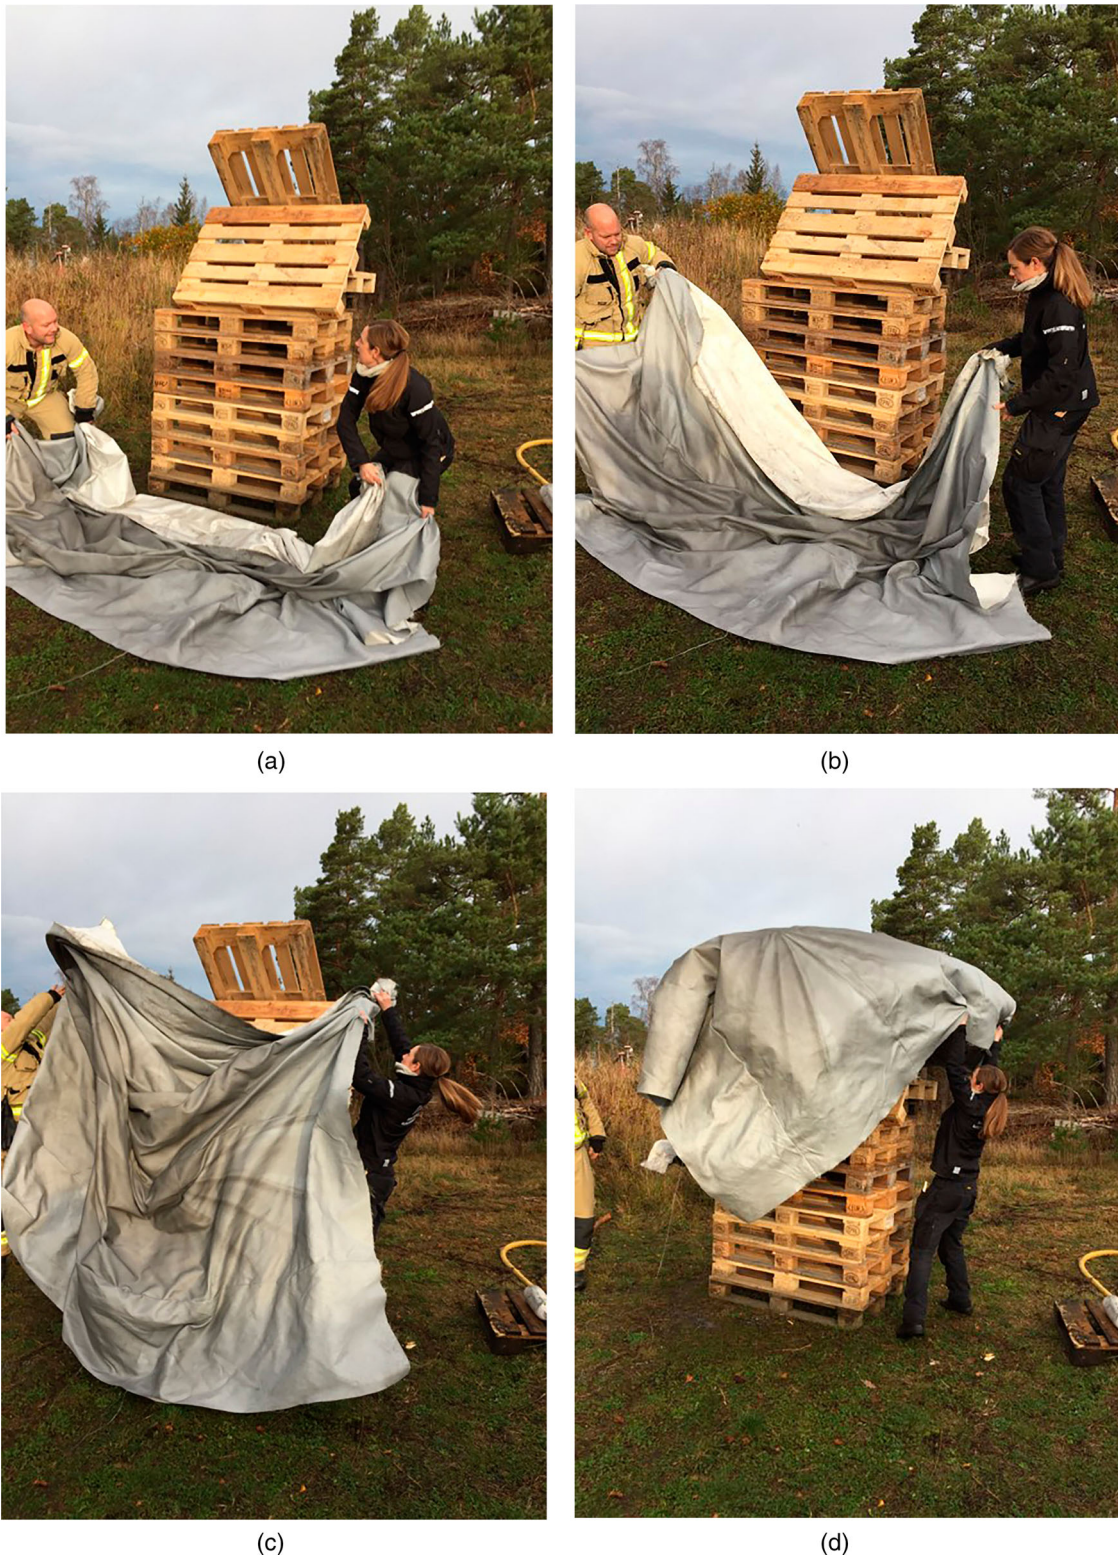
**Figure 11.** Throwing covers over the ‘pallet tower’ representing an altar.

up used was designed to imitate the shape of an altar-piece to be covered in the shortest possible time. The result was a ‘pallet tower’, measuring 265 cm (height) × 132 cm (width) × 120 cm (depth). The shape was made to mimic a historic item with angles and protrusions that would challenge the covering procedure.

Three textiles measuring  $4 \times 4$  metres were chosen to test a quick covering of a high altar mock-up. The selection was made based on the same format, as well as the variety in the types of textiles. The three textiles weighed  $520 \text{ g/m}^2$  (Product 1),  $630 \text{ g/m}^2$  (Product 4), and  $840 \text{ g/m}^2$  (Product 2), respectively. Each textile was tested twice, where it was thrown over the pallet tower from 'the front' of the altar mock-up, and each covering took between 15–20 s (Figure 11a–d). A stiffer fabric was easier to adjust after the throw, which had a positive effect if the fabric was thrown towards one side or too little above the top point. All

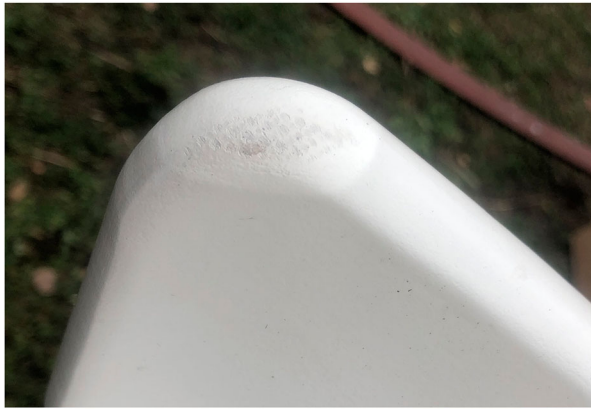
**Figure 12.** Example of ‘press marks’ on the painted surface touching the textile cover.

Five of the seven fire experiments resulted in ‘press marks’ on the painted surface where the textiles touched the chair (Figure 12). From a conservation perspective, this is of course, unfortunate. An insulation layer would probably have prevented this. However, it was considered acceptable damage considering the need for a single-layered textile product with good handling properties.
