Climate change impacts and fungal decay in vulnerable historic structures at Svalbard

Anne-Cathrine Flyen^{1,2*}, Cecilie Flyen^{2,3}, and Johan Mattsson⁴

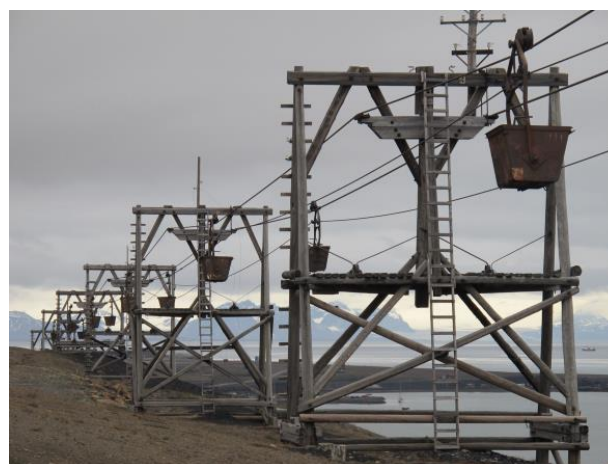
Fig. 5. Wooden structures with high risk of fungal decay where the wooden pylons are in contact with soil. Photo: Mycoteam/J. Mattsson

Wood in contact with soil have more favourable growth conditions for fungi, through accessing moisture from wet soil in the thaw zone, and because sun radiation induces higher temperatures locally on the soil surfaces (fig. 4). Fungal decay in lower parts of load-bearing timber piles is fatal for the stability of constructions, technical structures, or buildings (fig. 5).

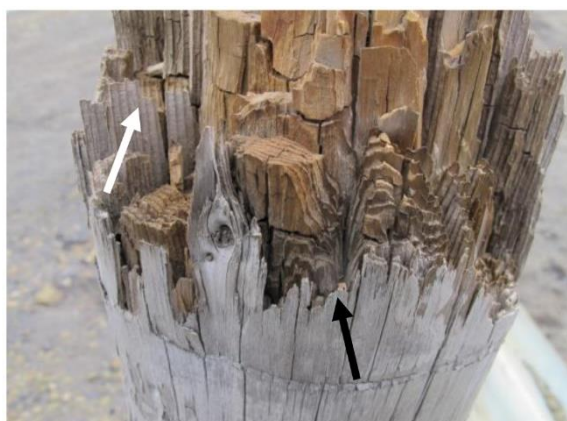
Fig. 6. Typical pattern of decay in wooden piles at Svalbard: an unharmed outer layer of 4-5 mm, and extensive deterioration in the internal part [37]. Photo: Mycoteam/J. Mattsson

directly on the ground. However, both international and national findings reveal significant biodeterioration in Polar environments [8, 30, 36-42]. Some rot fungi, such as the most active rot fungus in the historic structures at Svalbard, have adapted to living in cool environments, with optimized growth around 5-15°C. The microscopic analysis for rot fungal species determination in the ROT-project proved that the most common rot fungus at Svalbard is *Leucogyrophana mollis*, causing brown rot [8]. In wooden logs piled into the permafrost, *L. mollis* has special damage characteristics: The rot fungus is hardly ever visible on the wood surface. The degradation occurs directly beneath the surface, where extensive damage may be found, see fig. 6, 7, and 8. The damages

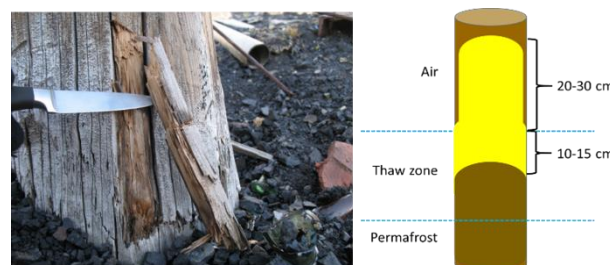
Fig. 7. On Svalbard, fungal decay is commonly found inside the wooden piles which are in contact with soil. Brown: sound wood. Yellow: decayed wood. Modified from [17]

usually extend to 12-30 cm above ground, and correspondingly 10-15 cm below the ground surface. The wood is heavily degraded from the inside and out, and the distance between the surface of fresh wood and established damage may often be only a few millimetres [33], as shown in fig. 6, 7, and 8. On the mainland, however, degradation caused by *L. mollis* appears more commonly on the outside of similar pylons [37].

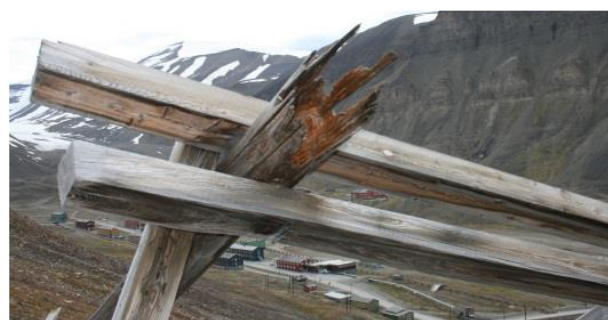
Fig. 8. Characteristic pattern of extensive, internal fungal decay in wood with soil contact at Longyearbyen, Svalbard. The external layer of wood is undamaged, whilst the inner parts are heavily decomposed. Photo: NIKU v/A.C. Flyen.
