# ADAPT

NORTHERN HERITAGE  
TOOLKIT

## Adaptation stories

*Examples of risk assessment, adaptation planning and conservation management of northern historic places*

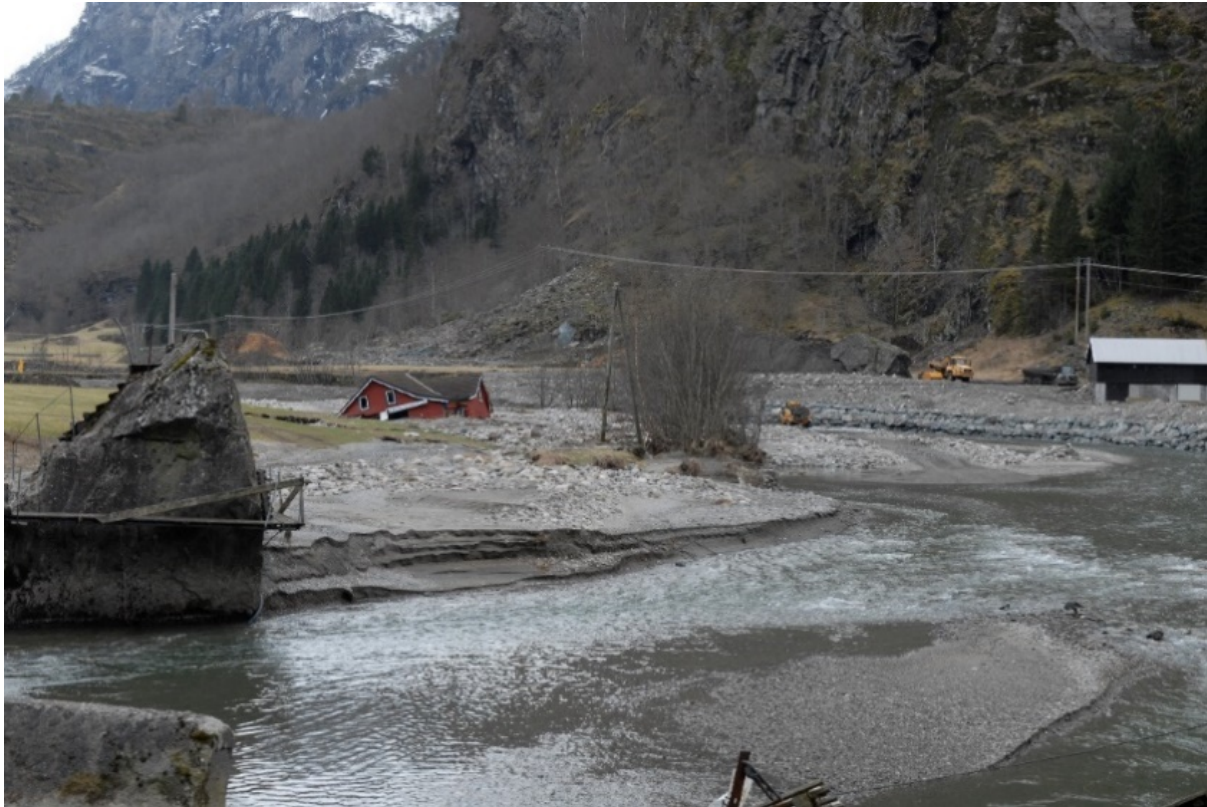
*Image 2 Many residential buildings and several farm buildings were destroyed in the flood.  
Photo: Marte Boro, Riksantikvaren*

In total, 13 residential buildings were damaged. The river eroded away foundations, so that a total of five houses burst into the river and were washed away. In addition, an operating building and several smaller outbuildings were completely damaged and valuable farmland was damaged. The road in the Flåm valley was damaged on several sections and several other roads were washed away. Estimates of the total costs from insurance, repair of infrastructure and restoration of terrain, as well as the strengthening of riverbanks against new flood damage amounted to more than NOK 250 million (approx. £23 million). Climate change appears to increase the frequency and magnitude of rainfall events in the region (Hanssen-Bauer, 2017). This means that intense short-term floods of the same type as in 2014 will occur more often than before (Multiconsult, 2016).

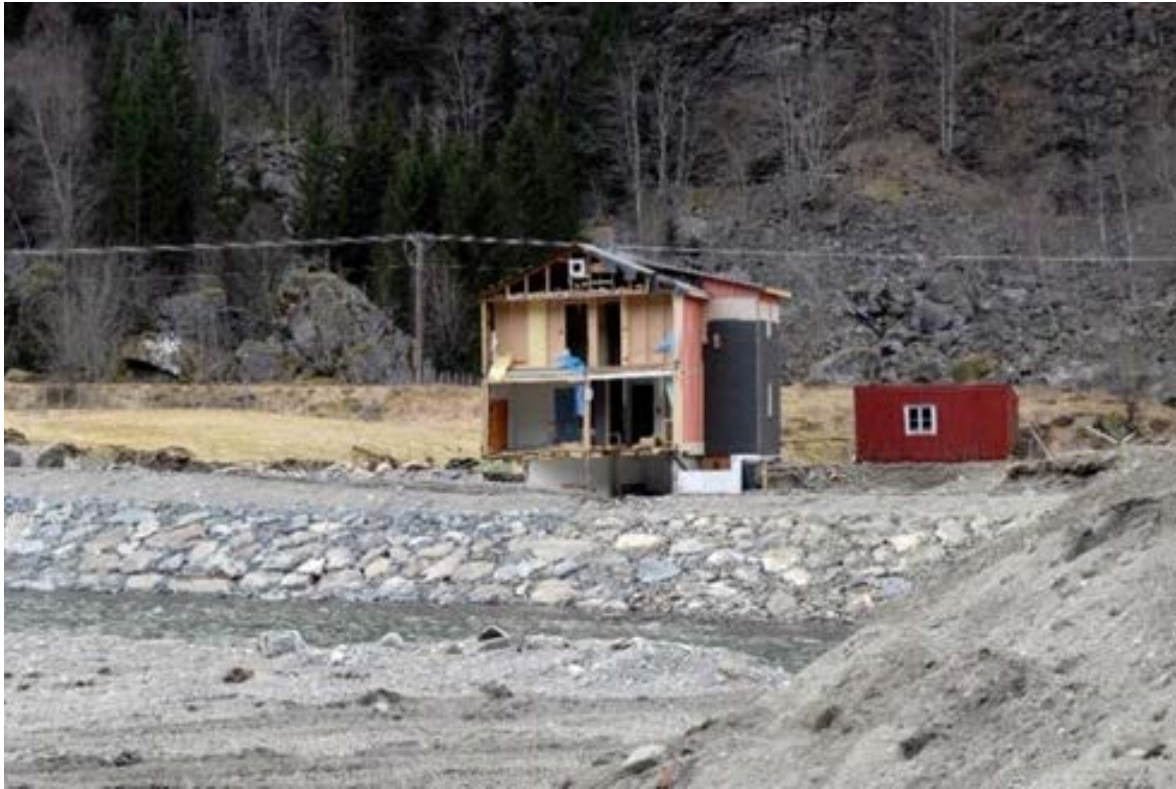
*Image 3 Securing the riverbank after the flood. In the background is one of the houses that were destroyed by the ravages of the water. Photo: Marte Boro, Riksantikvaren*

After the flood, extensive hedging work was carried out along the river. The road was repaired, bridges rebuilt and destroyed buildings replaced. The church was situated low in the terrain and plans to raise the entire building have existed for a long time. The flood clearly showed that this was necessary.

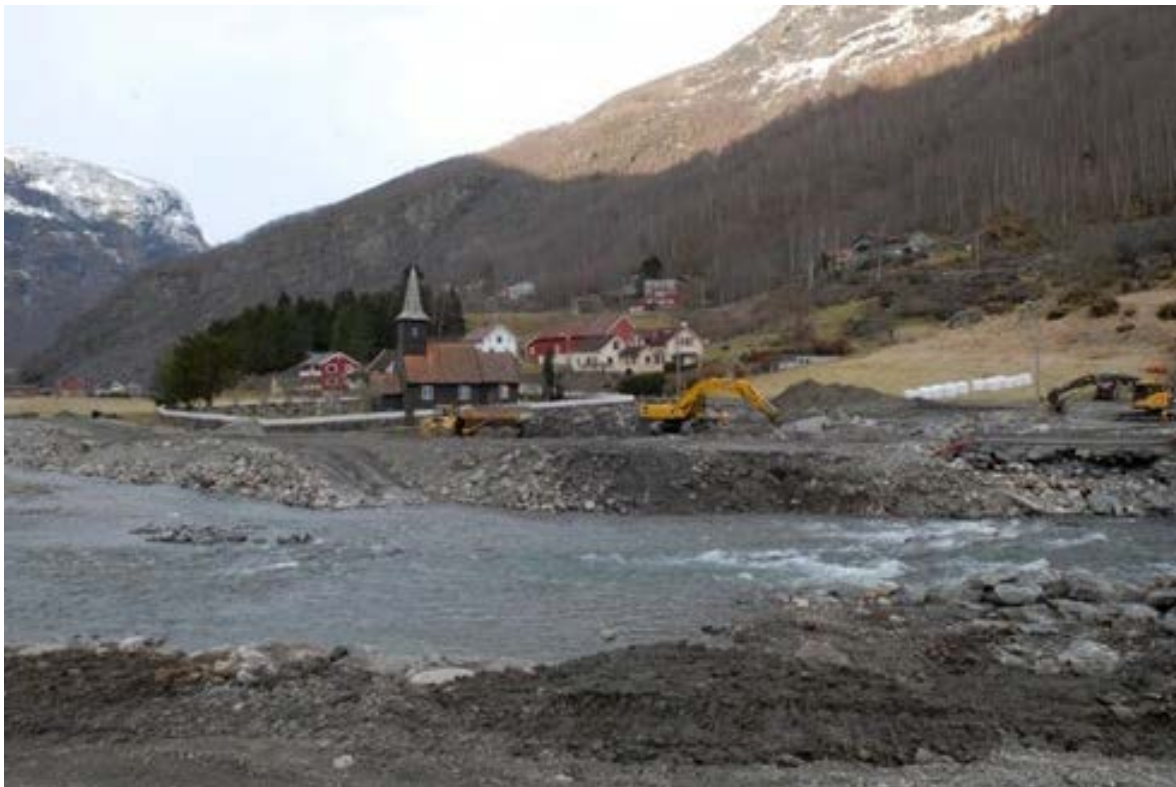
*Image 4 The flood caused large mass displacements. There was a need for extensive security work and mass return. In the background is Flåm Church. Photo: Marte Boro, Riksantikvaren*

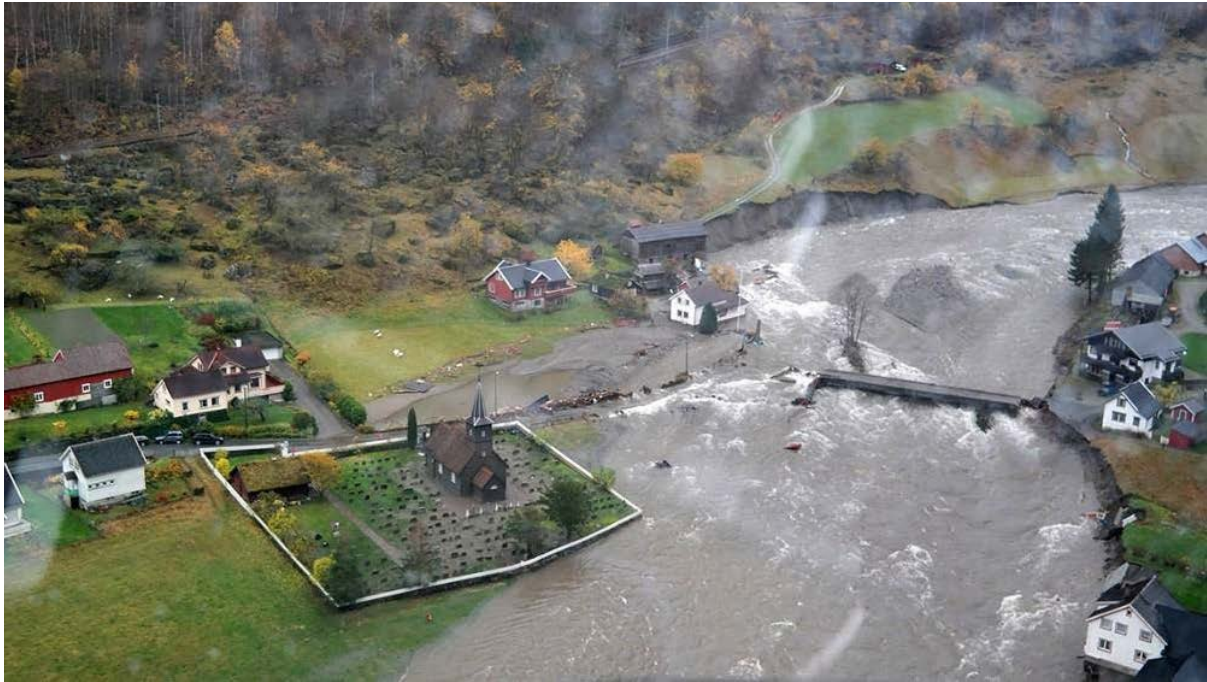
*Image 5 Flood 2014. Several buildings, land and roads were washed away by the flood. Flåm church and the graveyard after the top flood tide. Photo: Oddleif Løset, NRK*

The church and medieval cemetery are situated close to the river. During the flood, the river went up along the cemetery wall (image 5). Fortunately, the wall kept much of the water and streams away from the cemetery, but water and mud poured in through the gate and into the cemetery and the church. The water level stood above the floor of the church and mud was 20-30 cm up on the inside walls.

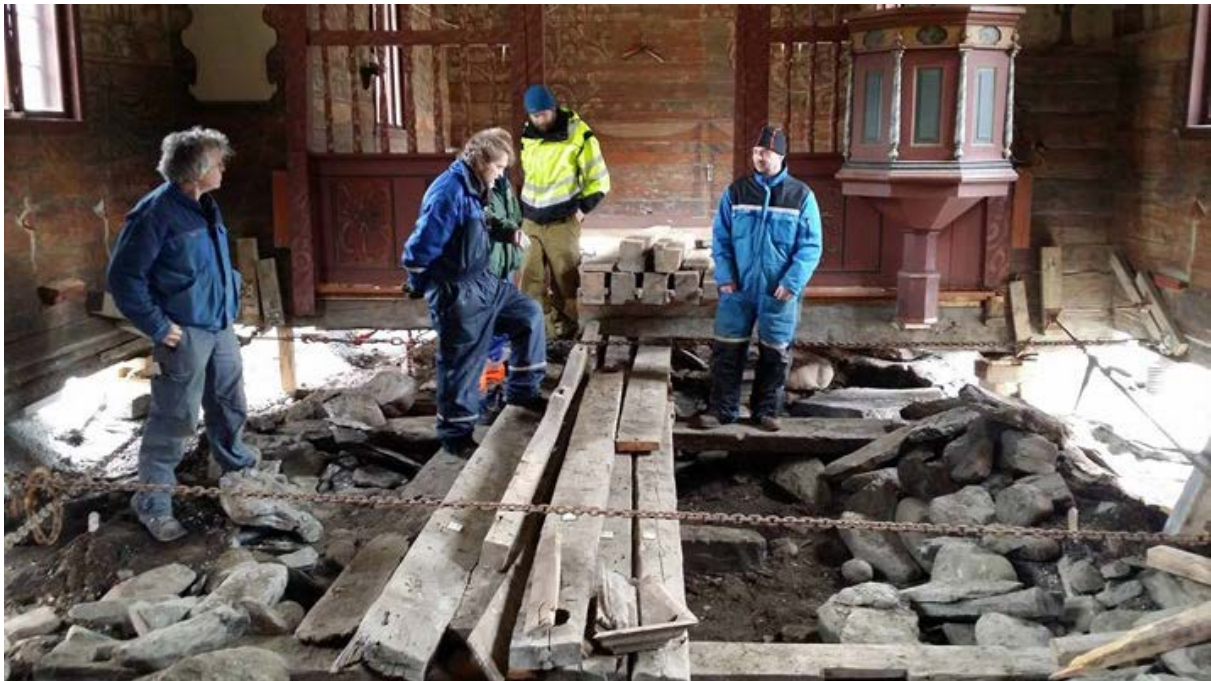
The flood had brought water and mud into the crawl space beneath the floor and beyond the floor. After an attempt to dry out the crawl space without removing the mud, it quickly became clear that the mud had to be removed. The floorboards were taken up, the mud was cleaned away, new beams were installed where needed and the floor was insulated, and the old floorboards were remounted (image 6).

*Image 6 Checking the conditions under the floor. A lot of sludge and moisture had accumulated here. Photo: Monica Finden, Aurland kommune*

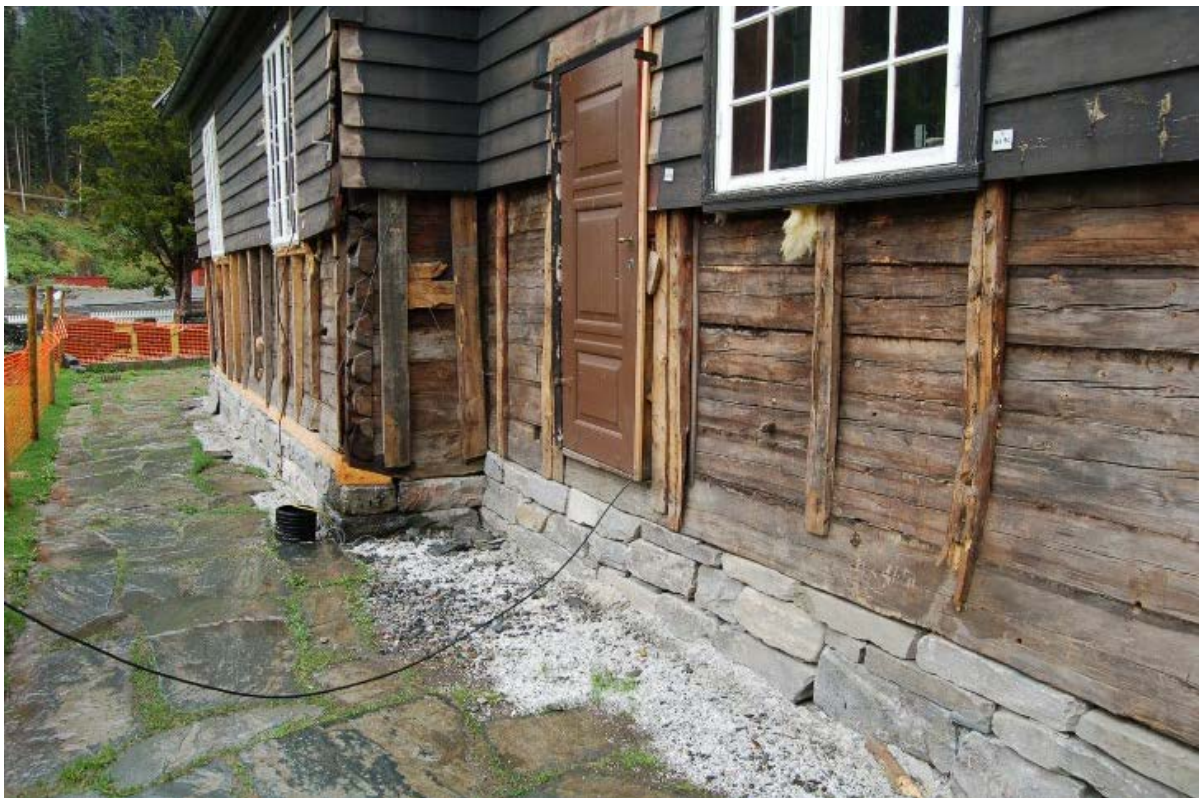
Image 8 Finalising the raise of the building. Photo: Kjersti Ellewssen, Riksantikvaren

A total of 14 jackets and 14 pumps were installed under the church (image 7). The building was then raised 1 cm at each in turn. This was repeated for many rounds, as it was important that the church was raised synchronously to avoid damage. Under the bell tower, which is self-supporting, 20-ton jackets were used. In total, the church was raised by approx. 38 cm. Then the building was lowered onto the foundation which was built with natural stone from the area (image 8). Inside, tension bars and jack straps were used to keep the church stable during the raising.

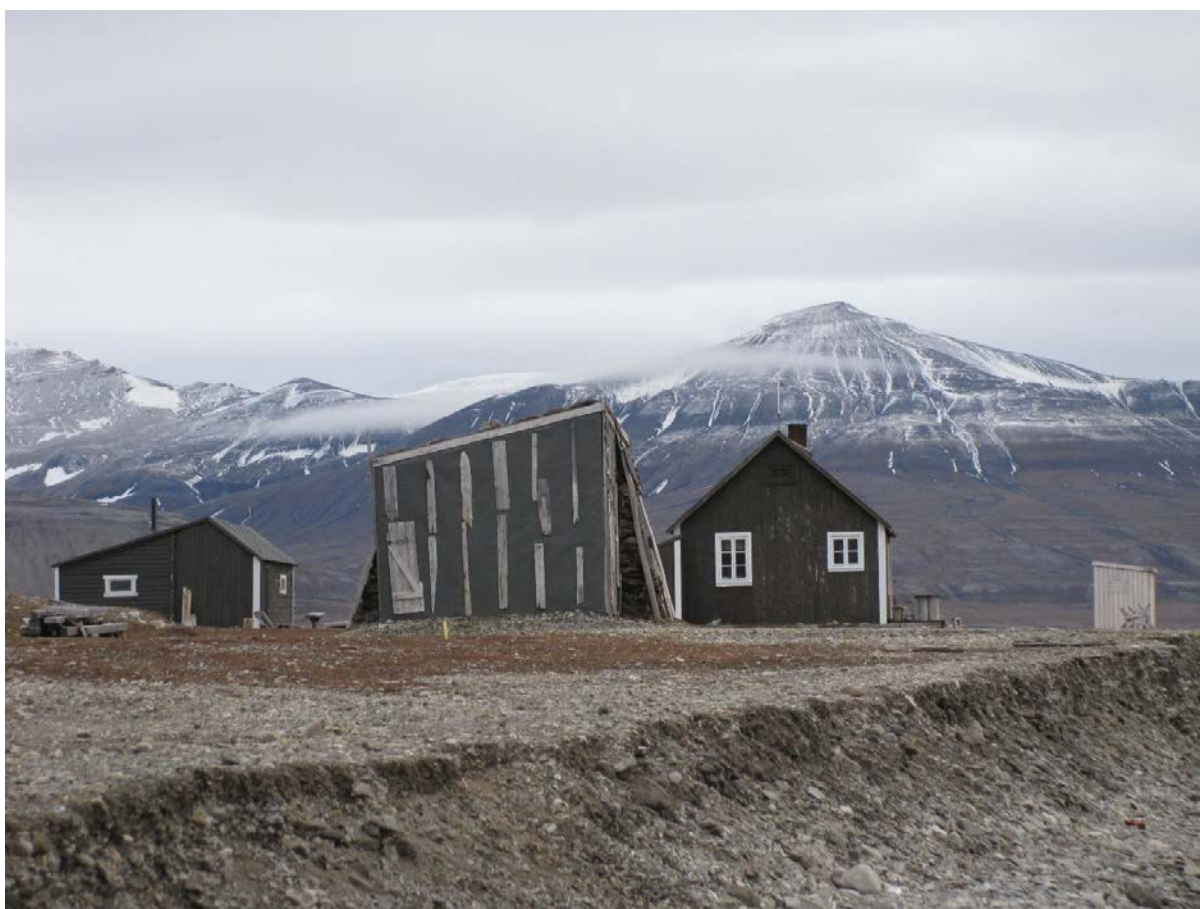
Image 9 Hunting station Fredheim close to the reosion edge. Photo: Anne-Cathrine Flyen, NIKU

Fredheim hunting station is threatened by coastal erosion. Over the past 20 years, reports repeatedly highlight that the station will be lost, if measures are not implemented. Currently, permafrost is limiting erosion, however, with increasing temperature of the active layer, this protection will reduce (M. Adakudlu et al., 2019).

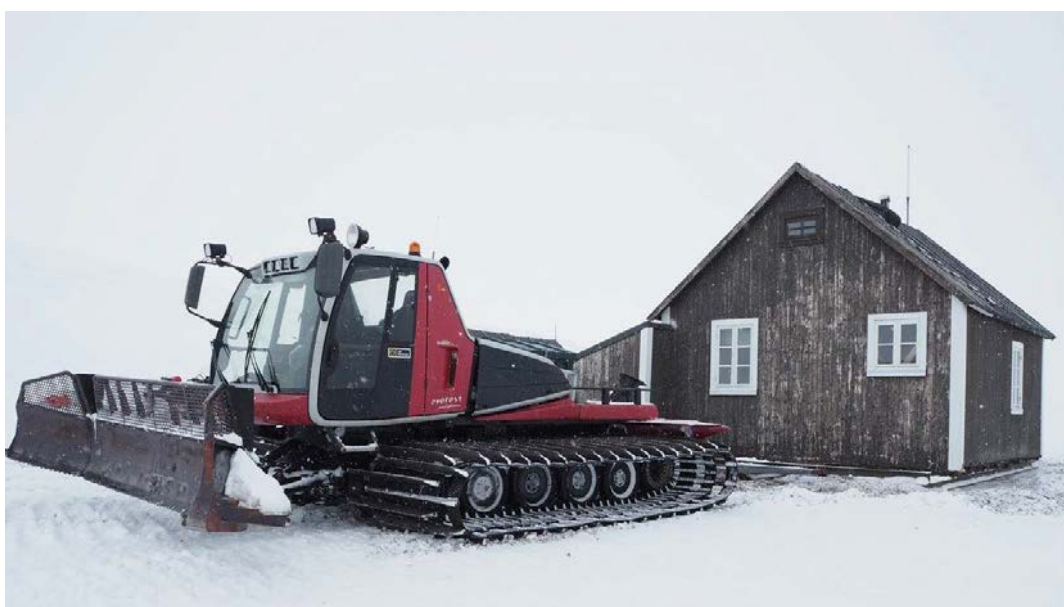
*Image 10 Relocation of Fredheim. Photo: Tone Hertzberg, Governor of Svalbard*

To prepare the cabin for the move, the floors and the barrel were removed. The building was reinforced from the inside and placed on a sledge made from steel. Preparations for relocation lasted a year but moving the main cabin Villa Fredheim only took a few minutes.

The entire hut was towed 50-60 meters away from the water's edge with a belt truck. The outhouses were also removed. The relocation went smoothly and the cabin was left on the steel foundation, which had been constructed to support it during the move. Remaining on the foundation means, it can be moved again in future, as erosion continues. Under medium to high emission scenarios, projections indicate an increase in erosion and sediment transport as well as near-surface permafrost thawing in coastal and low altitude areas (M. Adakudlu et al., 2019).

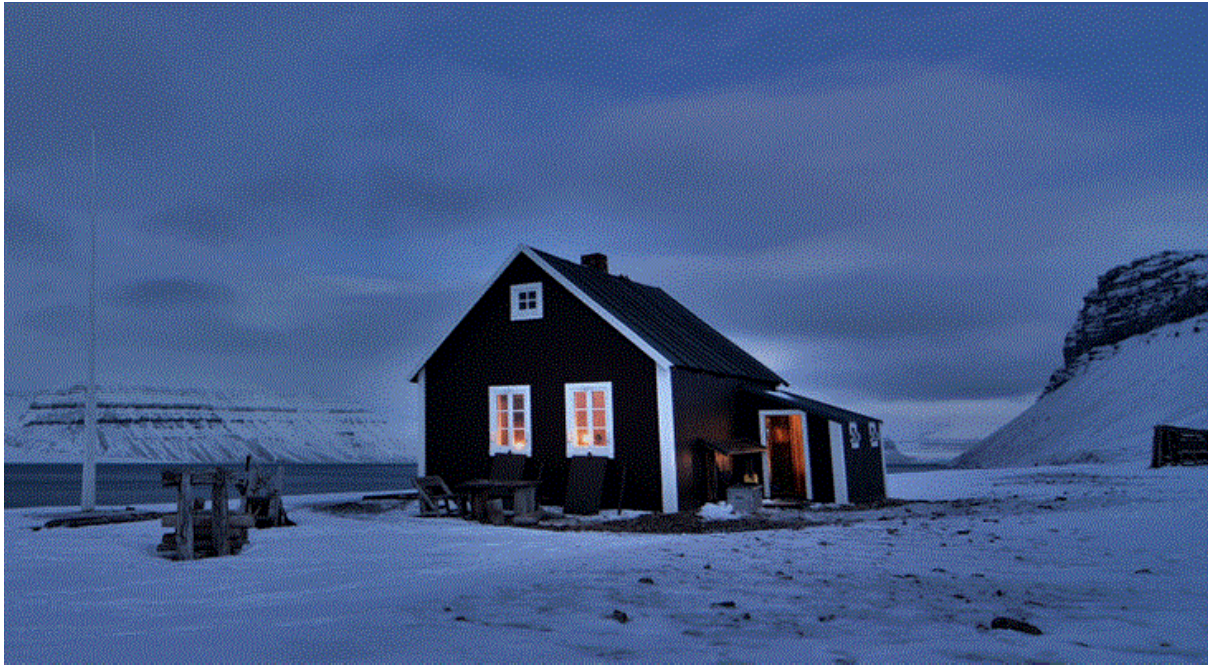
*Image 11 The main cabin at Fredheim 2019, Danielbu in the background, after relocation. Photo: Tone Hertzberg, Governor of Svalbard*

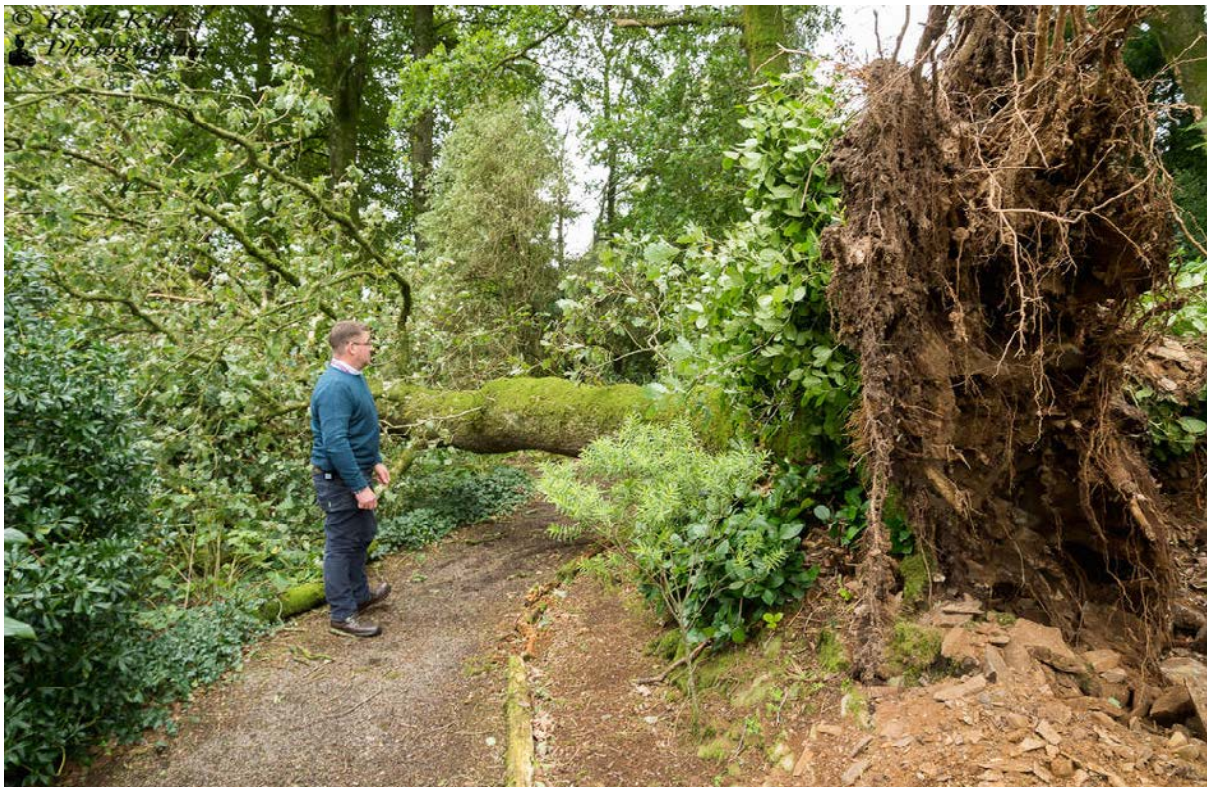
In 2018, Storm Ali caused 26 trees to fall. These trees varied in size, breed and age and resulted in a gap in the garden's shelter belt, a natural protection measure from more extreme weather occurrences based on the location of larger trees. This gap has resulted in a slow-acting domino effect that leaves the remaining trees more vulnerable. The lack of a continuation plan highlighted the importance of the natural shelter to the overall running of the garden. This shows, now more than ever, the need to adapt in the face of climate change should be brought to the forefront of conservation planning, education and training.

*Image 13 In the aftermath of storm Ali in September 2018, 26 trees fell in Threave Garden. Photo: National Trust for Scotland*

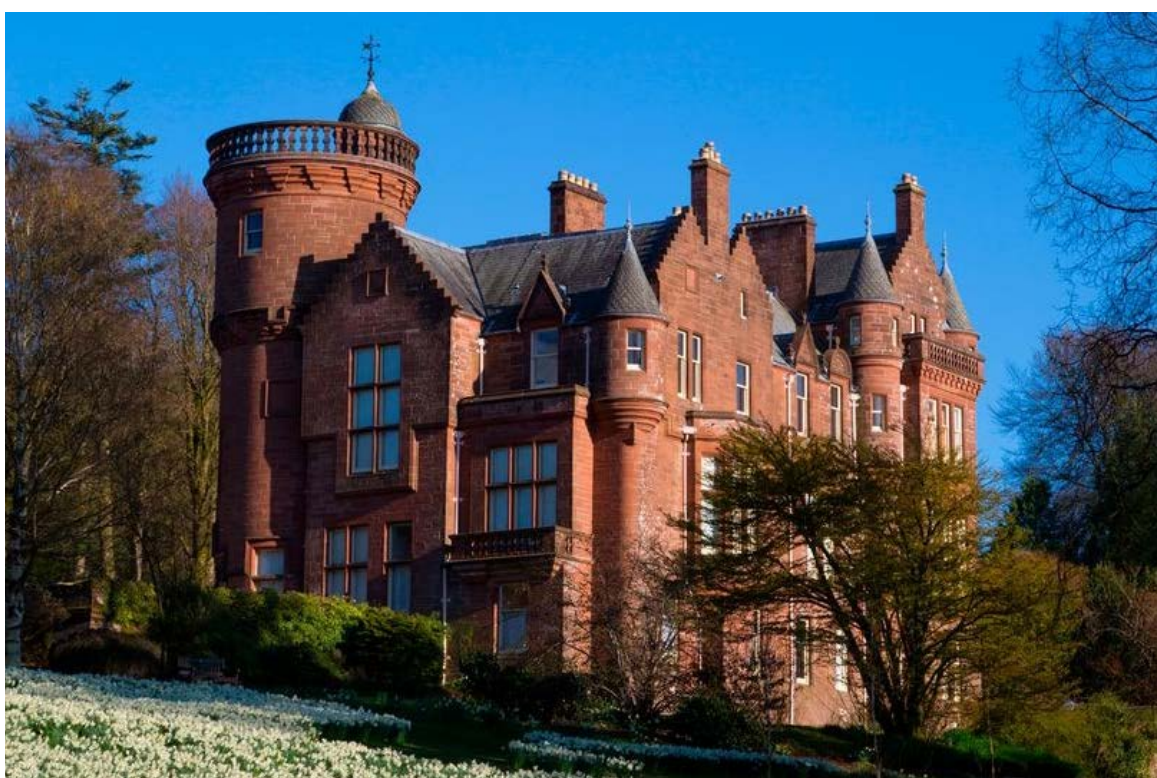
*Image 16 The Baronial House towering over the garden. Photo: The Daily Record*

Built in 1872 for William Gordon, this Baronial-style house was home to the Gordon family for many years. The land, including the estate was bequeathed to the National Trust for Scotland by Major Alan Gordon in the hopes of training a new generation of gardeners and caretakers. To this day, a gardening school is run by the National Trust for Scotland on the Estate, with new students recruited annually. The estate, house and gardens have been open to the public since 1960, with tours of the house conducted four times a week by local volunteers. Visitors are impressed by the Scottish Baronial style, which may have taken inspiration from Castle Fraser in Aberdeenshire.

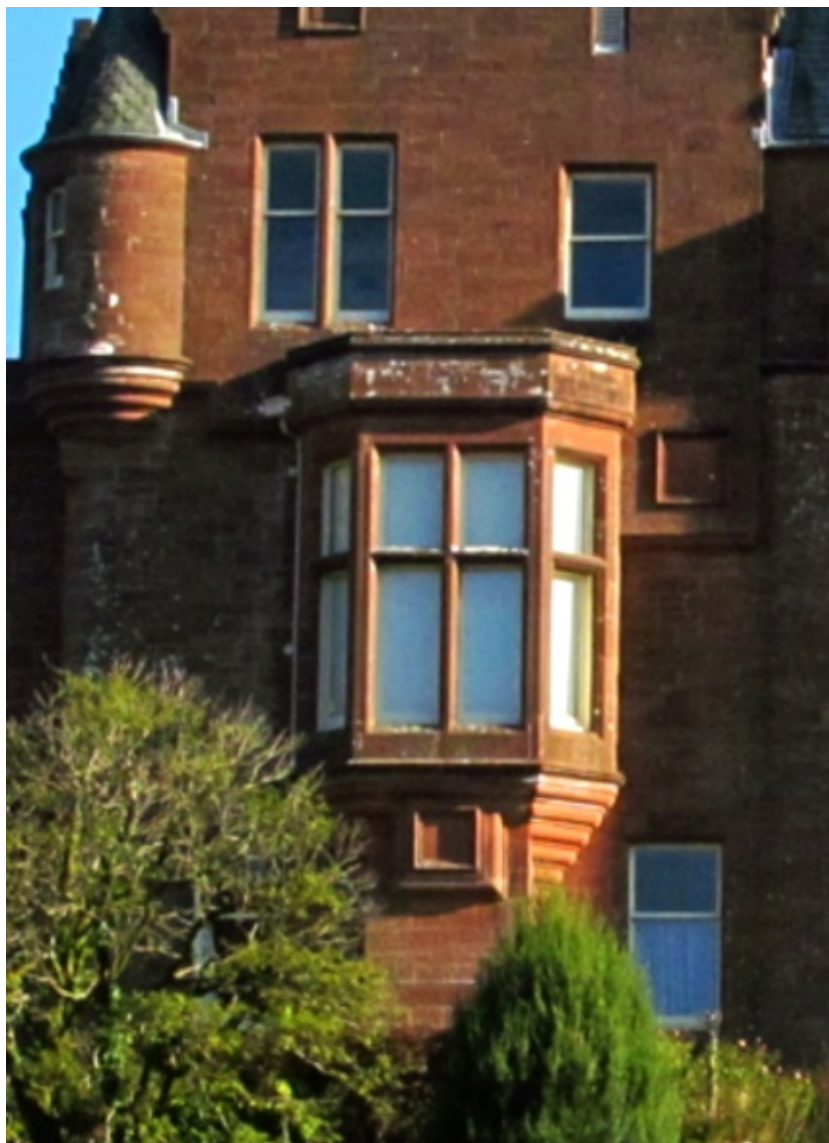
Existing hoppers and guttering on the house have been identified as struggling to cope with current precipitation levels. Particularly, the house's recessed roof above a west-facing bay window has experienced increased pressure onto its rainwater goods. A concealed pipe is too small to cope with the current precipitation levels. Combined with increased wind speeds, the west-facing window is impacted on by wind-driven rain. "Because of the frequency of increasing heavy torrential downpours, the rainwater goods are suffering from being overloaded by the sheer volume of water", Richard Polley observes. The more extreme weather events are causing this problem, he believes, and the increase in regularity makes the need for adaptation more pressing. Climate projections indicate fluctuations in precipitation, with decreasing levels in the summer months, but a 20% increase during the winter.

*Image 17 The west-facing bay window. Photo: The National Trust for Scotland*

Over the past years, work has been undertaken on the estate, including roof checks and remedial work. Extreme weather events have been increasingly considered and noted as part of routine maintenance at the house. In cooperation with Historic Environment Scotland, adaptation measures were applied over two years, following the maintenance work, to help with occasional overflow of the gutters at the west-facing bay window. Initially, the existing lead roof had been repaired, but as water was discovered to still be getting around the roof, it was decided to extend the lead. Its height was increased.

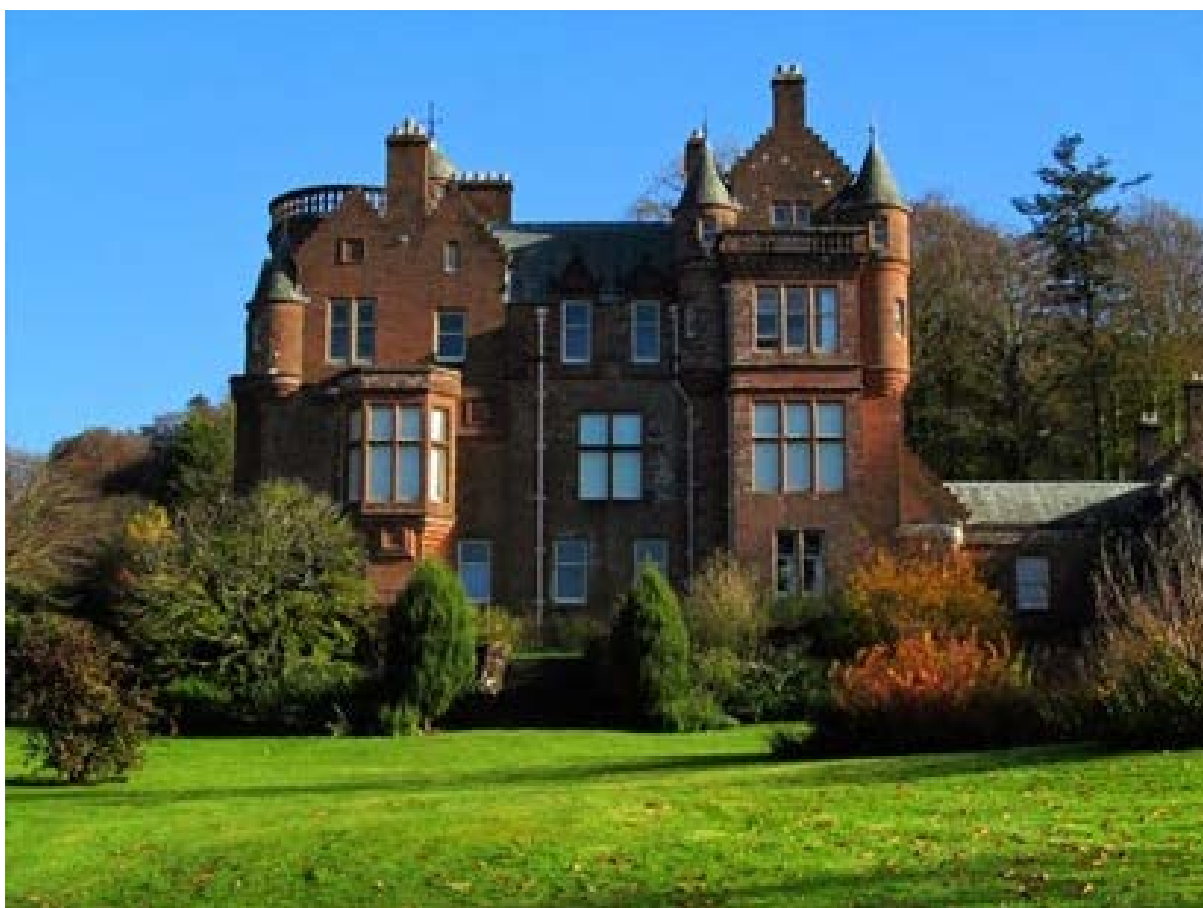
*Image 18 West facing side of the Baronial House. Photo: The National Trust for Scotland*

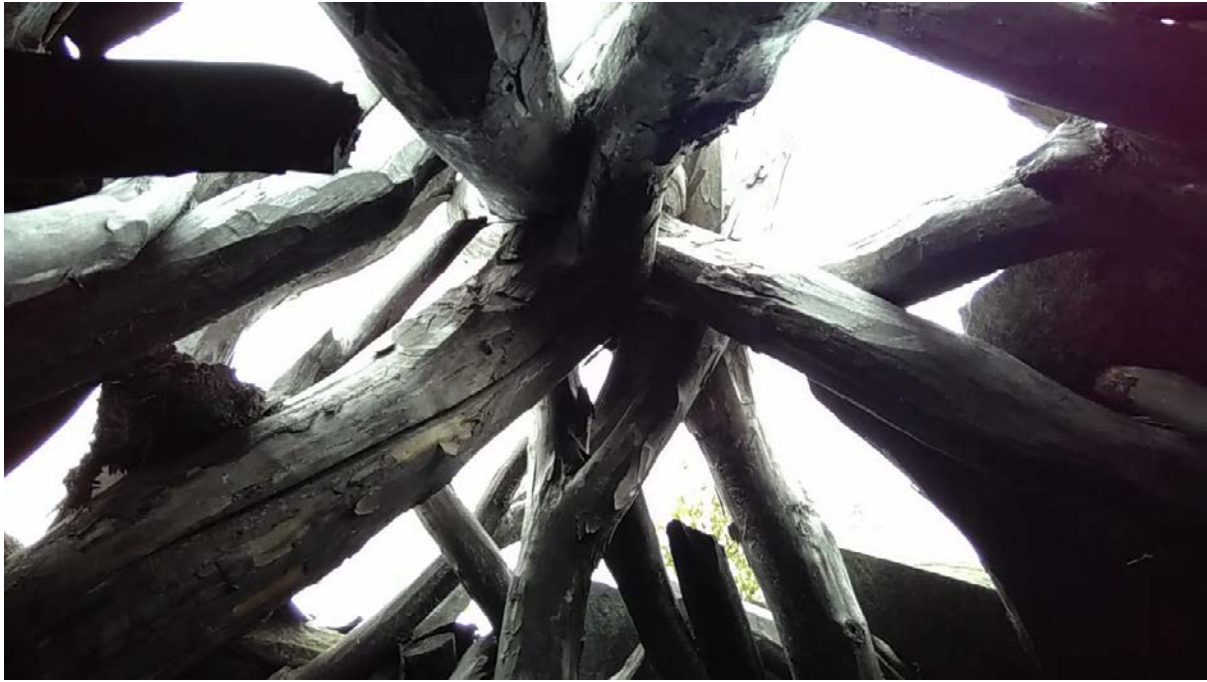
*Image 20 View of wooden construction of inside a traditional tipi. Photo: Jerker Bexelius, Stiftelsen Gaaltije*

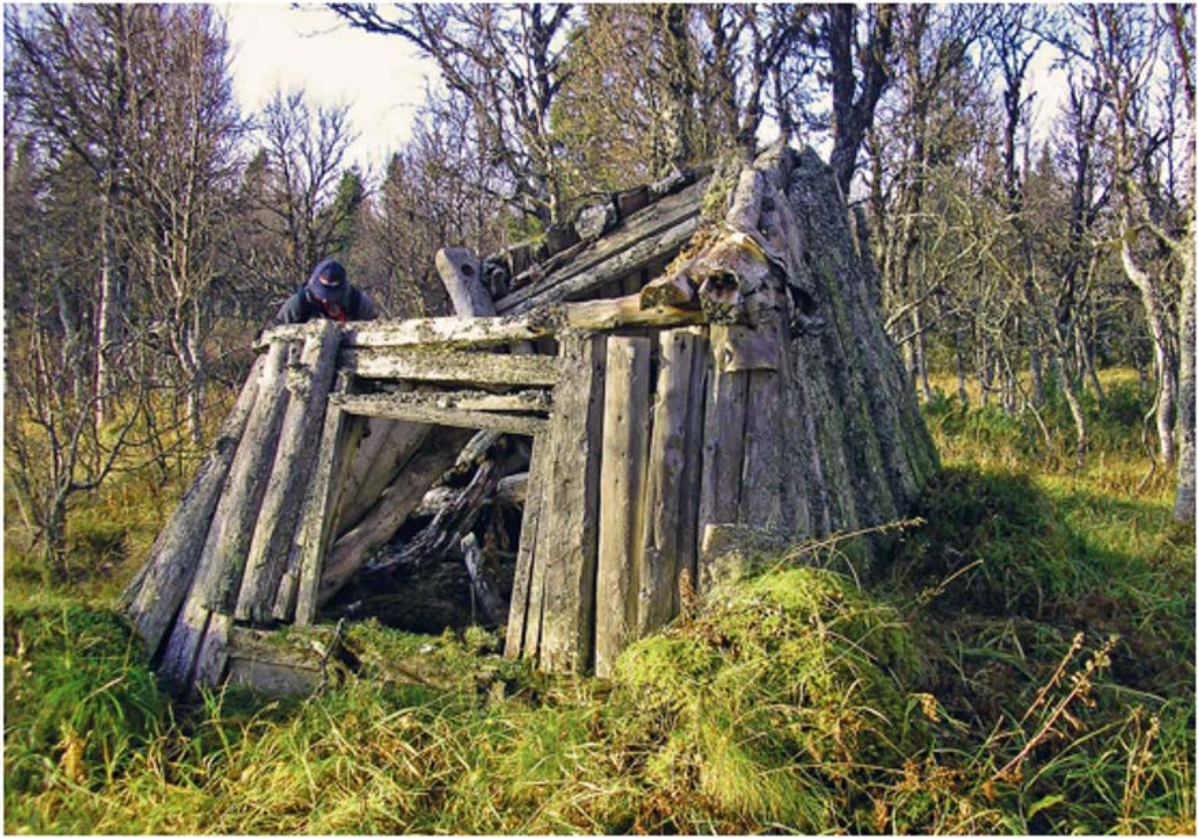
*Image 21 The camp's traditional tipi, made from turf and wood, falling into disuse and deteriorating quicker. Photo: Jerker Bexelius, Stiftelsen Gaaltije*
