CONSOLIDATING DISTEMPER PAINT - REVIEWING THE SUITABILITY OF STURGEON GLUE

Anne Apalnes Ørnhøi*, Tone Marie Olstad*, and Nina Kjølseth Jernæs*

*Norwegian Institute for Cultural Heritage Research (NIKU), Oslo, Norway.

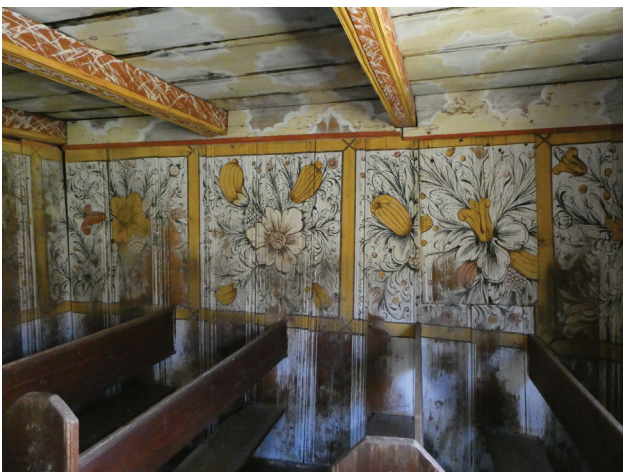
Figure 1. Example of distemper decorative painting in Nore stave church. Photo: Nina Kjølseth Jernæs, NIKU, 2020.

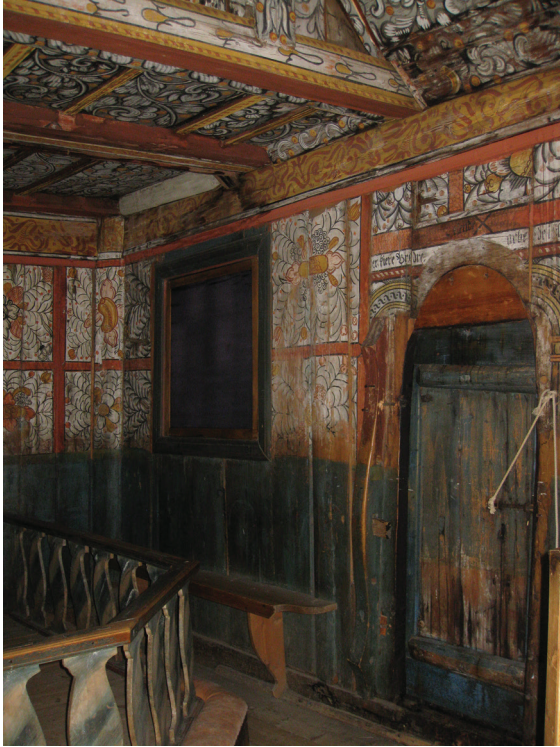
Figure 2: Distemper decorative painting in Uvdal stave church. Photo: Anne Apalnes Ørnhøi, NIKU, 2014.

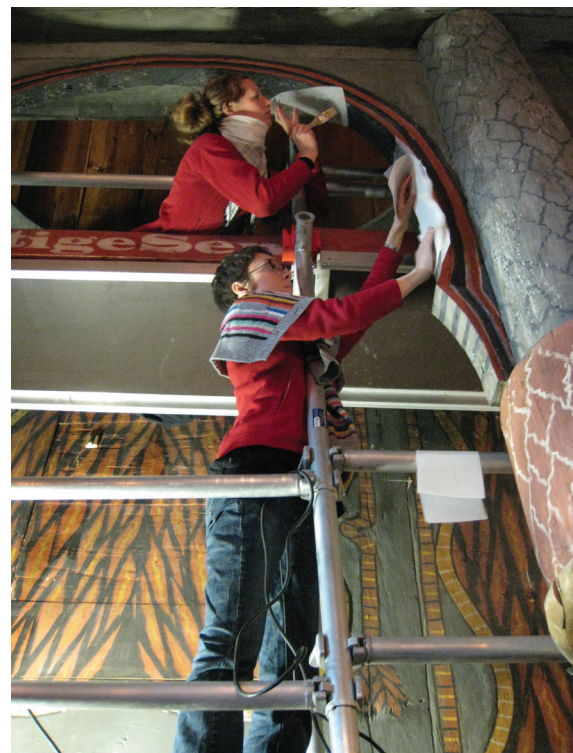
Figure 3. Consolidating distemper decorative painting with sturgeon glue in Ringebu stave church. Photo: Anne Apalnes Ørnhøi, NIKU, 2010.

Different methods of application of sturgeon glue were also explored. Application directly on the paint surface with a brush, application using Japanese tissue, spraying, the use of solvents before the consolidation material as well as solutions with different concentrations and temperatures were tried and assessed to find the most suitable method of application - a standard method that could be adjusted to the actual painting and situation.

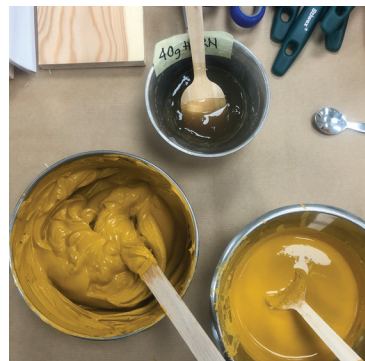
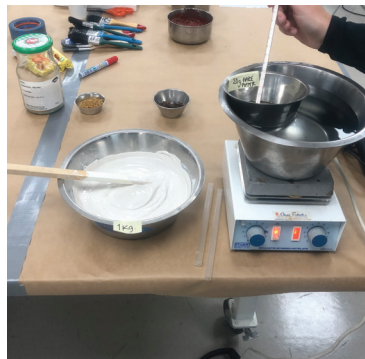
Figures 5 and 6: Making distemper paint on the course. Photo: Anne Apalnes Ørnhøi, NIKU, 2021.

To obtain more knowledge about the painting technique for parameter A, a course on making and applying distemper paint was held at NIKU. The aim of the course was to understand the observations made of the actual paintings: variations on the surface, the varying ratios between pigment and medium, the degradation based on the choice of pigment and how the painter worked. The two-day course for the conservators at NIKU was led by Professor Emeritus Jon Brønne. The intention was to see if the conservators could imitate the characteristics observed in the aged distemper paintings and to gain practical knowledge.

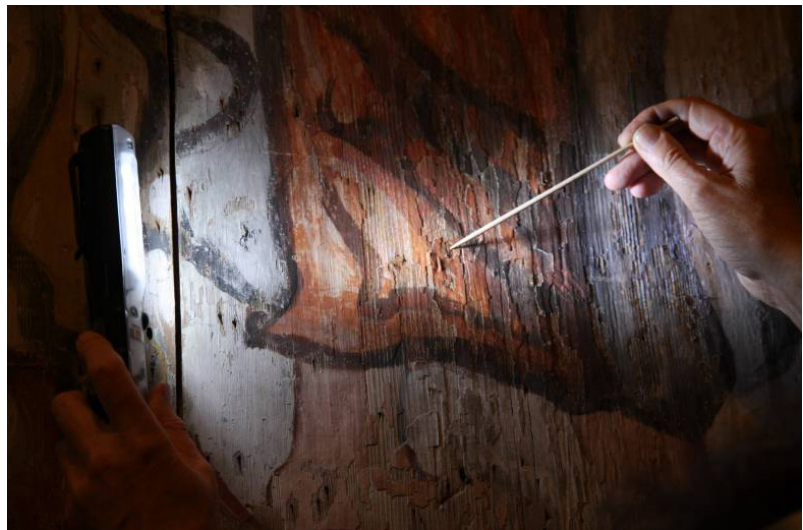
Figure 8: Flaking paint on the north wall in the chancel of Heddal stave church. Photo: Mille Stein, NIKU, 2013.

Both the Heddal and Ringebu stave churches have distemper decorative paintings with several paint layers and thick paint structures, often due to overpainting. Layers up to 1.5 mm thick were observed. Overpainting with distemper paint increases the thickness of the paint layer and complicates the penetration of the sturgeon glue. The Heddal and Ringebu stave churches both had reflaking paint 2–3 years after consolidation treatment.
