Fire performance of escape route doors in cultural heritage buildings A state-of-the-art review

Technical Report · April 2020

FRIC Research report no D.4.3-2019.02

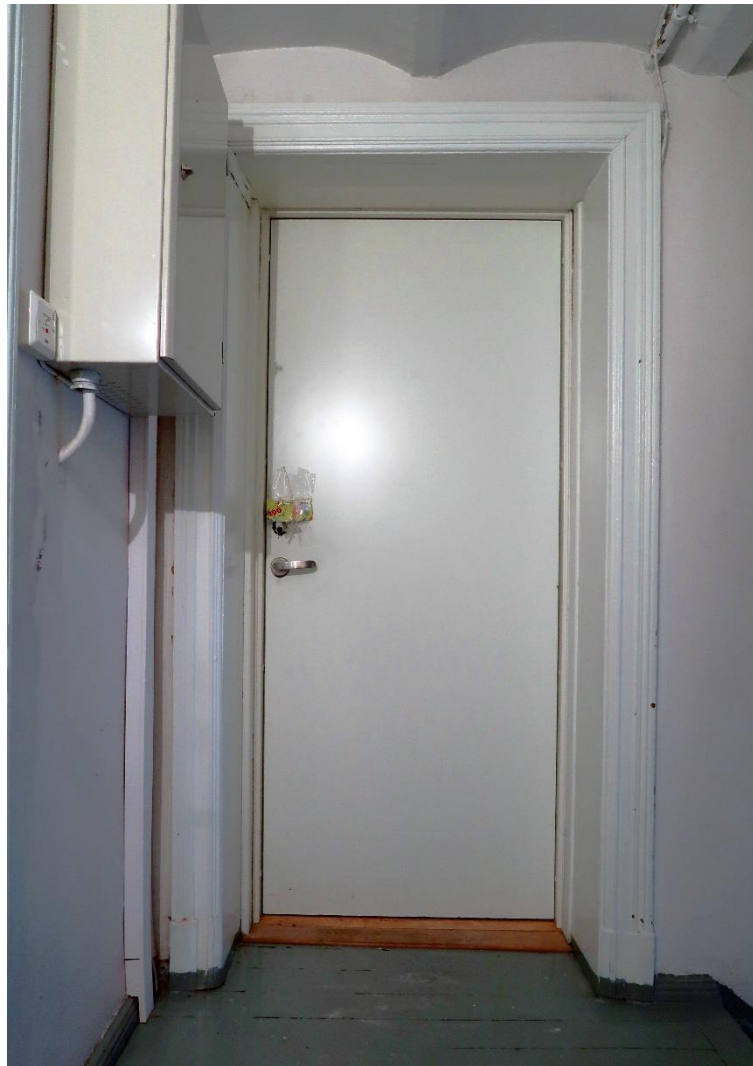
Figure 2-1 An example of replacement of unknown original door by a simple fire-rated door. Photo: B. Wedvik, NIKU, 2017.

Upgrading of existing doors can be done without losing the antiquarian values, and this is always recommended by cultural heritage authorities for old stairwell doors. From an antiquarian perspective, newly made "old style" doors cannot replace the aesthetic and historical qualities of an original door. Figure 2-1 shows an example where an original door has been replaced by a simple fire-rated door.

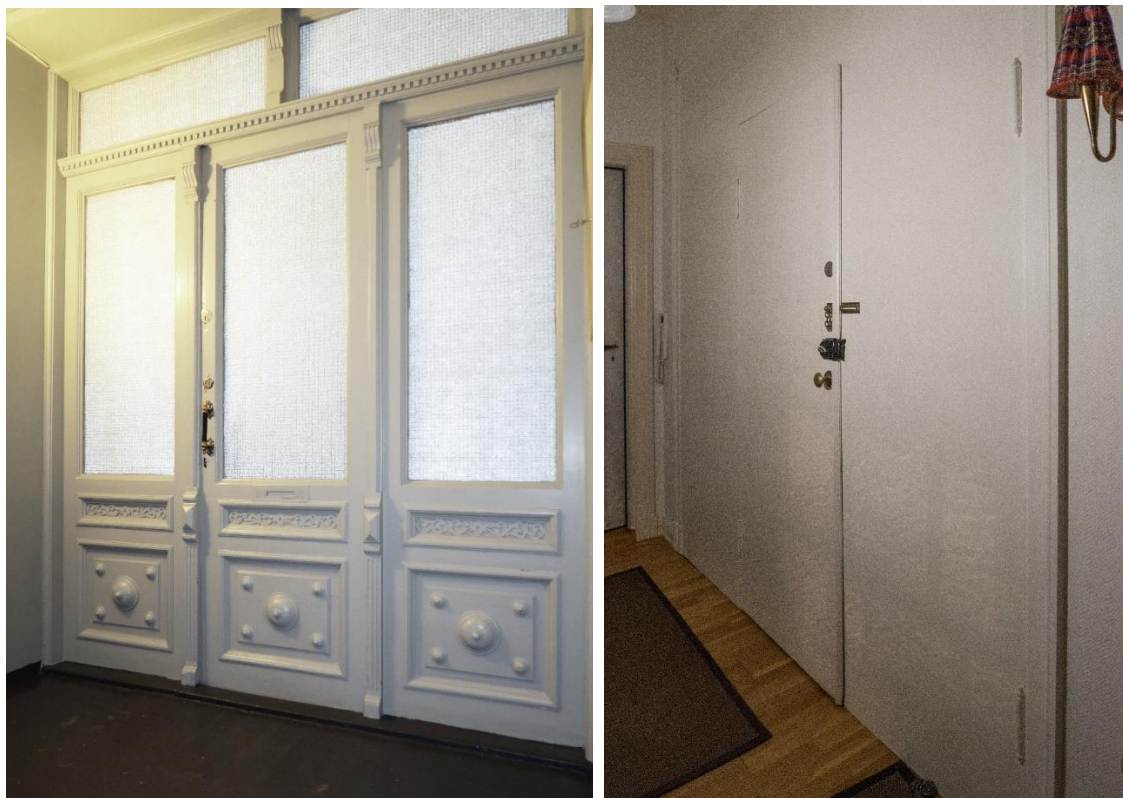
Figure 2-2 The picture to the left shows an example of door upgrading following The SINTEF Building Detail Sheet 734.503, stairwell side. The picture to the right is an example of door upgrading following The SINTEF Building Detail Sheet 734.503, apartment side. Photo: B. Wedvik NIKU, 2017.

This is a fire-technical improvement of old wooden filling doors where the door side to the apartment is covered by a fire-insulating board when parts of the door - most often mirrors, friezes or glass - do not meet the safety requirements, while the door side towards the stairwell is preserved as it is. An insulating board of plywood, chipboard or plaster is installed on the apartment side of the stairwell door, as is depicted in the left hand picture in Figure 2-2. The right hand picture in Figure 2-2 shows an example where the entire door area is covered by fire insulation boards. The original handle, hinges and astragal moulding are kept. In other examples of upgrading given in the SINTEF Building Detail Sheet 734.503 only the door lite and thinner wooden parts as panel and panel profiles are covered.

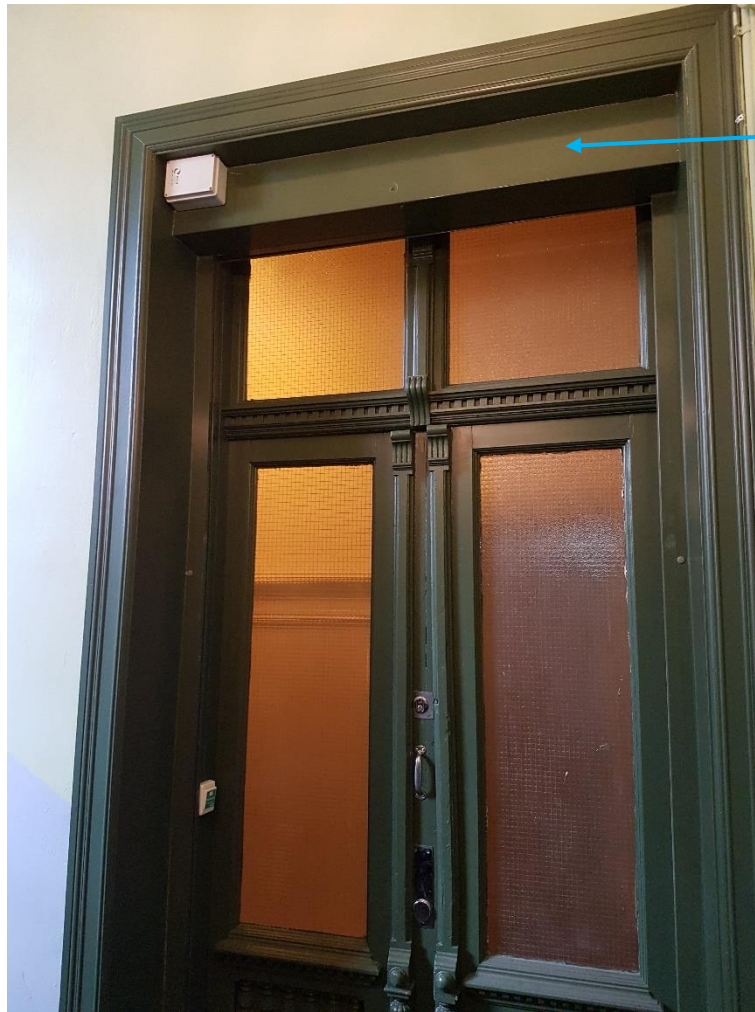
Figure 2-4 Fire curtains in front of stairwell door, Oslo. The fire curtain is inside the horizontal green box on the upper part of the door, see blue arrow. Photo: A. Korsaksel, Byantikvaren, 2018.

Fire- and smoke curtains have been used for upgrading a staircase room in Oslo, see Figure 2-5. This is a non-invasive solution and should be considered.

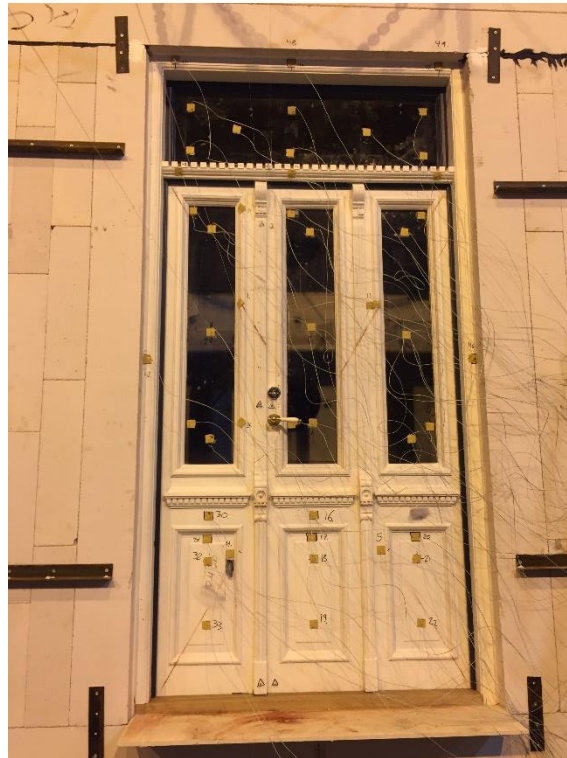
Figure 2-5 Fire resistance test set-up for old stairwell door. Thermocouples are shown attached to door, registering the temperatures on the unexposed side. Photo: B. Wedvik, NIKU 2019.

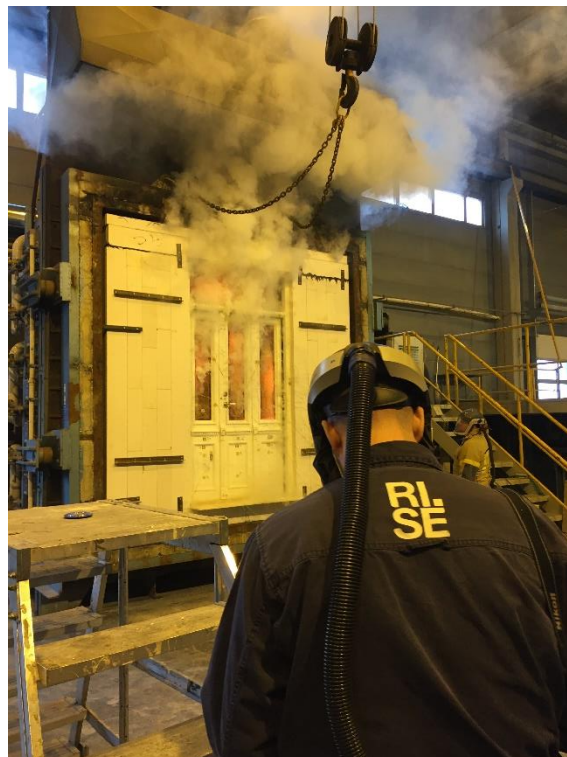
Figure 2-6 Fire resistance test. Glass panes have broken, smoke and flames are visible. Photo: B. Wedvik, NIKU 2019.

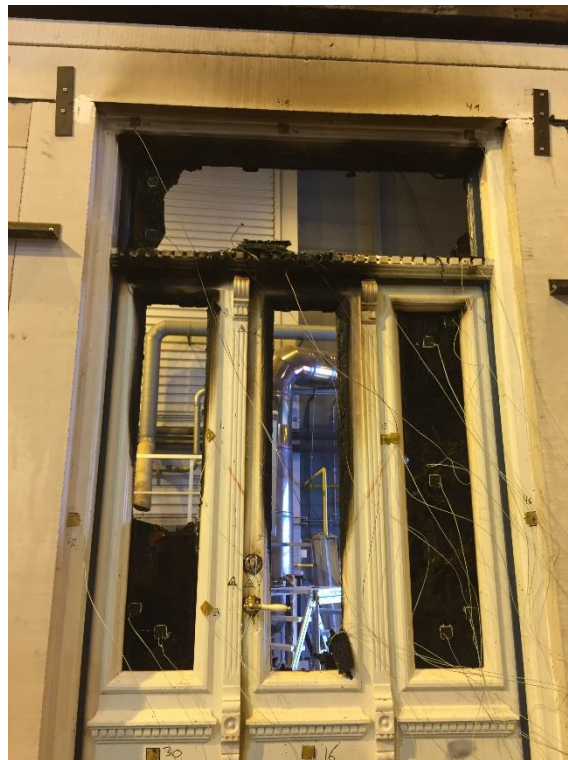
Figure 2-7 Fire resistance test. Test is ended. All glass panes are broken. Photo: B. Wedvik, NIKU 2019.
